Wild Center Property Condition Assessment

LaBella Project No.: 2244417
Prepared On: 11/6/2024

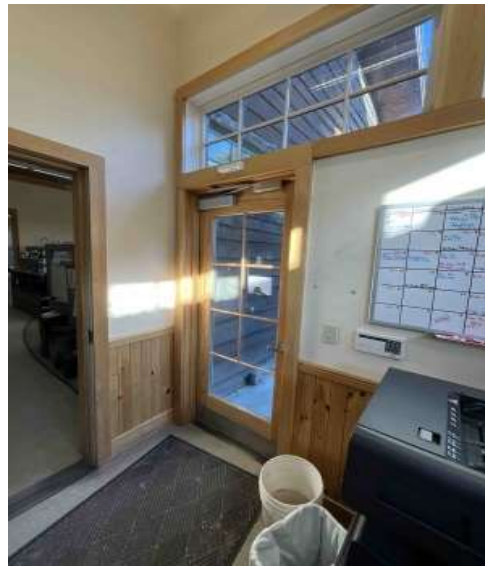
Building	Space Number	Space Name	Element	Description	ID
Bio Building	101	Vestibule	Arch	Exterior door wear is showing. 3-5 yr replacement expected	004

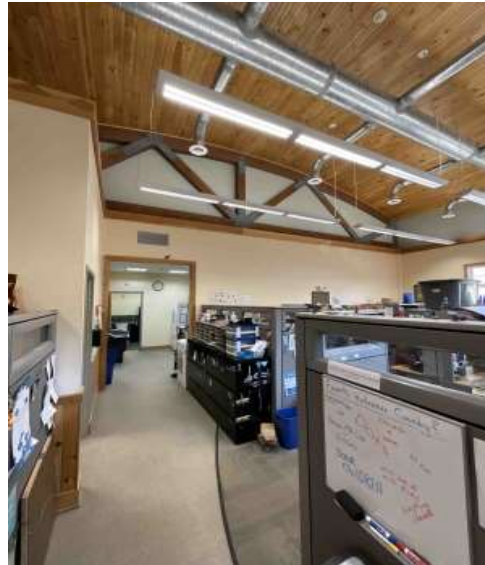
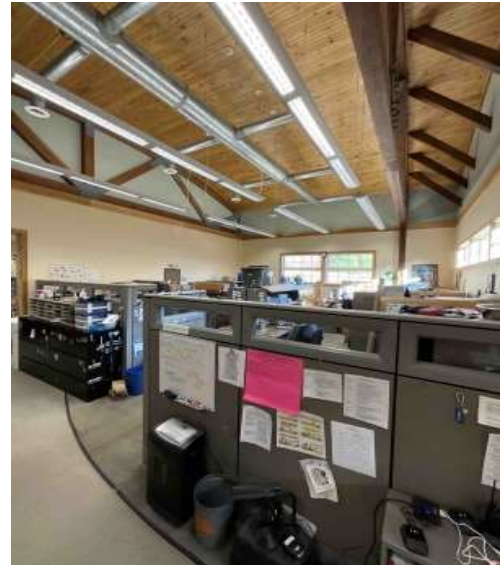
Bio Building	103	Naturalist Office	Arch	Windows in good condition	009
--------------	-----	-------------------	------	---------------------------	-----

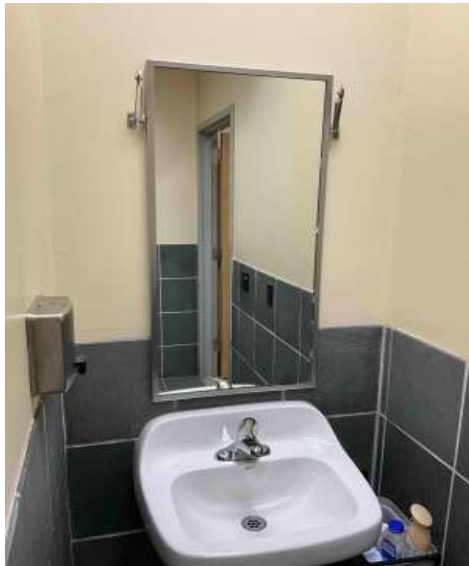
Bio Building	107	HC Bathroom	Elec	LIGHTING CONTROLS	057
--------------	-----	-------------	------	-------------------	-----

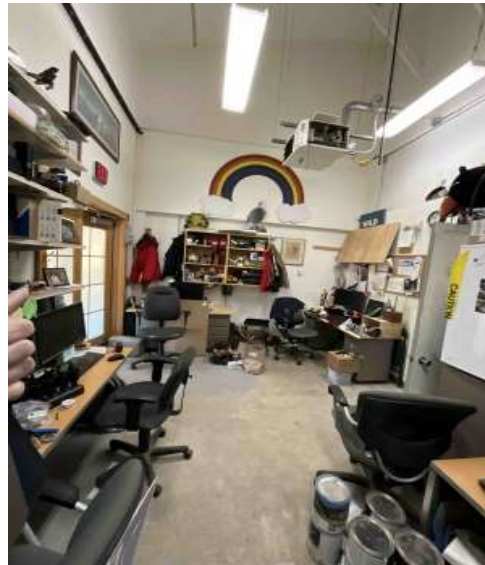
Bio Building	110	Event Storage/Garage	Arch	Floor seal required, minor cracking.	023
--------------	-----	----------------------	------	--------------------------------------	-----

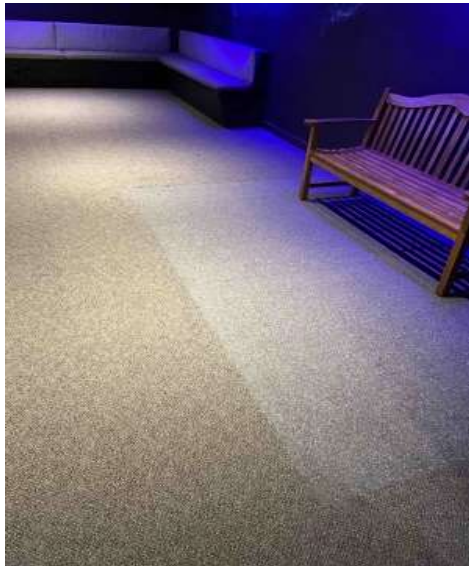
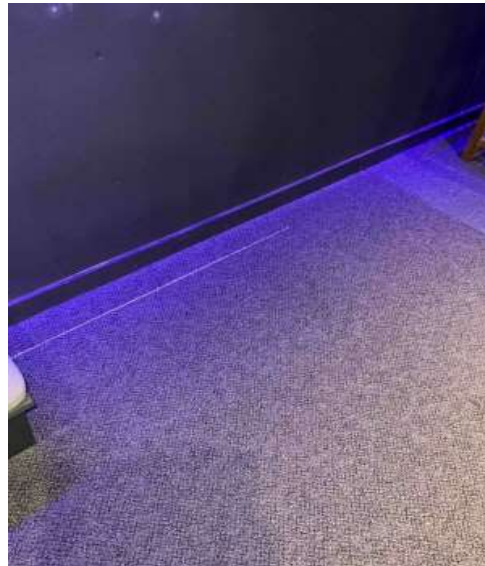
Museum	N/A	Arch	Flooring needs resealing	227
--------	-----	------	--------------------------	-----

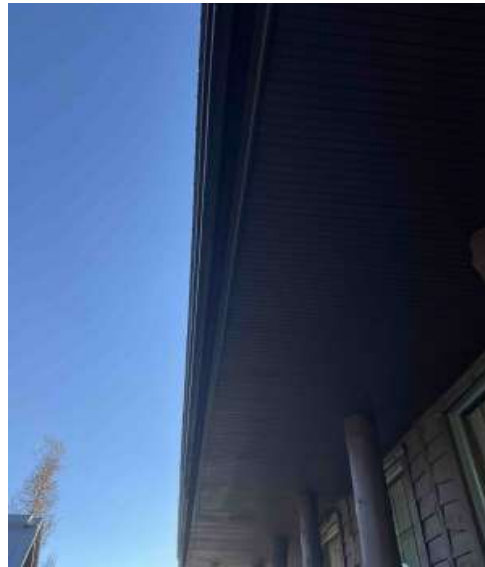
Museum	000	Exterior	Siding	Damaged Paint	183
--------	-----	----------	--------	---------------	-----

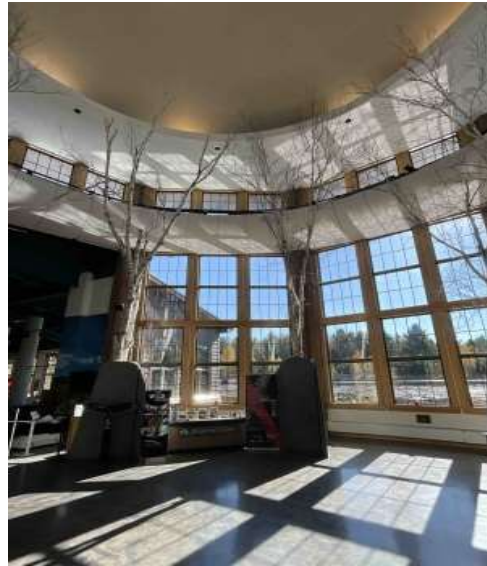
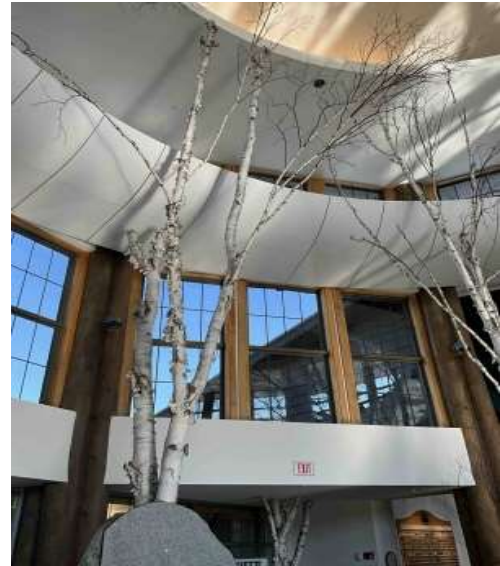
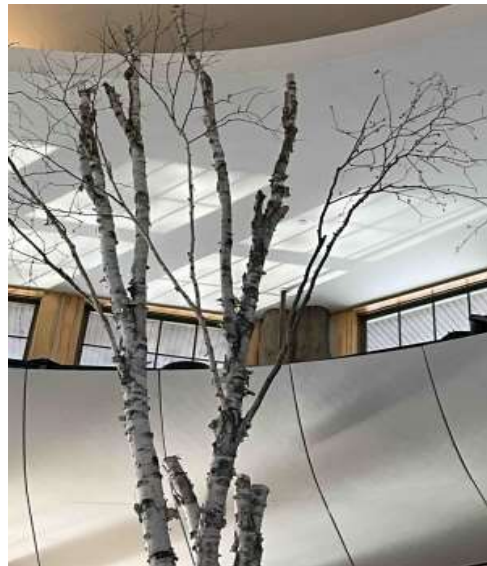
Building	Space Number	Space Name	Element	Description	ID
Museum	101	Great Hall	Arch	Window refinishing to start Replacement in 5 years estimate	225

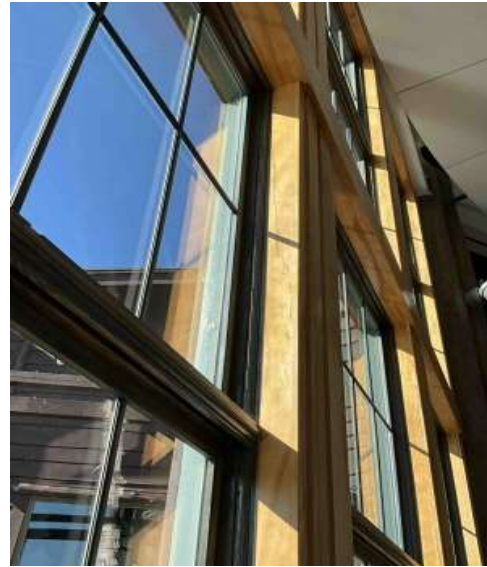
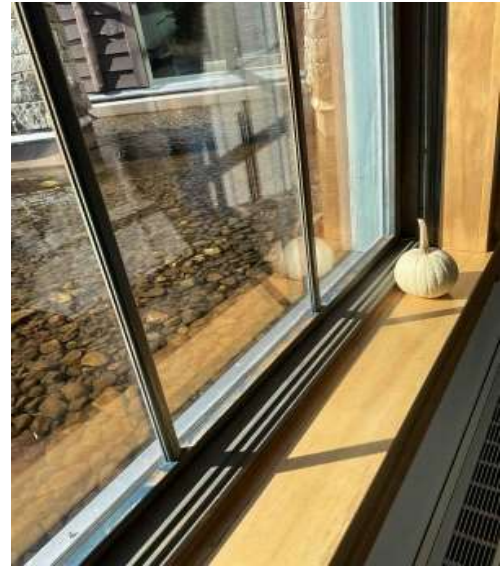
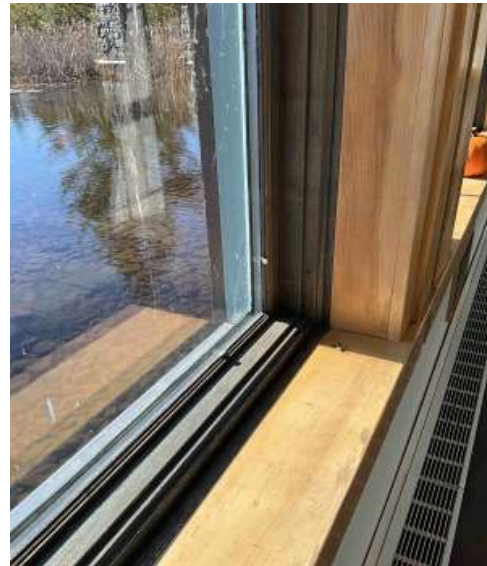
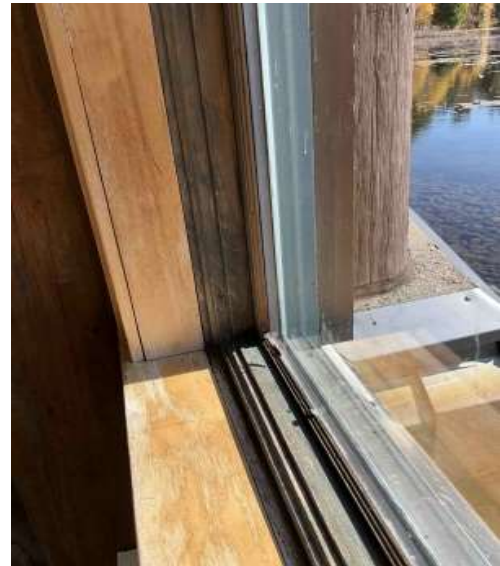
Building	Space Number	Space Name	Element	Description	ID
Museum	101	Great Hall	General Interior Condition	General interior conditions	257

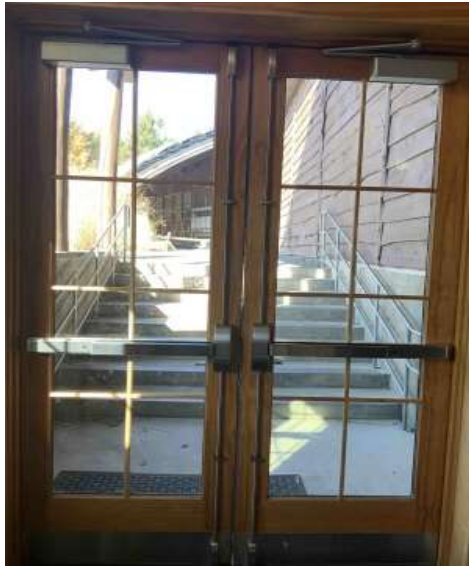
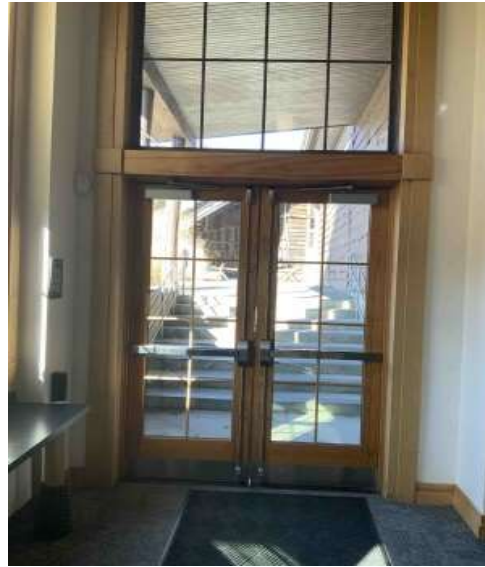
Museum	102	Laboratory	General Interior Space	General interior condition	037
--------	-----	------------	------------------------	----------------------------	-----

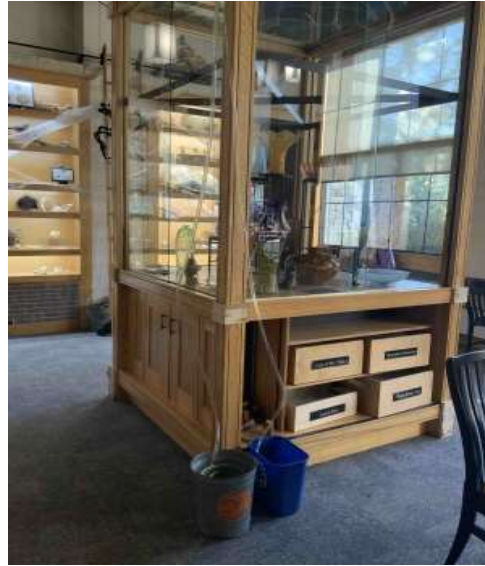
Museum	102	Laboratory	Interior Finishes	Plumbing fixtures outdated	042
--------	-----	------------	-------------------	----------------------------	-----

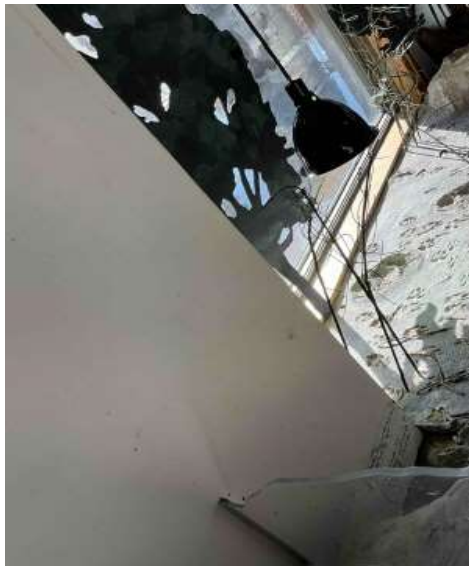
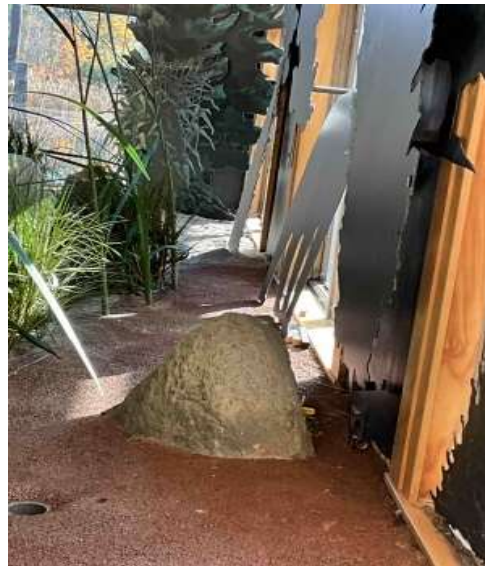
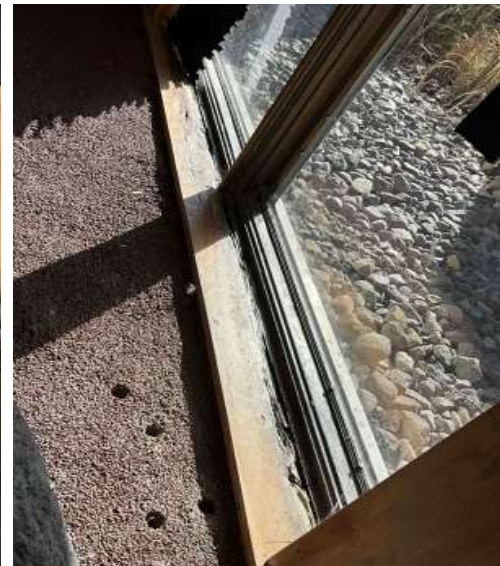
Museum	109	Exhibit Hall	Arch	Wood window deterioration significant concern	217
--------	-----	--------------	------	---	-----

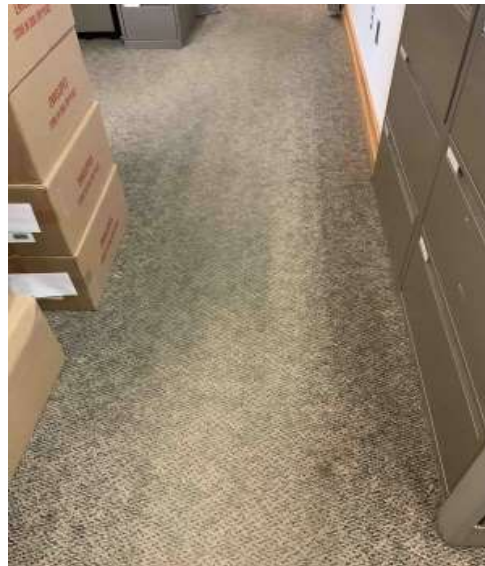
Museum	123	Kitchen	General Interior Condition	General interior conditions - floor fair, ceiling fair; door good, fixtures fair	250
--------	-----	---------	----------------------------	--	-----

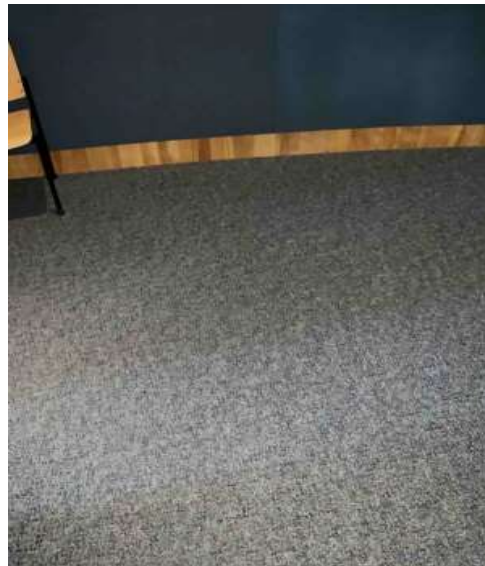
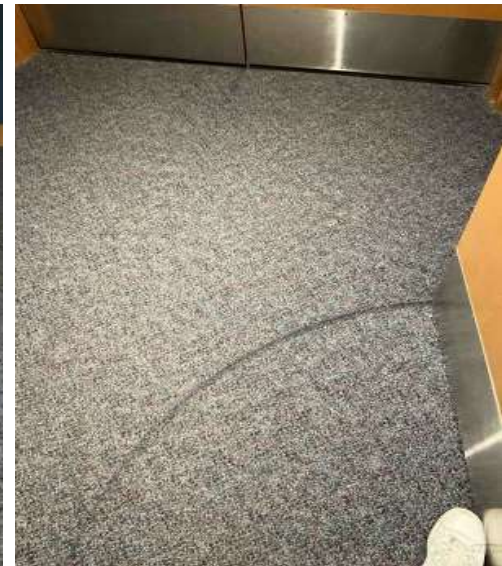
Museum	130	Theater	Arch	Carpet stains	233
--------	-----	---------	------	---------------	-----

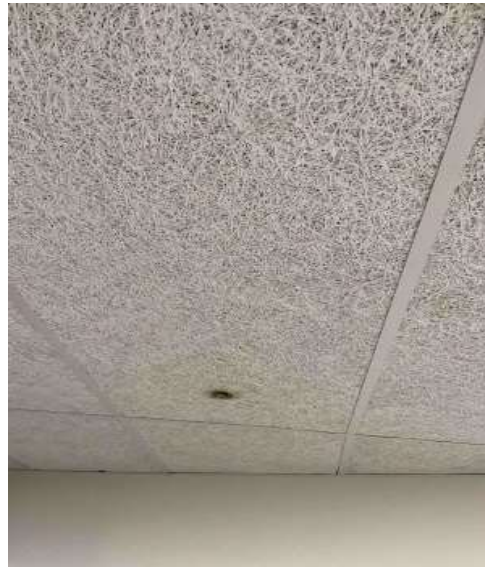
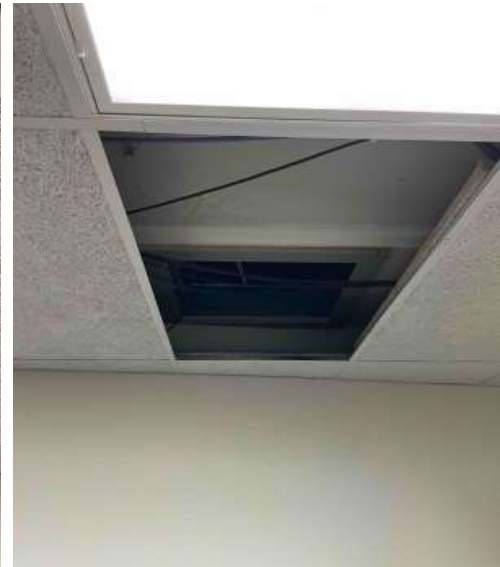
Museum	201	Projection Booth	Arch	Ceiling tile missing and sprinkler head cover missing 033	
--------	-----	------------------	------	---	--

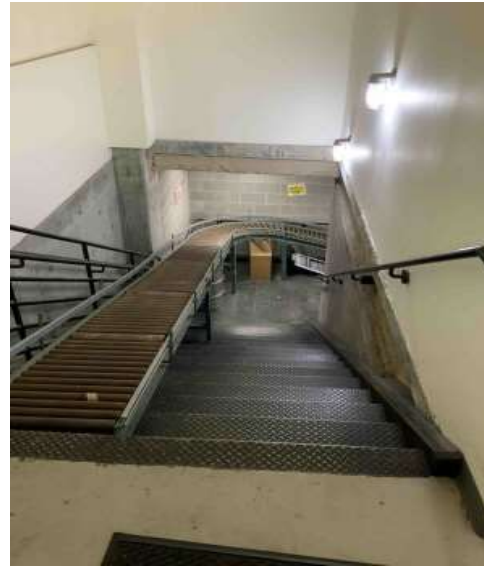
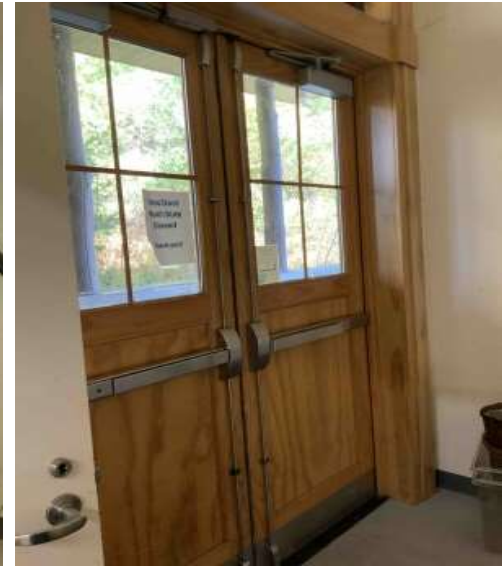
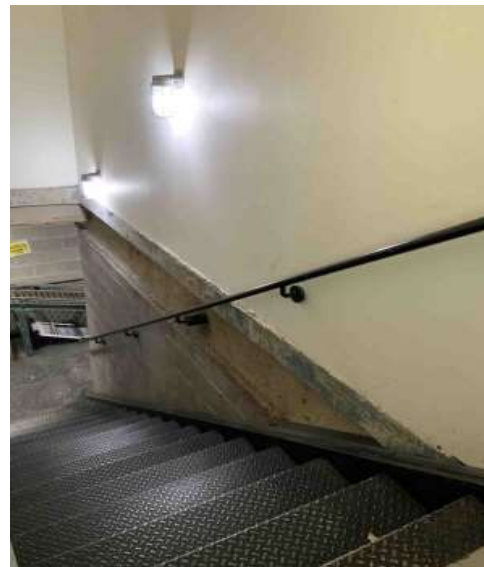
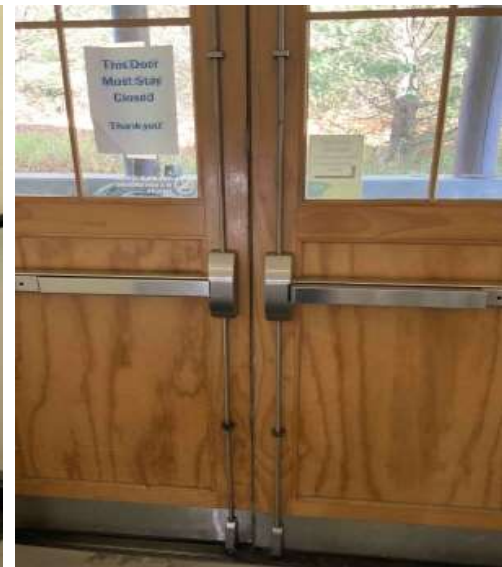
Building	Space Number	Space Name	Element	Description	ID
Museum	SA	Stair A	General Interior Condition	General interior conditions - poor	178

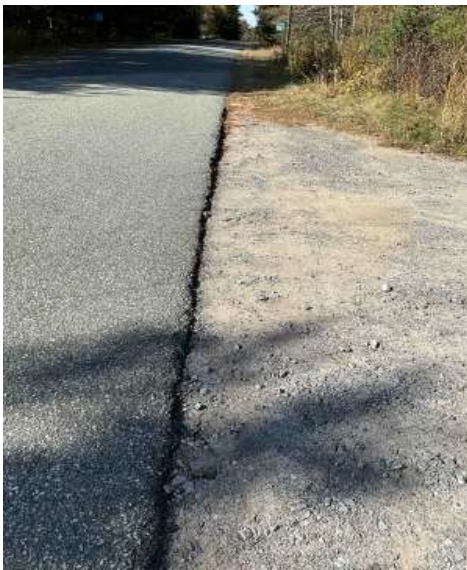
N/A		Civil/LS	Asphalt cracking wear and tear	061
--	-----	--	----------	--------------------------------	-----

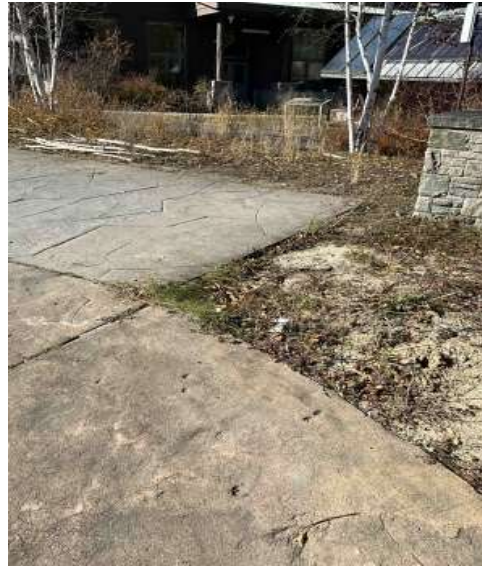
N/A		Civil/LS	Concrete Tripping hazard	132
--	-----	--	----------	-----------------------------	-----

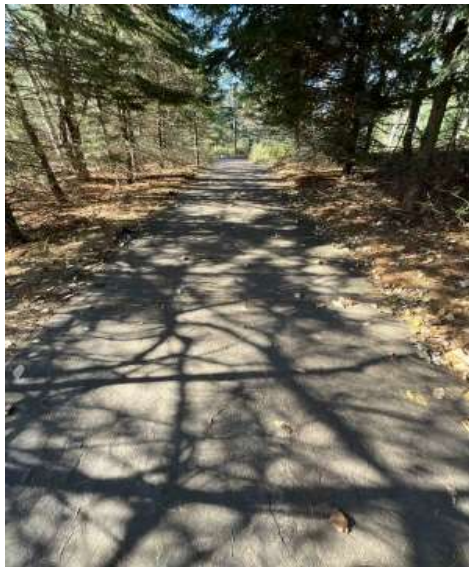
N/A		Civil/LS	Surface change	182
--	-----	--	----------	----------------	-----

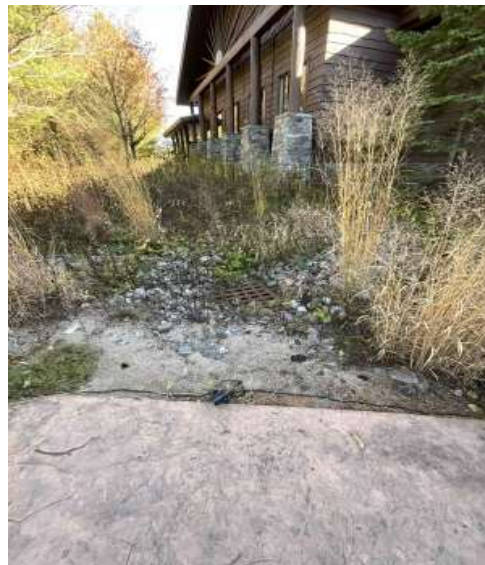
Building	Space Number	Space Name	Element	Description	ID
		N/A	Civil/LS	Concrete Tripping hazard Concrete	189

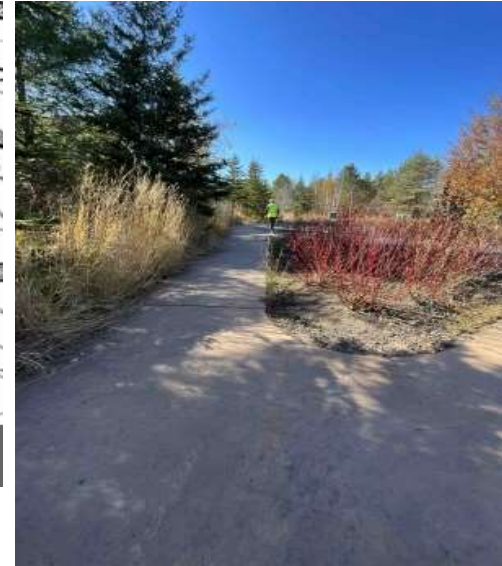
Building	Space Number	Space Name	Element	Description	ID
		N/A	Civil/LS	Concrete Tripping hazard Concrete	191
