## WILD CENTER PROPERTY CONDITION ASSESSMENT NARRATIVE

### 01 EXECUTIVE SUMMARY

#### FINDINGS REPORT AND CONCLUSION

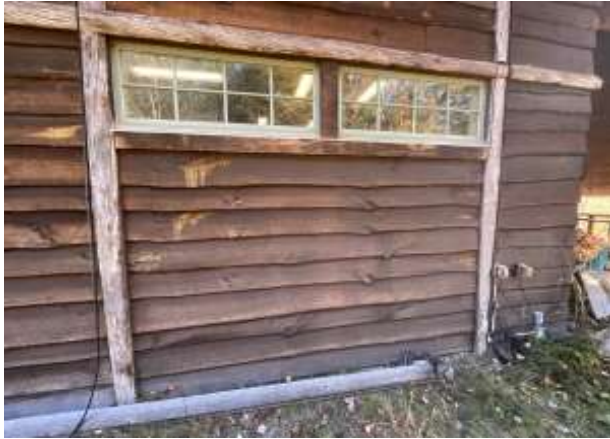
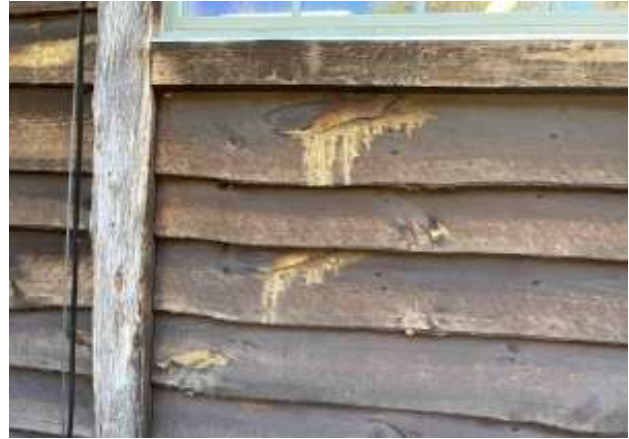
The wood siding on the building is deteriorating and damaged in multiple areas around the perimeter. There is some damaged timber trim at and near windows as well. It will be important to maintain a schedule to re-stain the exterior envelope every 5-7 years. During this re-application of stain selected areas of siding that are showing more significant damage should be replaced or repaired. Overall, the exterior siding condition is good and can be elevated to excellent with a combination of deferred maintenance efforts and limited replacements.

*Siding condition examples*

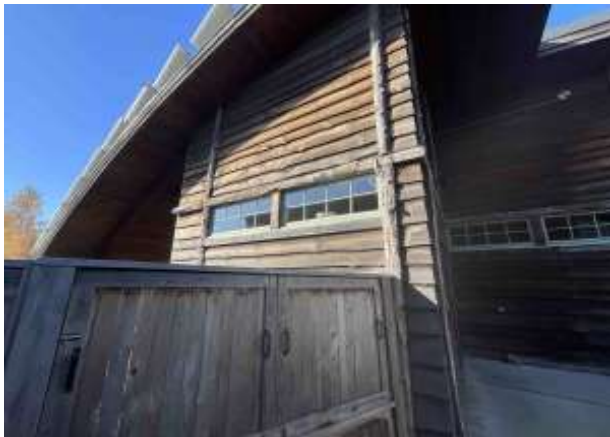
*Damaged timber trim*

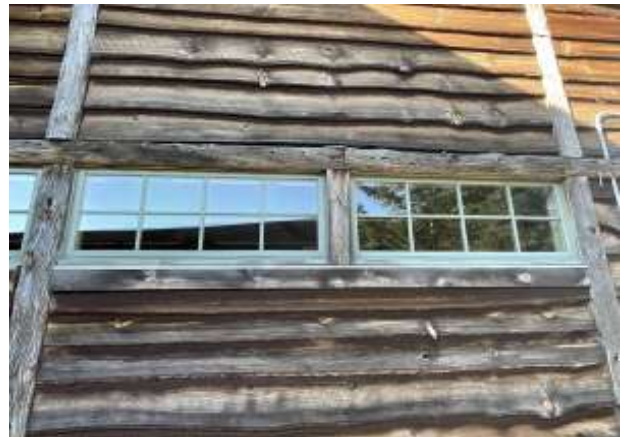
*Damaged window sill trim*

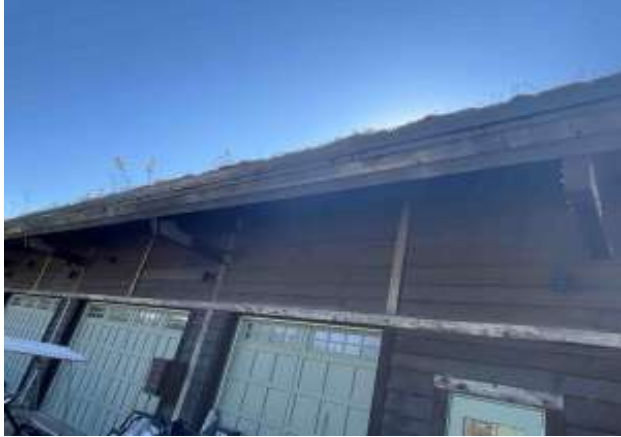
The fascia boards are experiencing significant degradation. There is evidence of decay and visual observance of moss growth along the drip edge and fascia boards. Failing roof flashing along the south edge at the solar panel locations also requires full replacement. Replacement of the roof edge components should occur within the next 3-5 years. The TPO roofing membrane appears to be performing well and there is no evidence of roof leaks at the Bio Building. The Green Roof systems also appears to be in good condition and performing as expected. The life expectancy for a green roof system like this is typically 30-50 years, and replacement should be considered in approximately 10-15 years. The PV panels are aging out, and the electrical narrative in this report details opportunities to capitalize on improvements for this system. Overall, the roof condition is good, and the fascia, soffit and flashing elements are in poor condition.

*Moss growth at roof edges*

- Address failing fascia, flashing, and soffit at the roof perimeter to prevent water infiltration and minimize future damage within 3-5 years.
- Monitor the roof membrane, which has an estimated lifespan of 10–15 years, for signs of wear. Plan for green roof TPO and plant replacement in 10-15 years.

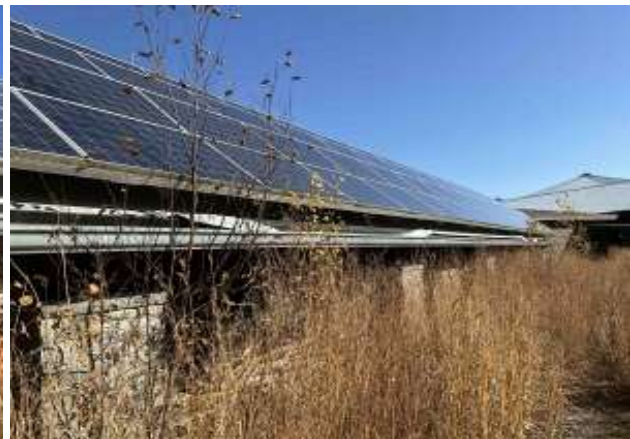
*Roof flashing at solar panel locations*

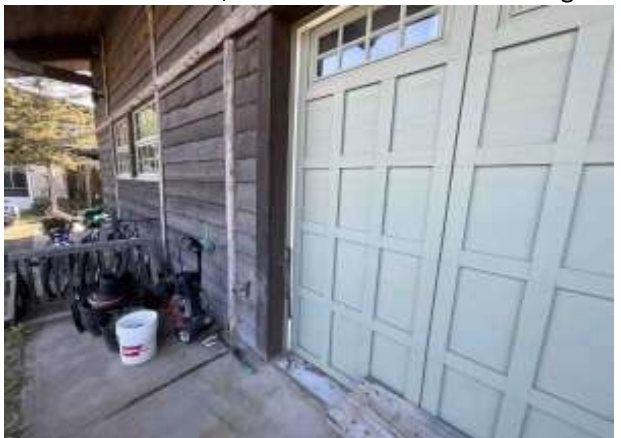
*Damaged jamb trim at 108B*

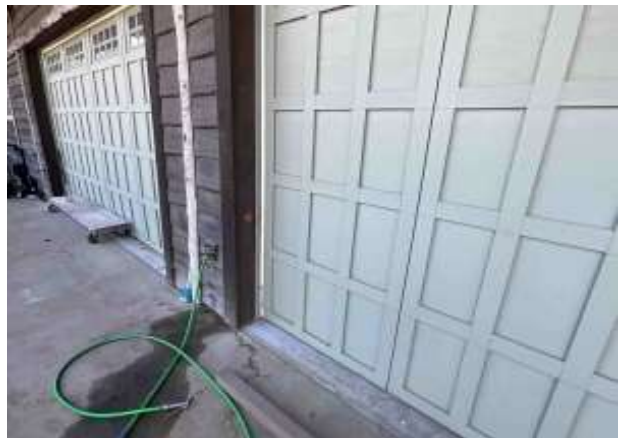
*Damaged jamb trim at 108A*

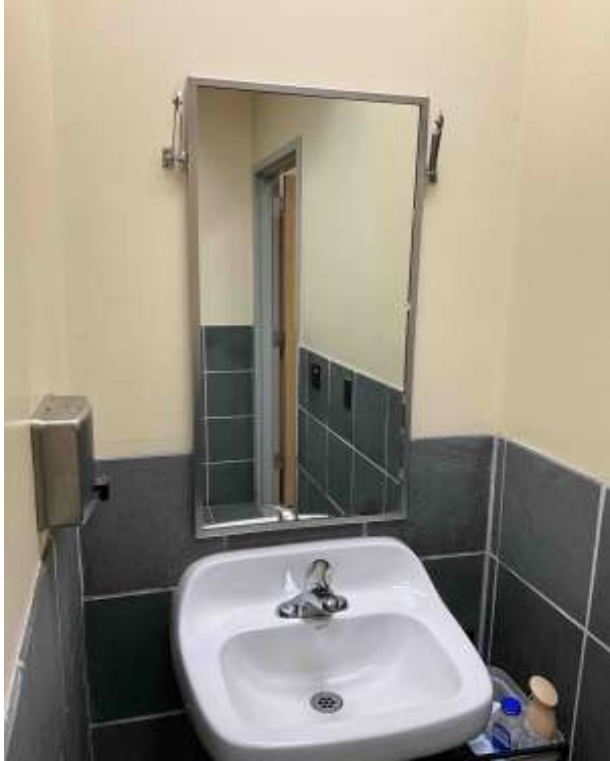
*HC Bathroom mirror*

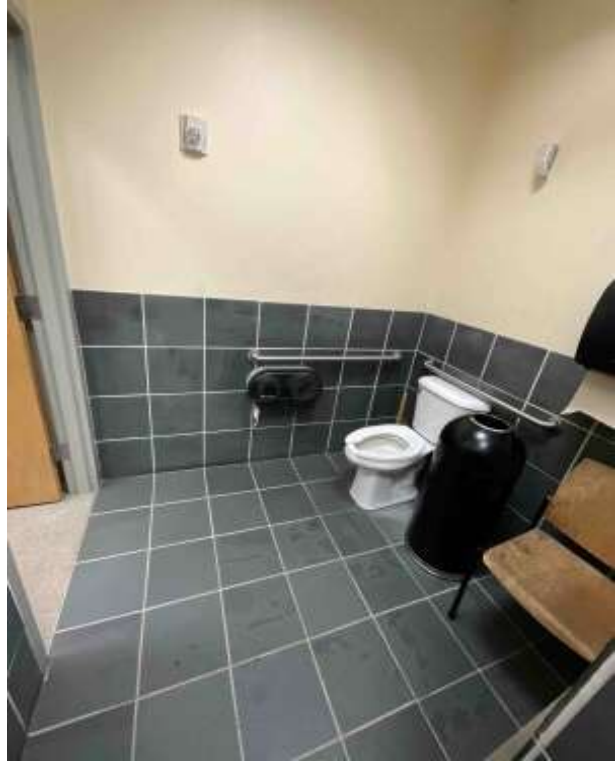
*HC Bathroom floor and wall tile*

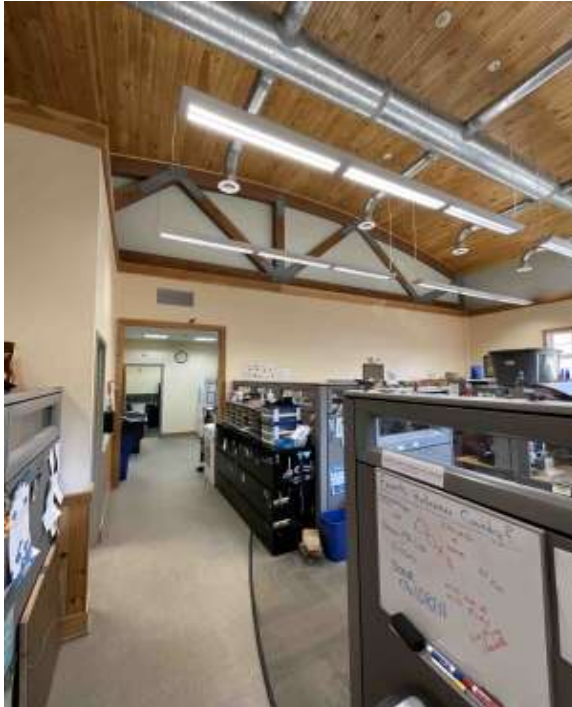
The Naturalist Office area requires some patch and paint. Carpet transition is failing and is at end of life. The windows in this area are in good condition.

*View of Naturalist Office*

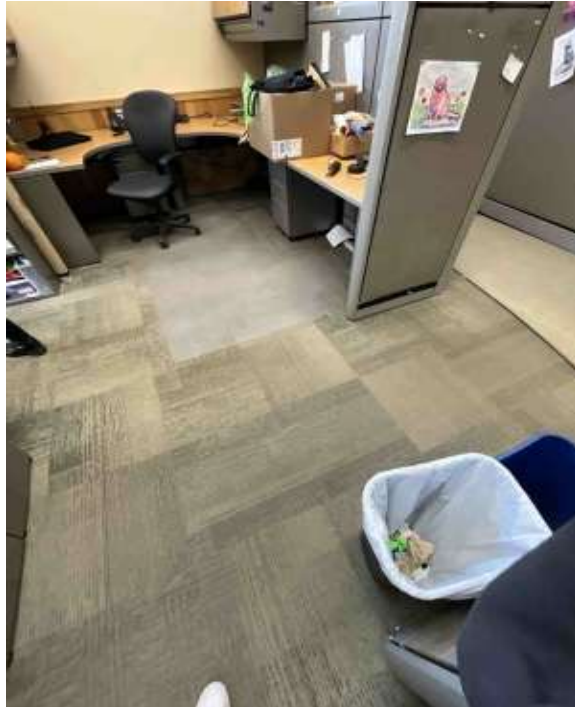
*Carpet in Naturalist Office*

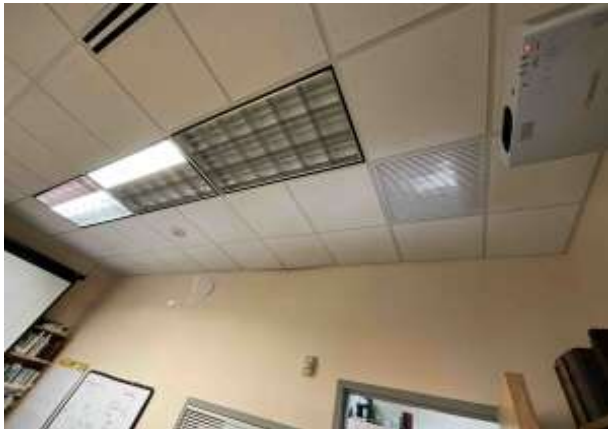
The Conference Room requires some minor repairs to the ceiling and patch and paint areas of walls. The adjoined Kitchenette is missing cabinet pulls but otherwise in good condition. And the HC Bathroom slate wall and floor tiles have staining and there's minor degradation.

*Conference Room ceiling*

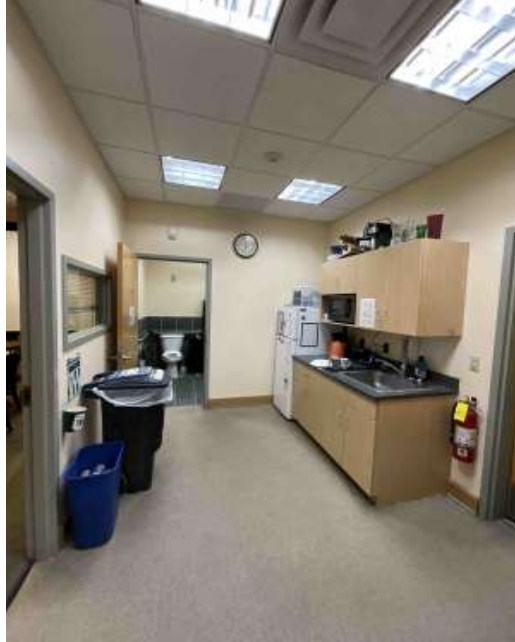
*Kitchenette*

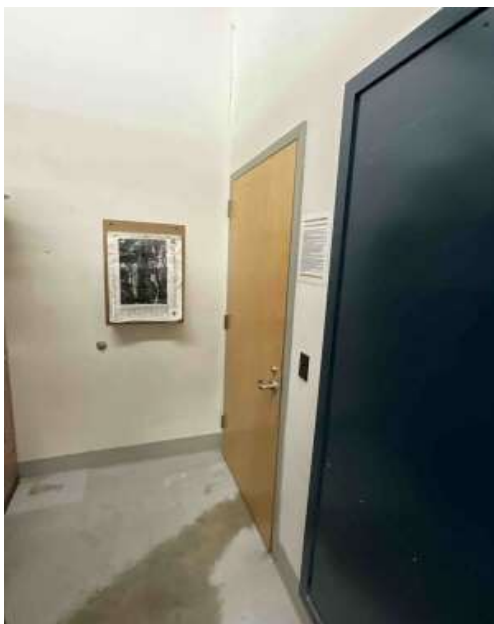
The fire door entrance into the Garage from the office space door is not latching and the exterior exit door has approximately 2-5 year replacement timeline. The overhead door at 108A weather gaskets are failing and frame shows damage. The Garage concrete floor has minor cracking and requires sealing throughout to prolong it's life.

Modifications to the original layout of the Event Storage/ Garage area are slightly out of compliance. This new separation is required to be fire rated and the 90 minute door requires a closer to maintain this protection as it is necessary to separate the garage function from the newly created office/ storage area. This work is easily accomplished, will bring this office into compliance should be prioritized.

*Garage interior fire door*

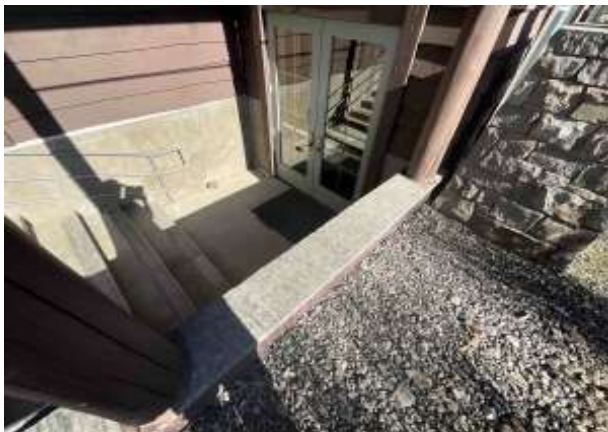
*Missing guardrail; code non-compliance*

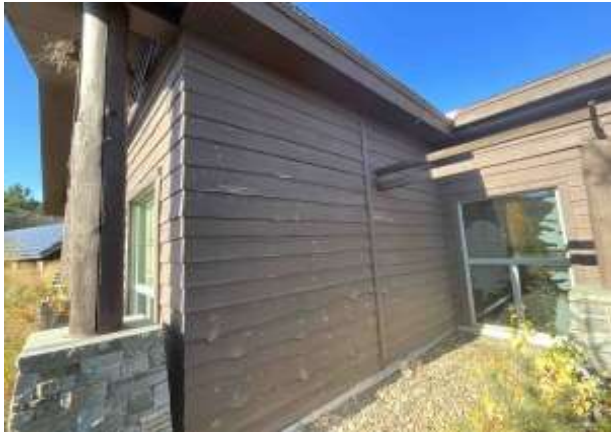
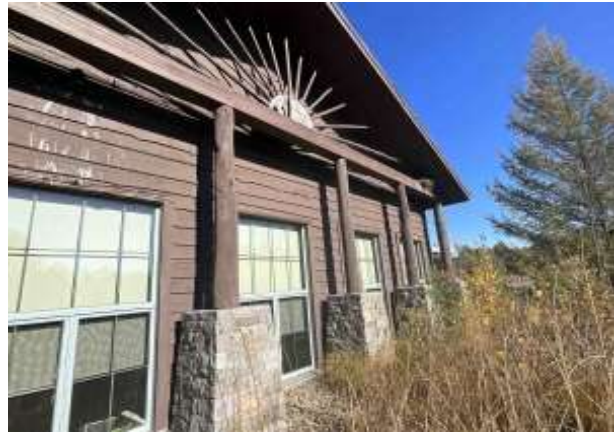
Sections of the wood siding around the perimeter show signs of weathering, including peeling paint and minor rot. Repainting and selective board replacement are needed. Minor cracks and warped boards need replacement to restore integrity and appearance. Evidence of moisture damage in some areas should be mitigated to prevent further deterioration. There are some damaged timber columns as well that will need repair or maintenance.

*Examples of damaged siding*

- Replace deteriorated siding in focused areas over the next 10 years, and re-stain entire building in 2026 with a plan to re-stain every 5-7 years.
- Replace seals and gaskets around exterior doors and windows to enhance weatherproofing.
- Replace exterior man doors to maintain security and functionality within the 3-5 years.
- Plan for the replacement of roof-mounted solar panels in the next 10 years as they approach the end of their life expectancy.
- Update interior finishes systematically over the next 10 years, starting with flooring, patch and paint throughout, grout and tiling.

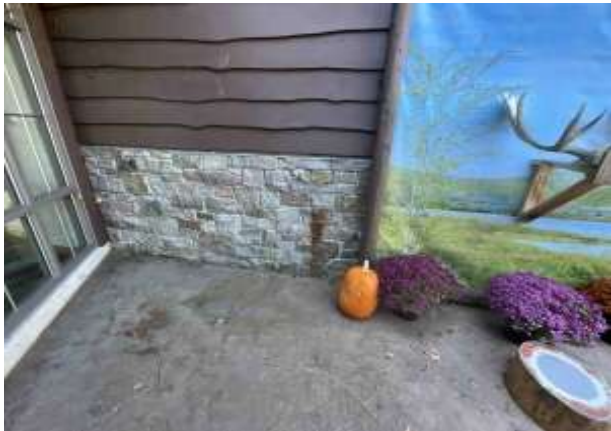
*Example of stained stone façade*

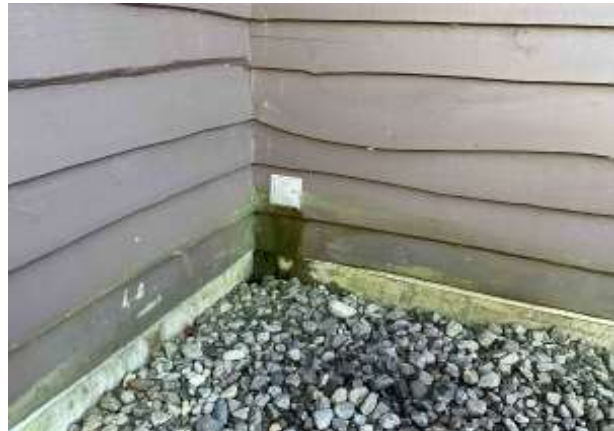
*Example of assumed moisture damage*

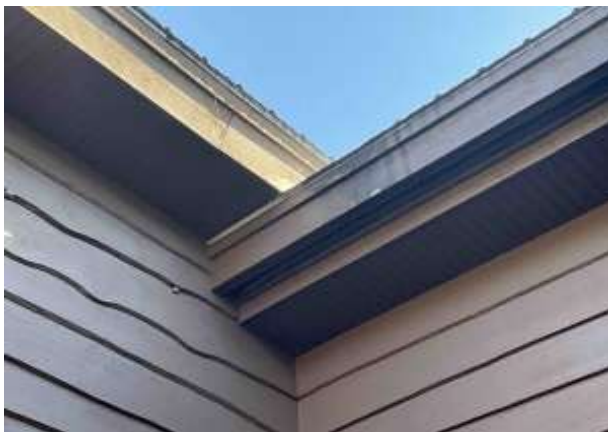
*Example of fascia board damage*

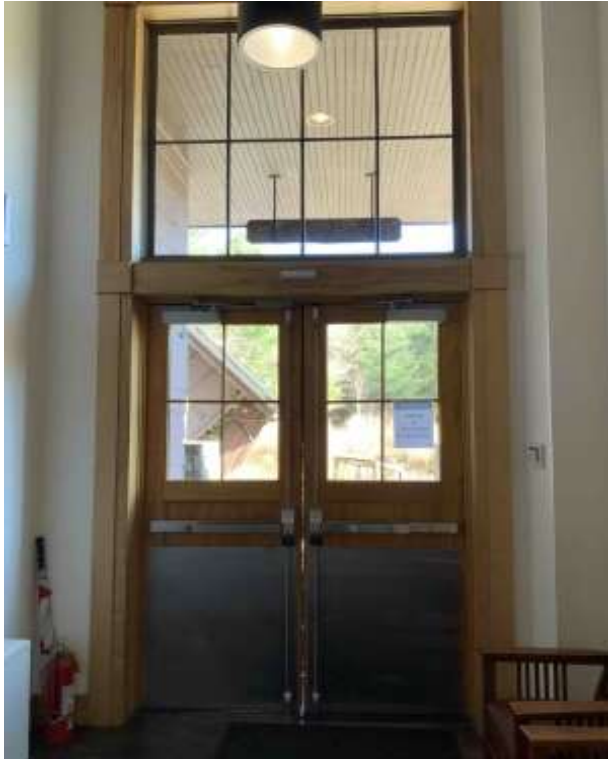
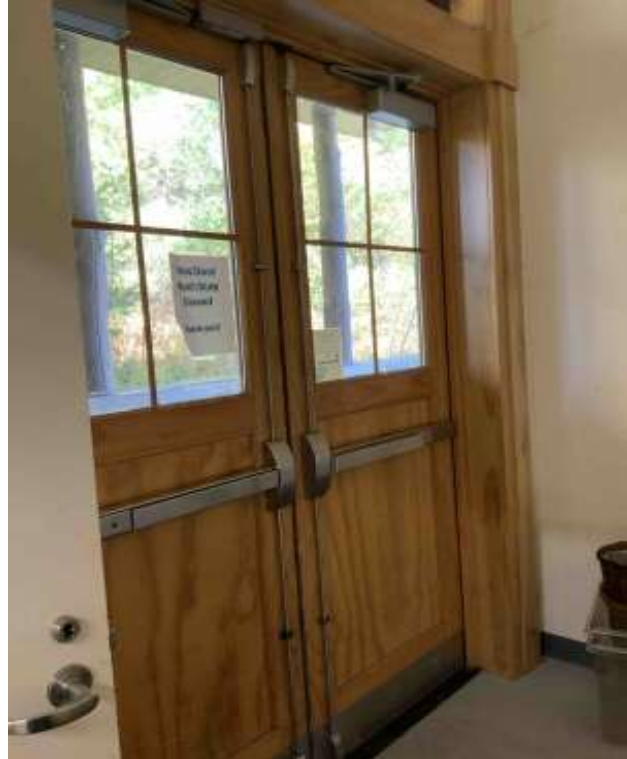
The exterior man doors of the building are showing signs of wear and are approaching the end of their useful life. While they remain functional at present, replacement will be necessary within the next 3–5 years to maintain security, energy efficiency, and aesthetic appeal.

*Exterior door examples*

- Replace exterior wood doors and aluminum door hardware to maintain security and functionality within 3-5 years.
- Plan to replace interior door hardware every 2 years.

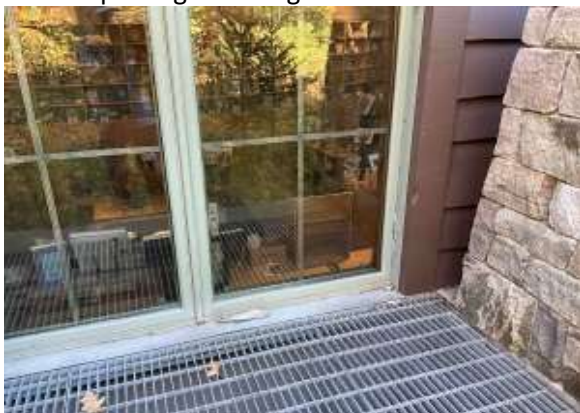
Many windows on the building show significant signs of wear and moisture-related damage, primarily due to their location and exposure to the elements. Frames exhibit signs of rot and warping. Paint or finish is peeling or fading in other areas. These issues will require repair or replacement within 1-3 years.

*Example damaged window weatherstripping at exterior*

- Damaged exterior timber columns will need repair or maintenance within 3-5 years.
- Replace deteriorating windows effected by proximity to water within 1-3 years. Replace remaining windows within 10 years.

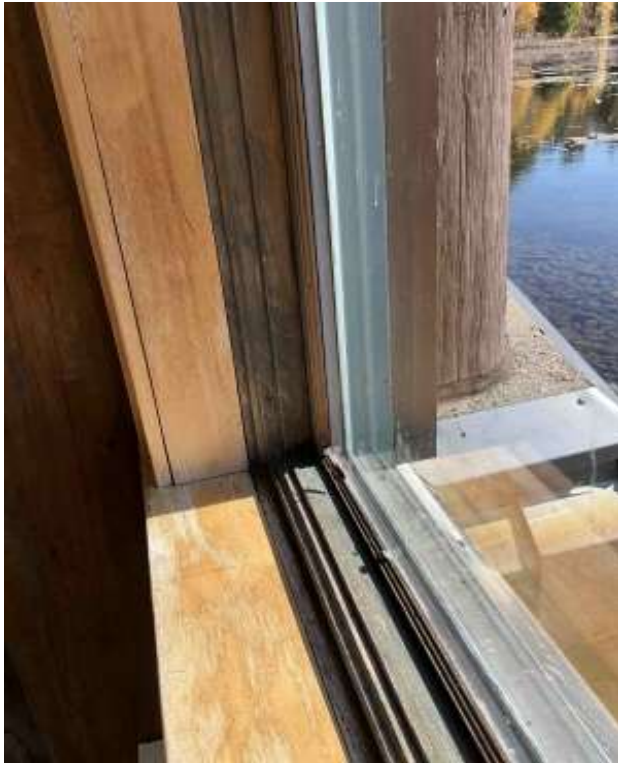
*Example of worn window finish*

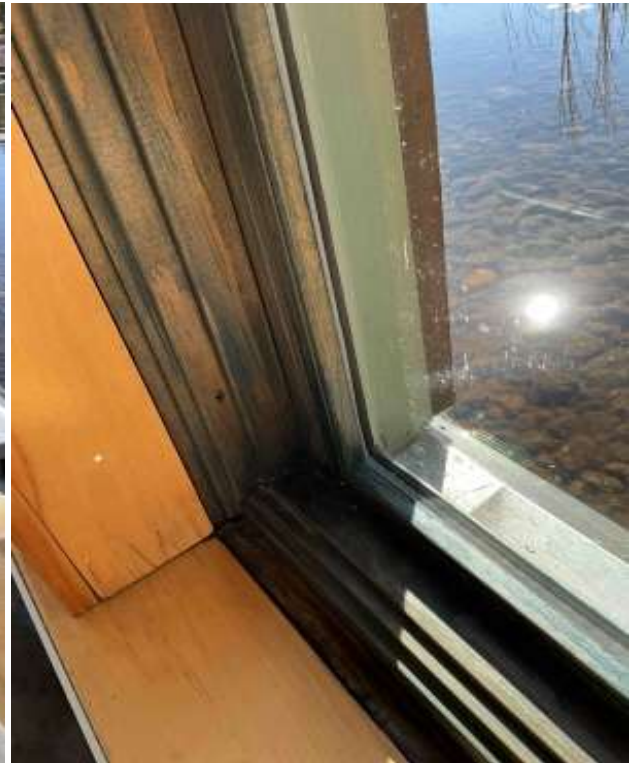
*Evidence of water infiltration at sills*

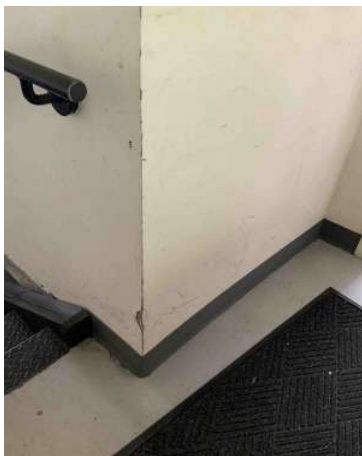
*Example of area requiring patch/paint*

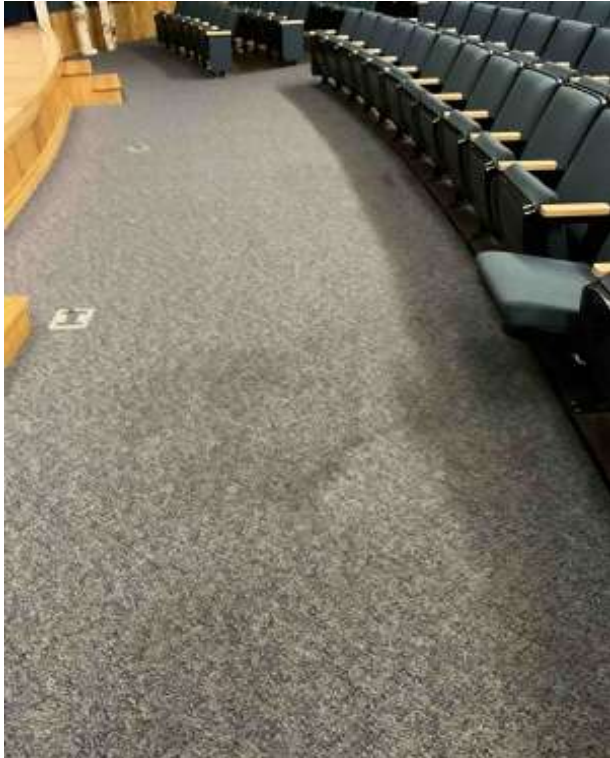
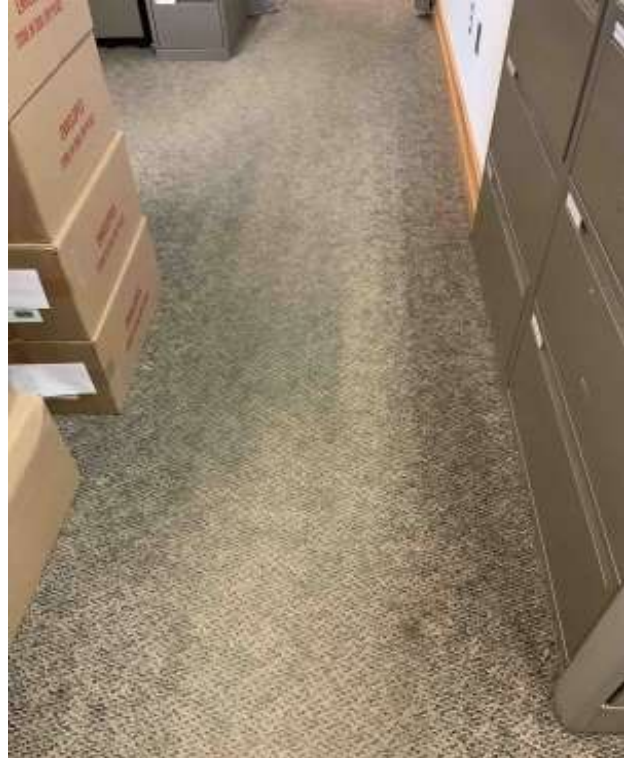
*Examples of worn carpet*

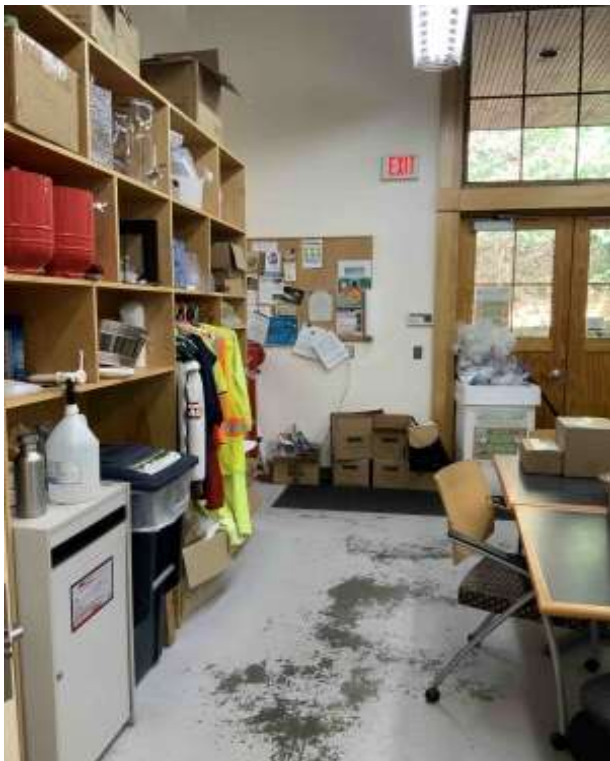
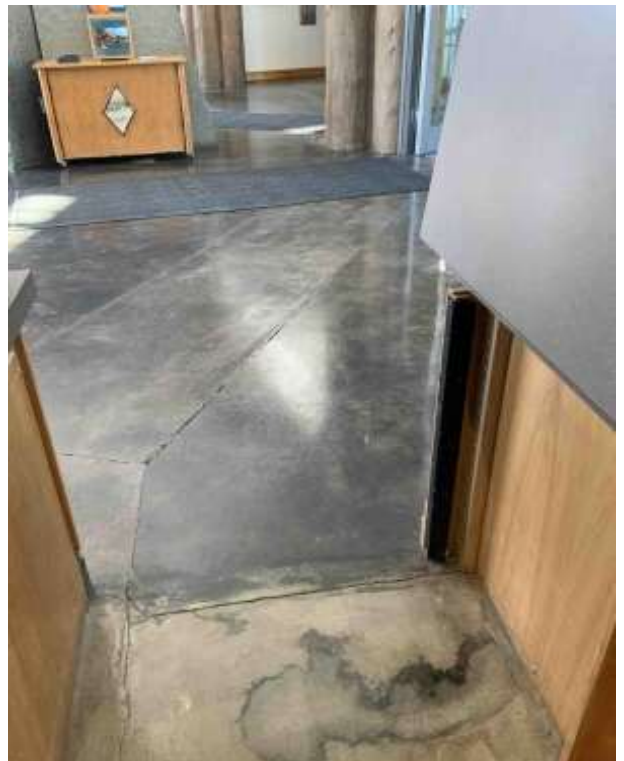
*Examples of concrete floor requiring refinishing or repair*

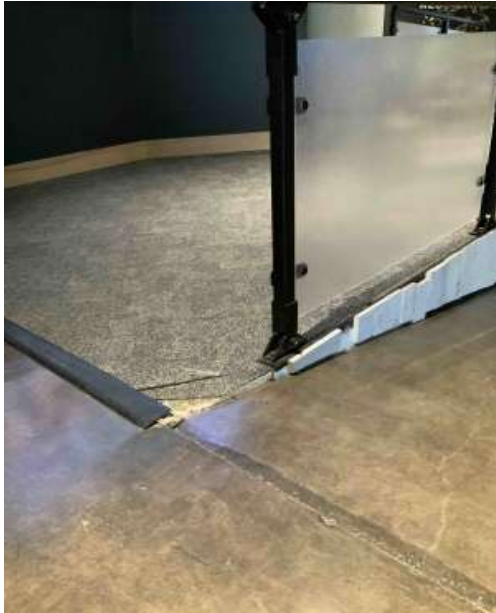
*Example of flooring transition*

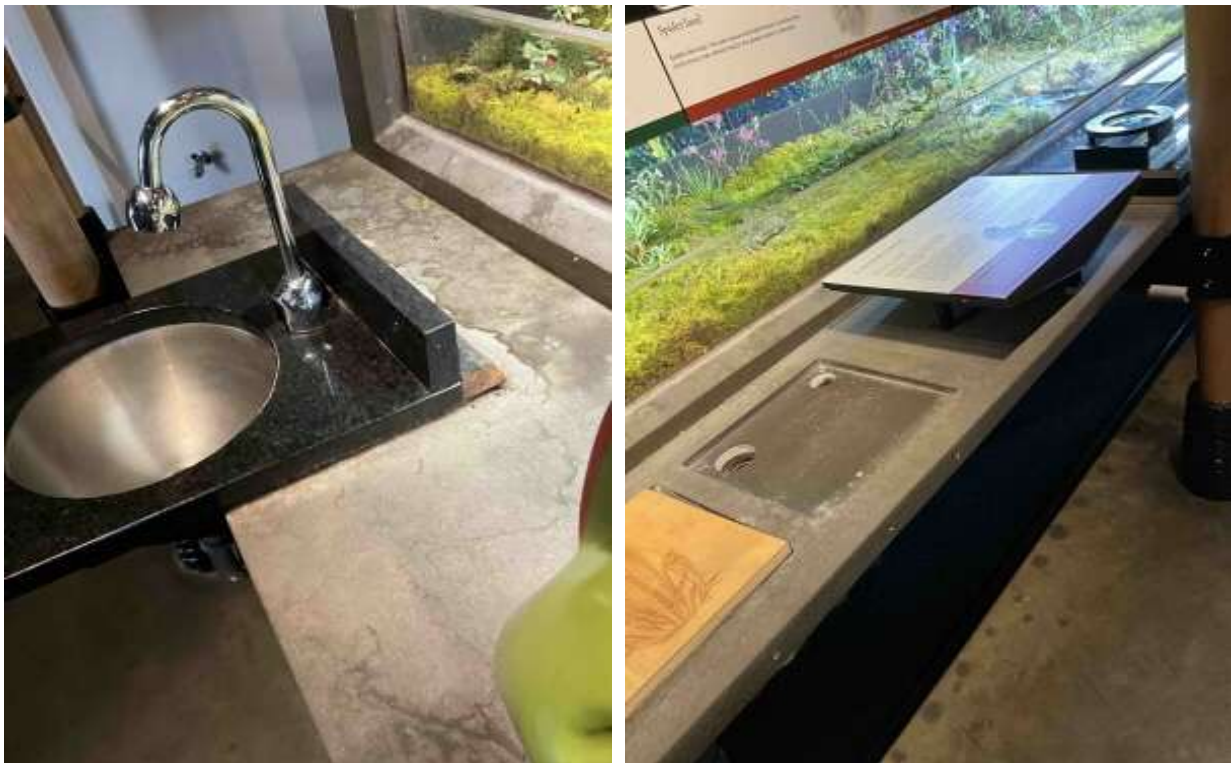
Some of the exhibit spaces in the building require countertop repairs and updates to plumbing fixtures to improve functionality and appearance. These updates will ensure that the spaces continue to meet the operational needs and maintain a professional and polished presentation.

*Examples of exhibit finishes*

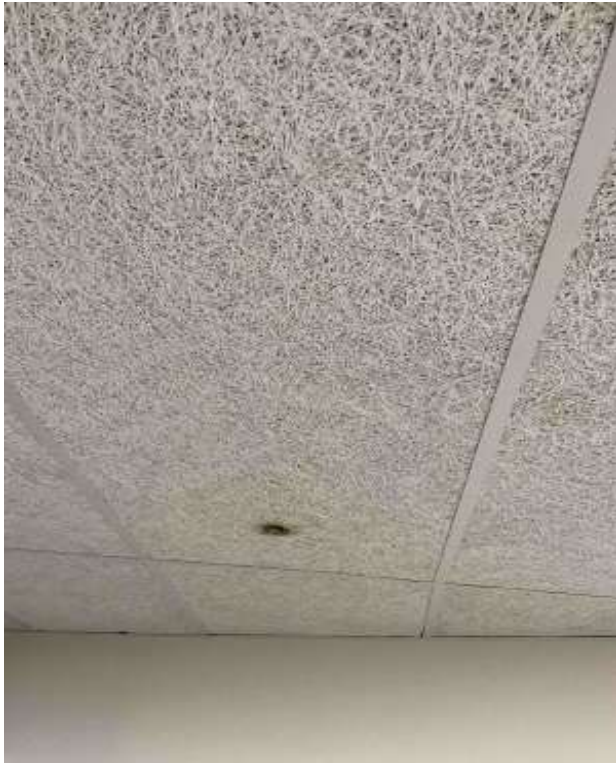
*Example of damaged ceiling tile*

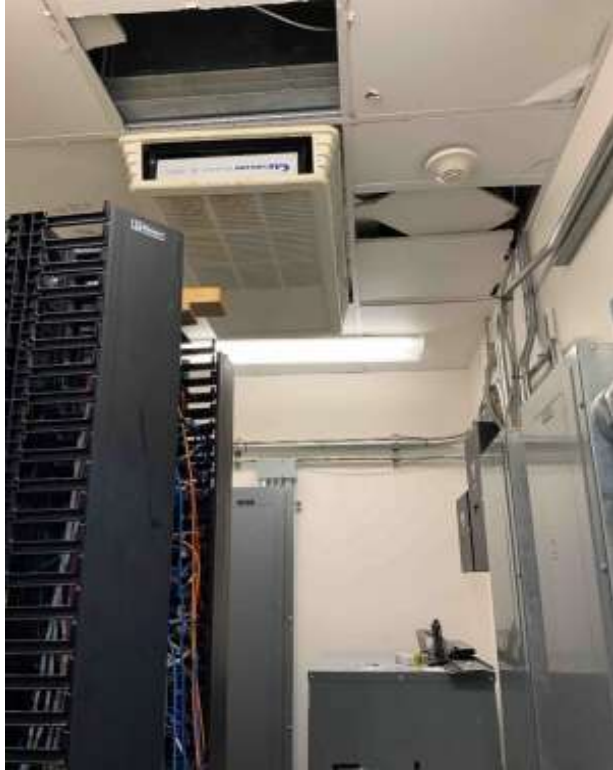
*Example of missing /damaged ceiling tiles*

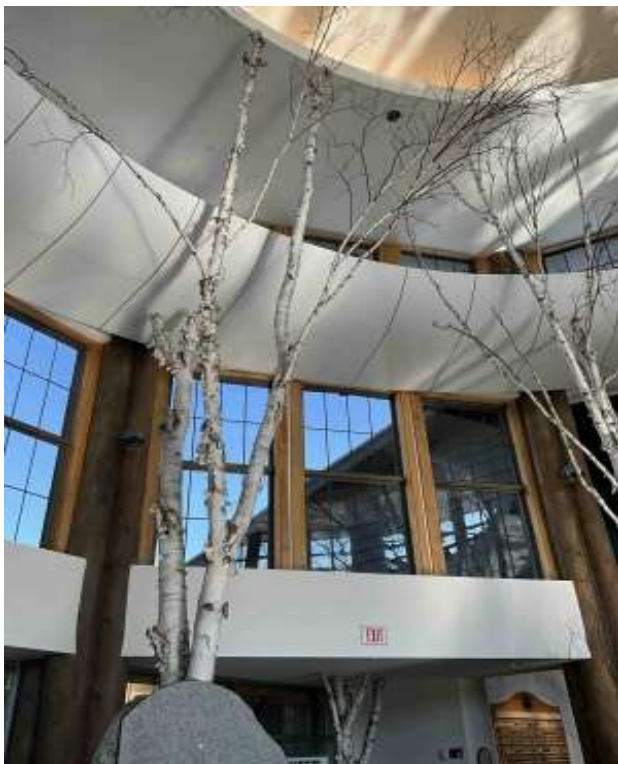
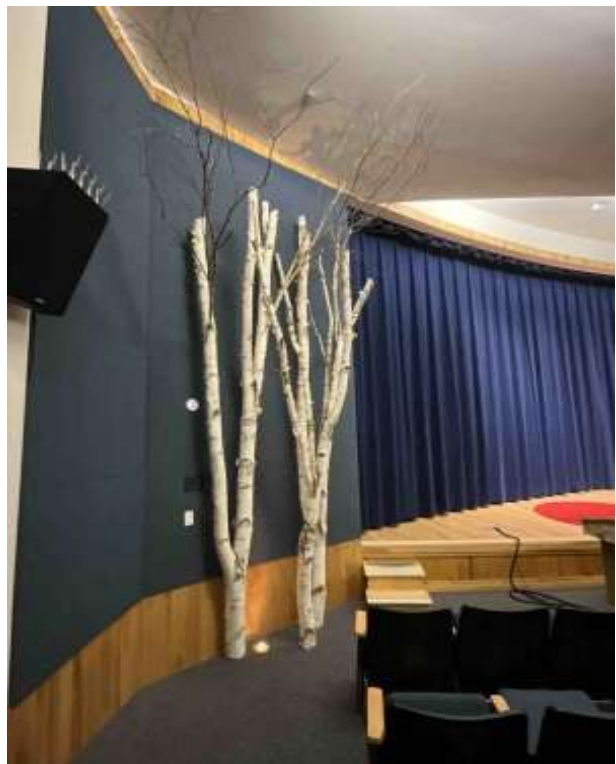
The interior birch trees are aging and will need replacement throughout within 1-2 years.

*Examples of interior birch trees*

- Interior birch trees will require replacement within the next 1-2 years.
- Install vertical grab bars in bathrooms to make code compliant.
- Update interior finishes systematically over the next 10 years, including repainting, flooring and casework and countertop repairs or replacement, and addressing minor damage to trim, walls, and ceilings.

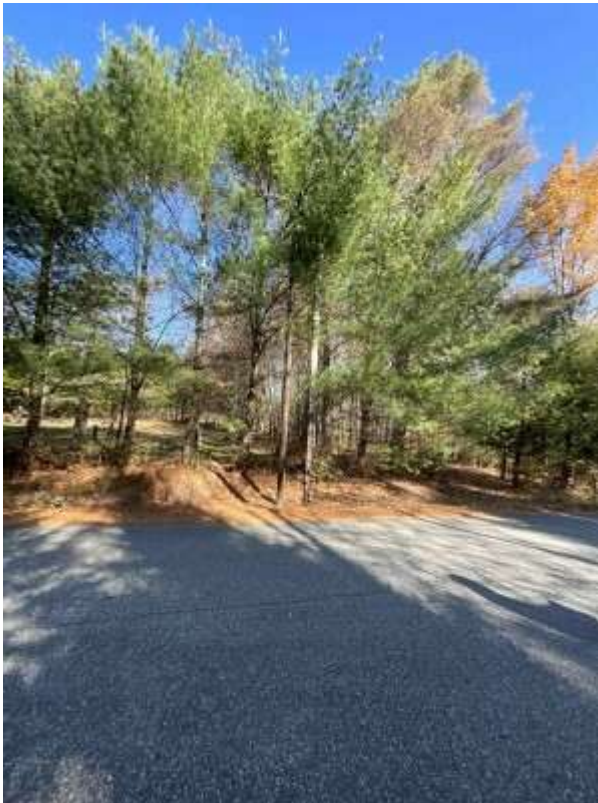
*Figure 4 Entry Lighting, good condition, tree pruning recommended*

The only recommendation for maintaining the quality and functionality of the landscaping is to keep up with tree pruning and vegetative management around site lighting, walking trails, and signage. Regular pruning will ensure that lighting fixtures remain unobstructed, providing adequate illumination for pathways and parking areas, while also maintaining clear visibility of important signage for visitors.

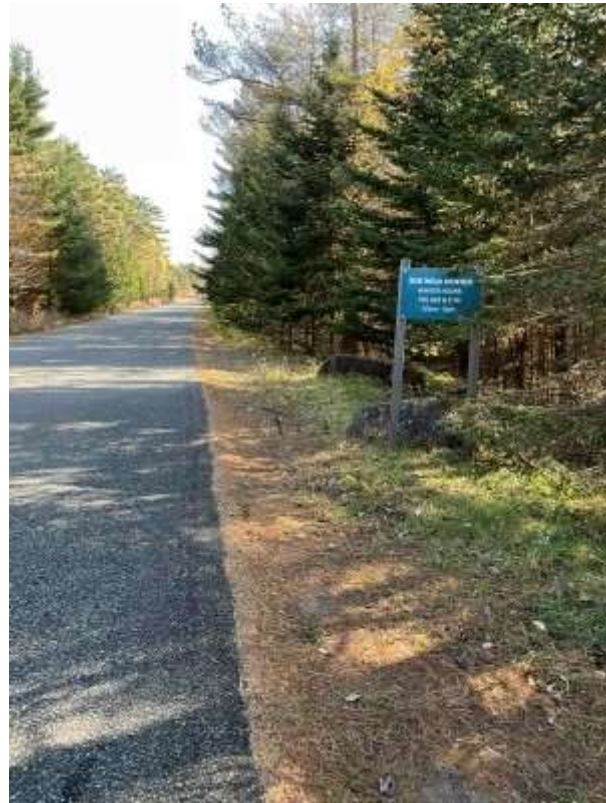
*Figure 3 Entry signage, good condition, vegetative management recommended*

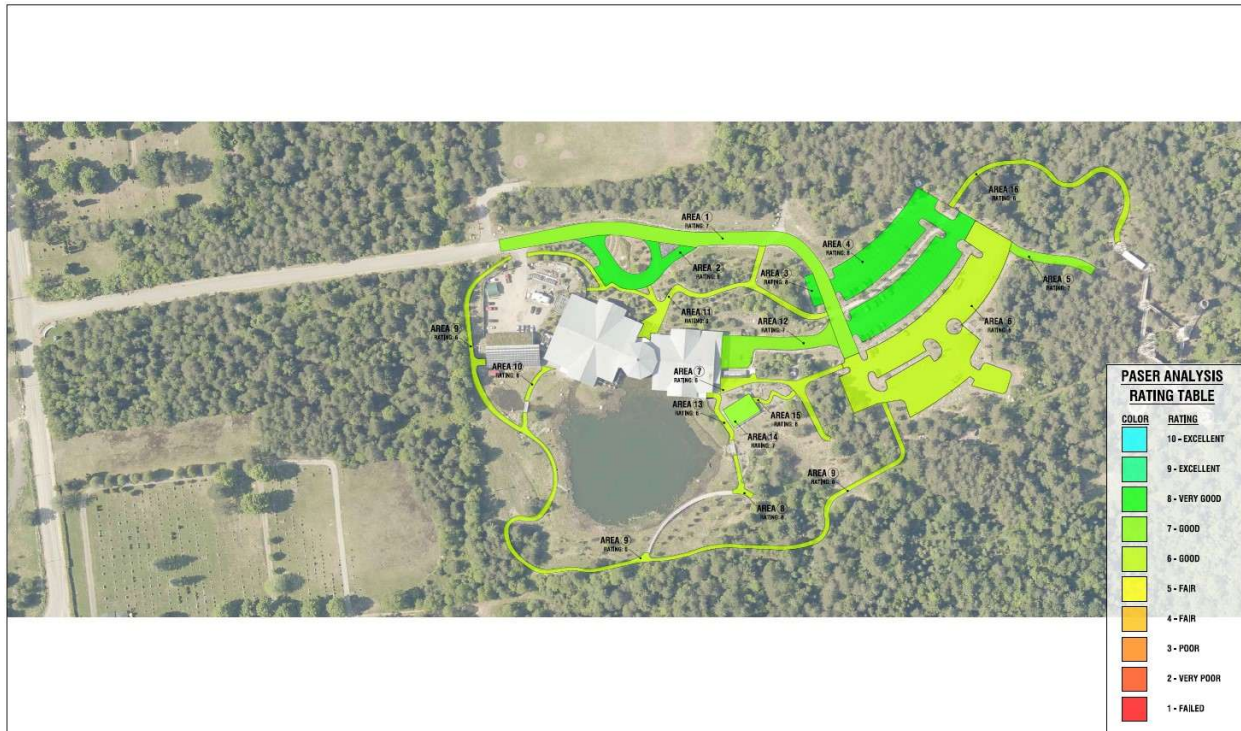
**THE WILD CENTER**  
PASER RATING DIAGRAM

The paving, curbing, parking, and loading areas across the Wild Center site, which include asphalt, concrete, crusher stone, and permeable pavers, cover a total of 161,980 square feet and are in overall good condition, as reflected in PASER ratings ranging from 6 to 8.

Asphalt surfaces rated 8 (43,778 square feet) are in very good condition, requiring minimal maintenance, while areas rated 6 (83,340 square feet) and 7 (34,862 square feet) show minor deterioration.

Concrete areas are generally stable but present localized issues such as edging lips, spalling at crosswalks, and transitions between materials. Addressing life safety concerns, including tripping hazards and surface inconsistencies, remains a high priority, particularly in high-traffic pedestrian zones and during winter events like Wild Lights.

1. Address Tripping Hazards:
  - Prioritize remediation of tripping hazards caused by edging concrete lips, hardscape transitions, and spalling at crosswalks.

3. Asphalt Repairs:
  - As a secondary priority, address minor wear and tear in asphalt areas by filling and sealing cracks.
  - Refresh parking striping to improve visibility and organization.

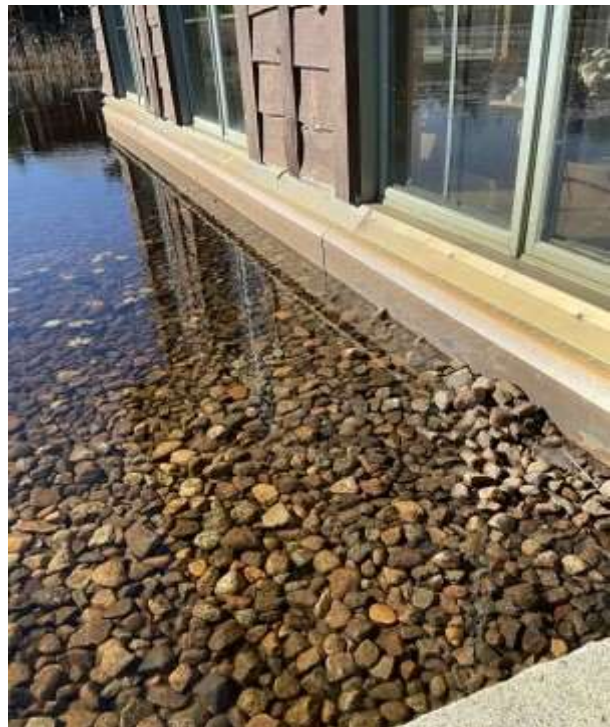
The pond remains in good condition, supporting an established habitat and a functioning drainage spillway designed to manage flooding and prevent breaches. The short-term repairs, completed in the fall of 2024, addressed immediate concerns by stabilizing the pond liner failure. Tasks included removing and stockpiling organic soil, preparing and compacting the subgrade, and placing clay material in 6" lifts compacted to 95% Modified Proctor. The outlet pipe joint was sealed with hydraulic cement and butyl, and the pond liner was temporarily secured within the clay layers. The site was restored with organic soil replacement, erosion control removal, and debris cleanup, ensuring interim stability pending long-term repairs. However, concerns were noted regarding the longevity of the repair.

*Figure 8 Pond Liner at Building Foundation*

Pond: Proceed with long-term pond liner repairs using high-quality materials and following precise compaction and sealing practices. Emphasize erosion control and site restoration to minimize environmental impact.
