Wild Center Property Condition Assessment

LaBella Project No.: 2244417
Prepared On: 11/6/2024

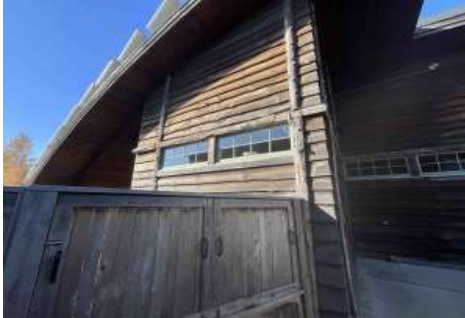
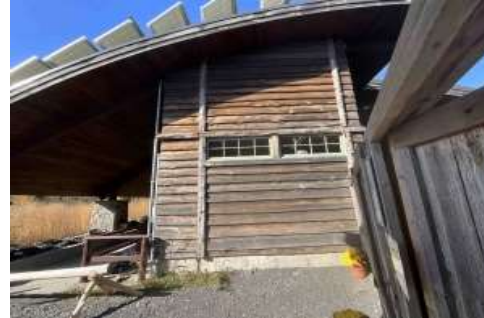
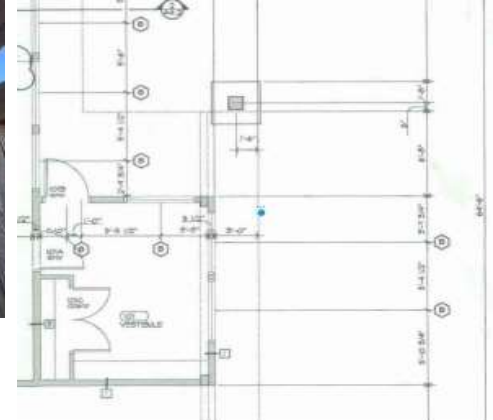
Building	Space Number	Space Name	Element	Description	ID
Bio Building	000	Exterior	Arch	Damaged Timber Trim	039

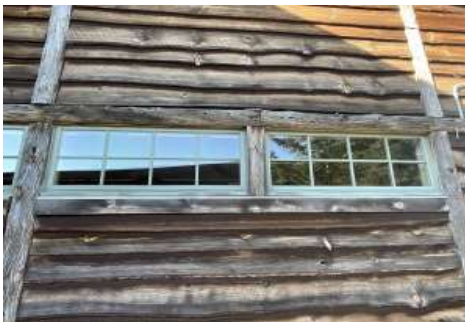
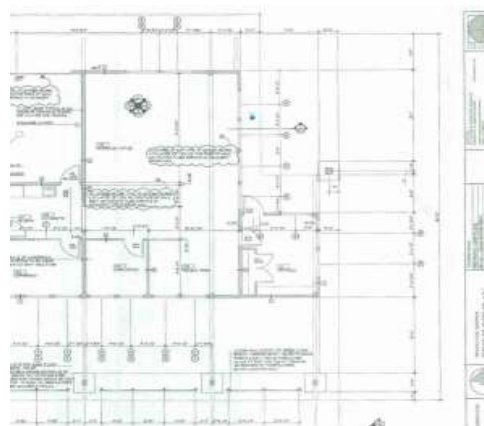
Bio Building	000	Exterior	Windows	Damaged Sill Trim Paint	046
--------------	-----	----------	---------	-------------------------	-----

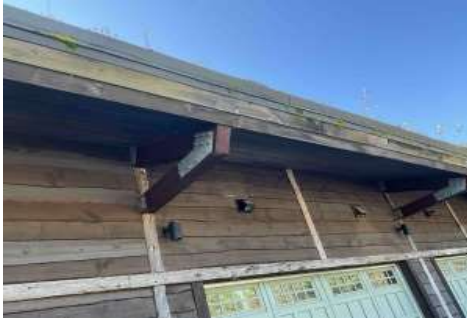
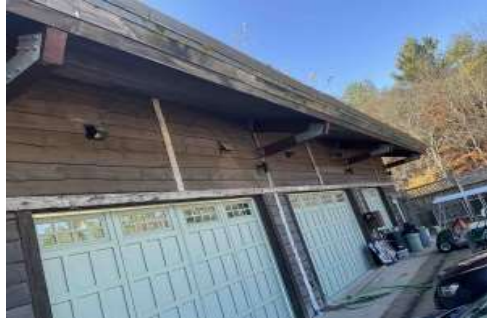
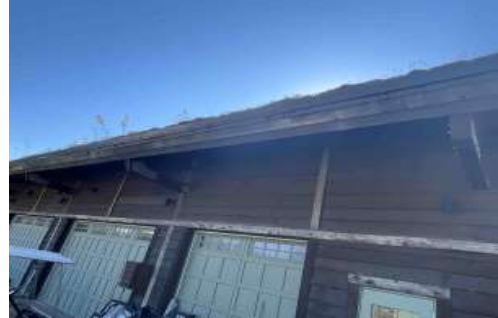
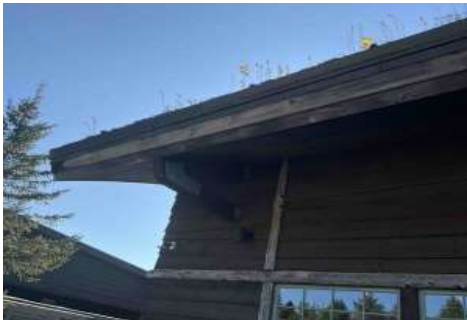
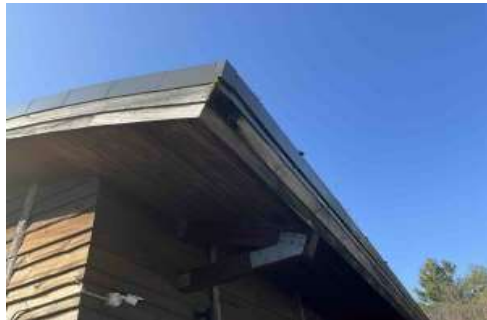
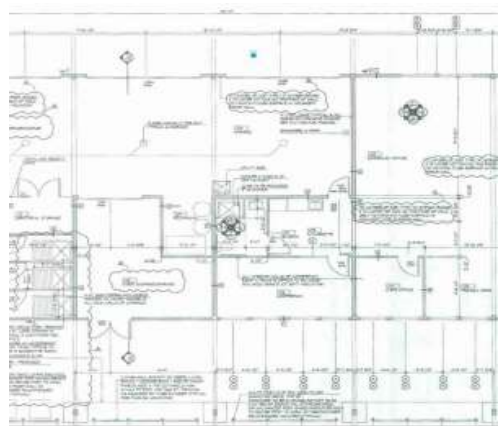
Bio Building	000	Exterior	Fascia/trim	Moss growth	051
--------------	-----	----------	-------------	-------------	-----

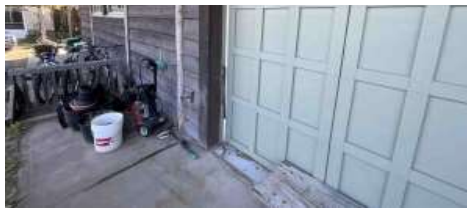
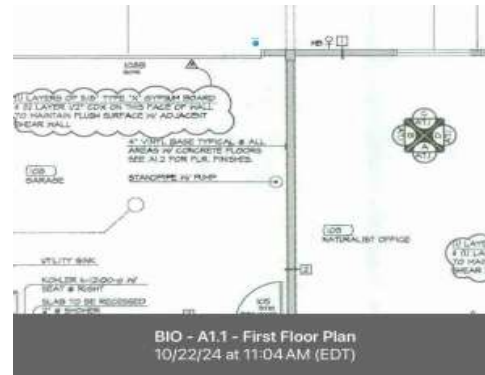
Bio Building	000	Exterior	OH door	Damaged Jamb Trim	055
--------------	-----	----------	---------	-------------------	-----

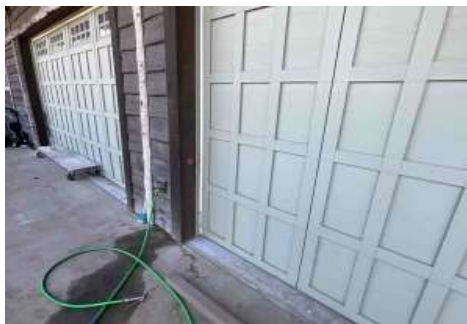
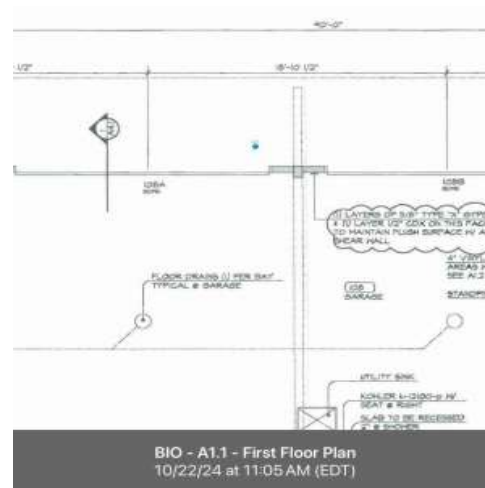
Bio Building	000	Exterior	OH door	Damaged Jamb Trim	058
--------------	-----	----------	---------	-------------------	-----

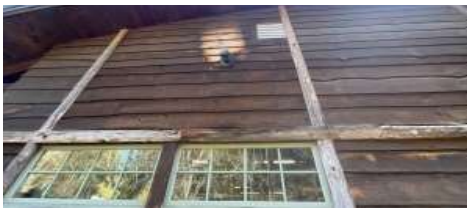
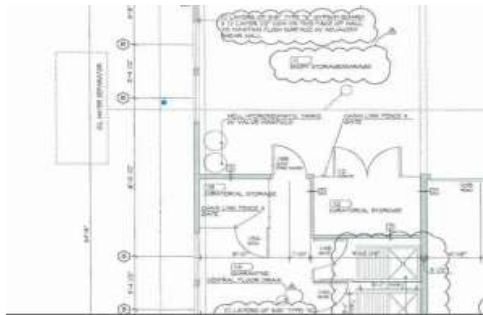
Bio Building	000	Exterior	Siding	Eroded stain	063
--------------	-----	----------	--------	--------------	-----

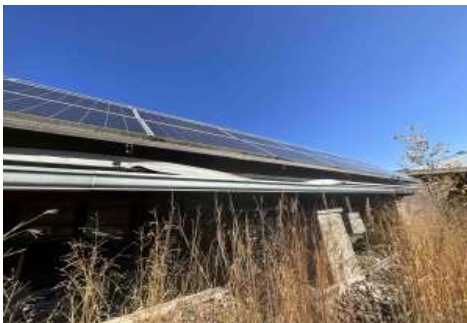
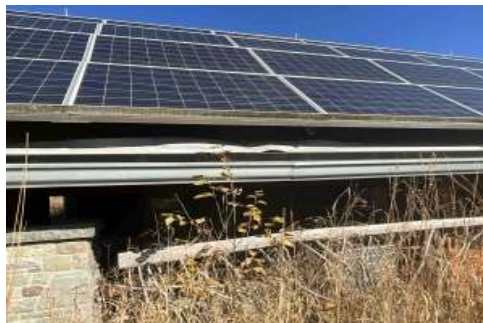
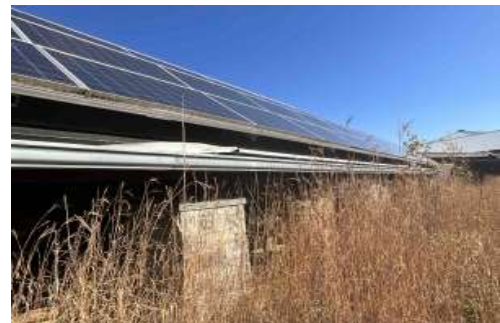
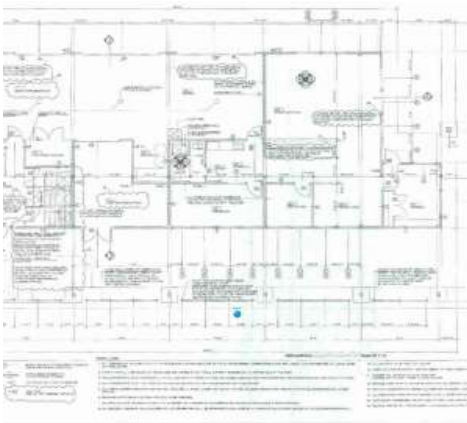
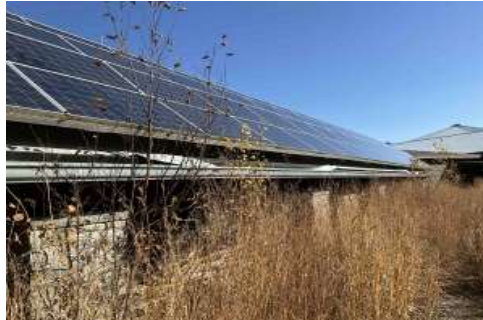
Bio Building	000	Exterior	Roof flashing	Failing along edge	074
--------------	-----	----------	---------------	--------------------	-----

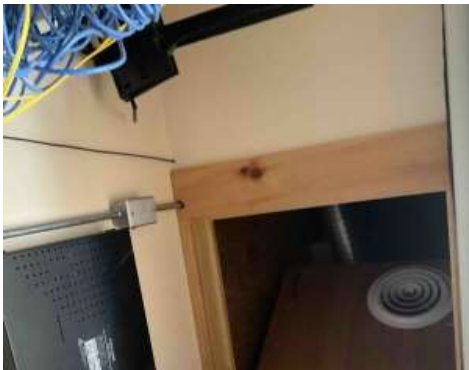
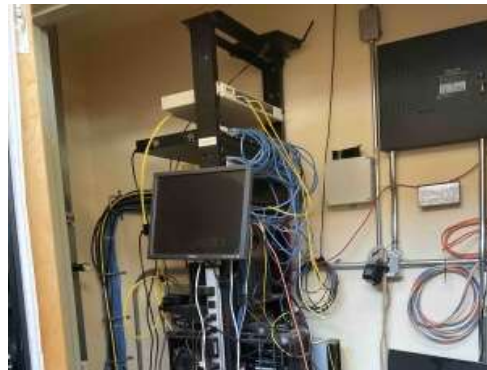
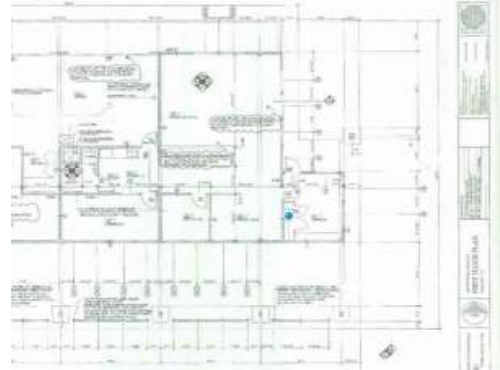
Bio Building	101C	IT Closet	MPF	Excessive heat gain data /telecom closet	006
--------------	------	-----------	-----	--	-----

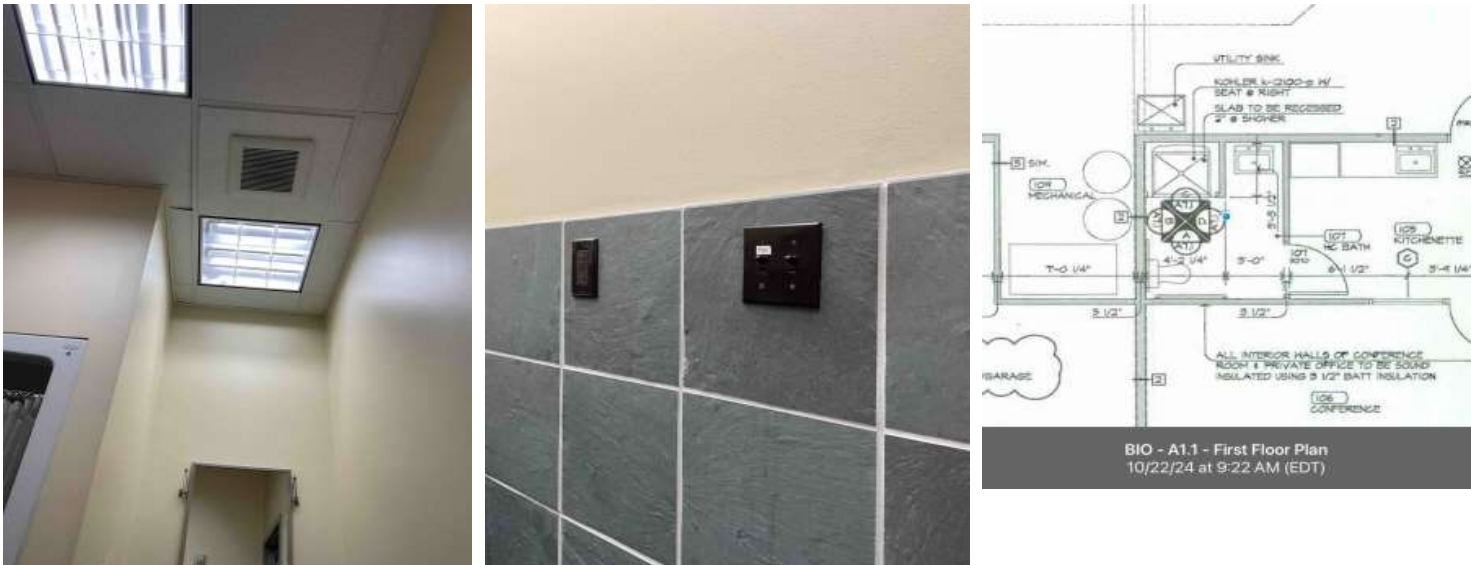
Bio Building	107 HC Bath	MPF	Exhaust fan with wall switch. Air changes unclear. Reportedly low	008
--------------	-------------	-----	---	-----

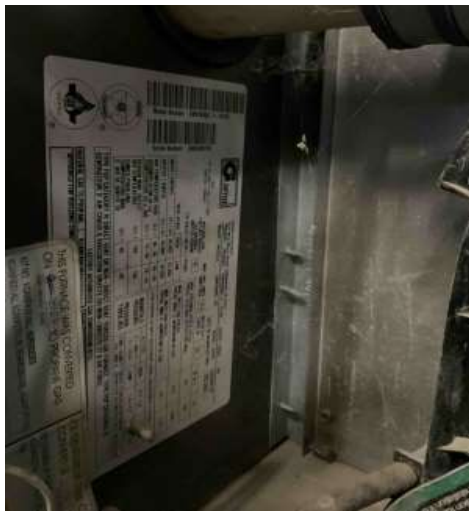
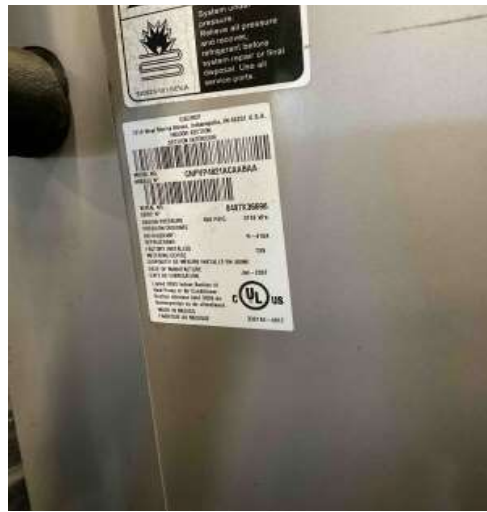
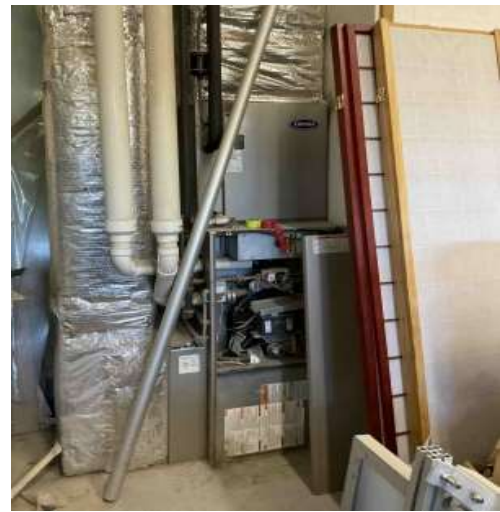
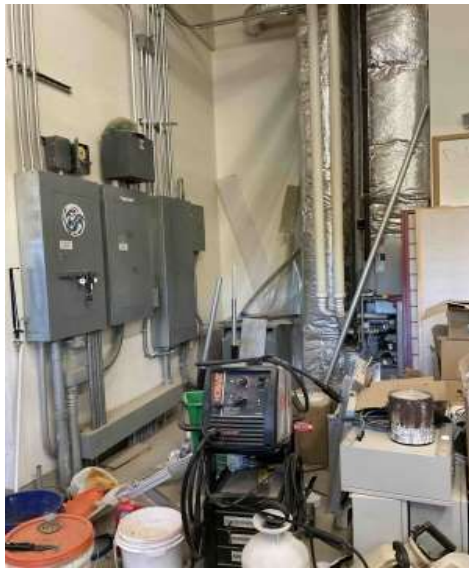
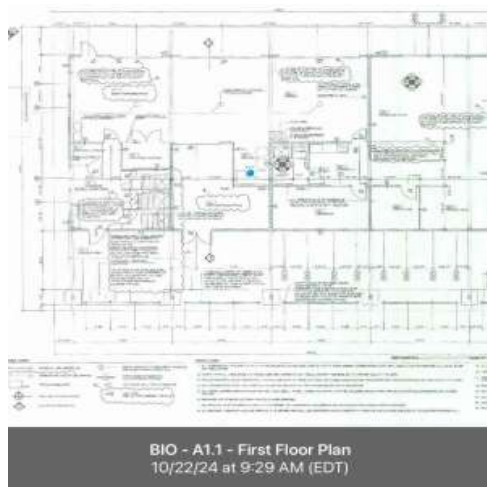
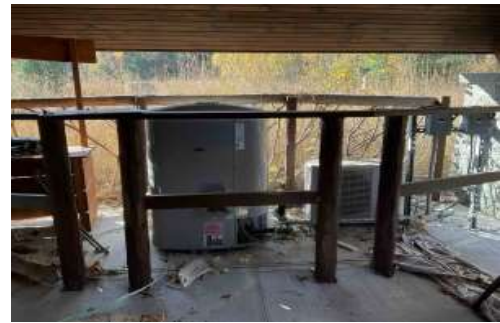
Bio Building	109 Mechanical	MPF	Gas fired furnace vintage 2007- panel removed; R410a refrigerant circuit; also insufficient elec panel 012 clearance	
--------------	----------------	-----	--	--

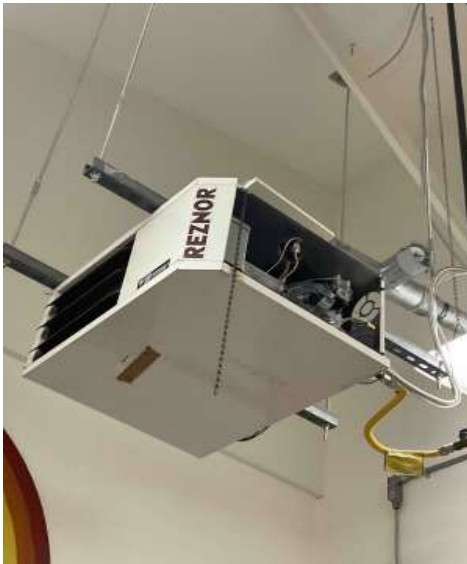
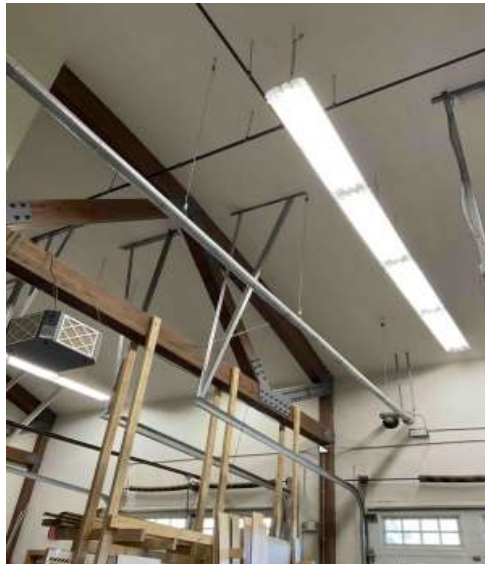
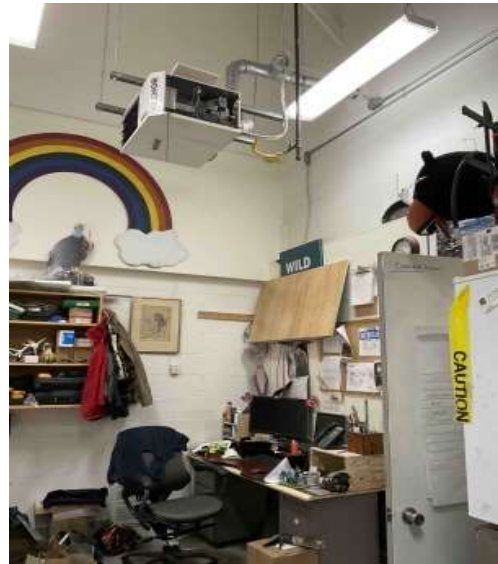
Bio Building	110 Event Storage		MPF	Gas fired unit heater with type 1 (or 2) vent located in space used as office; access door on GF SA duct open	017
--------------	-------------------	--	-----	---	-----

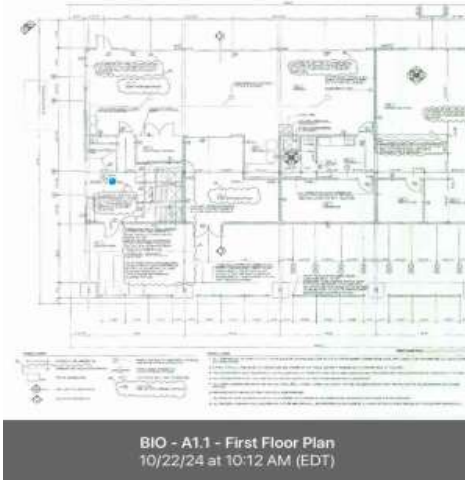
Bio Building	105 Kitchenette	MPF	Booster water heater	032
--------------	-----------------	-----	----------------------	-----

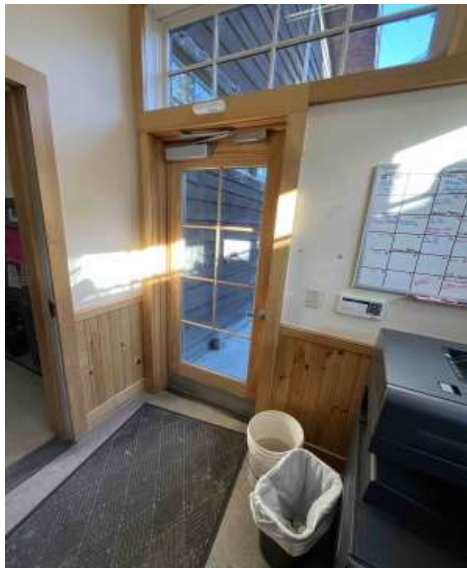
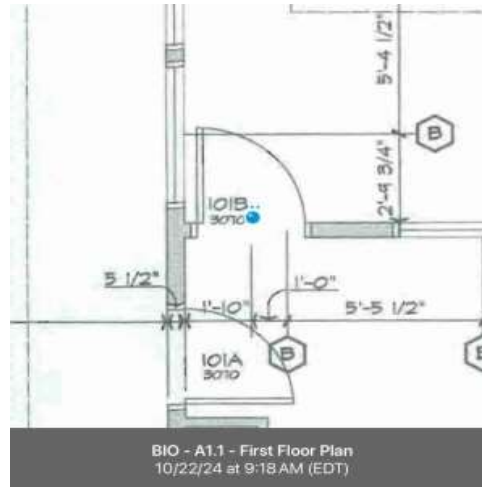
Bio Building	101	Vestibule	Arch	Carpet at end of life & transition failing	005
--------------	-----	-----------	------	--	-----

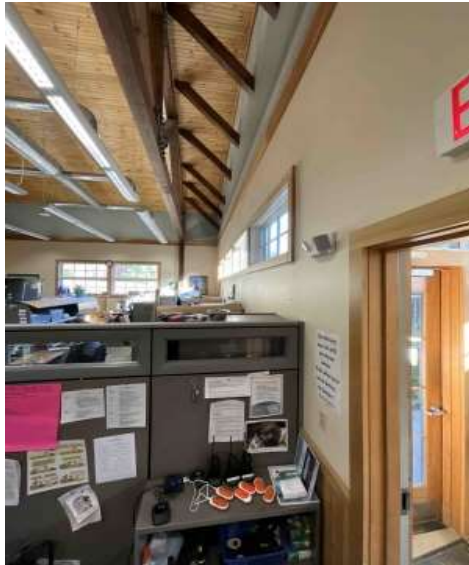
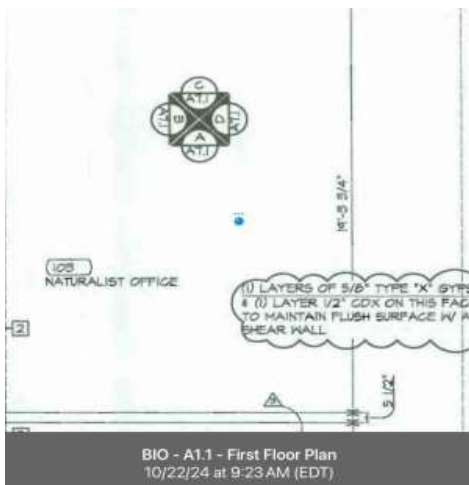
Bio Building	103	Naturalist Office	Arch	Windows in good condition	009
--------------	-----	-------------------	------	---------------------------	-----

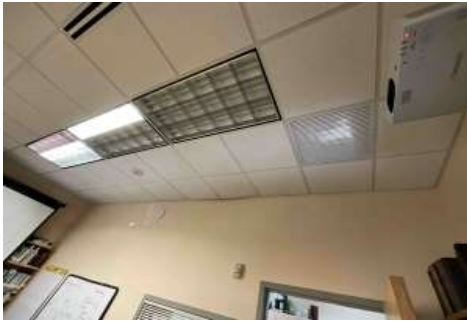
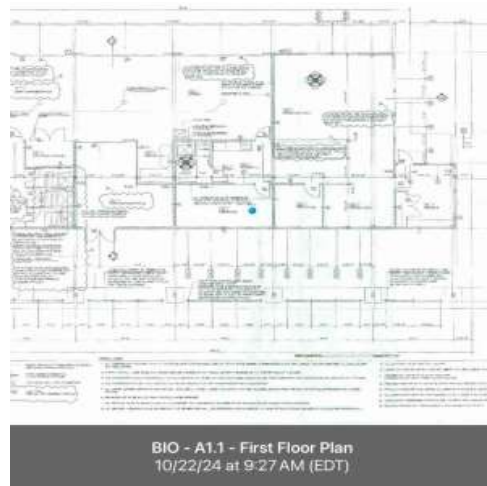
Bio Building	106	Conference	Arch	Ceiling minor repair.	010
--------------	-----	------------	------	-----------------------	-----

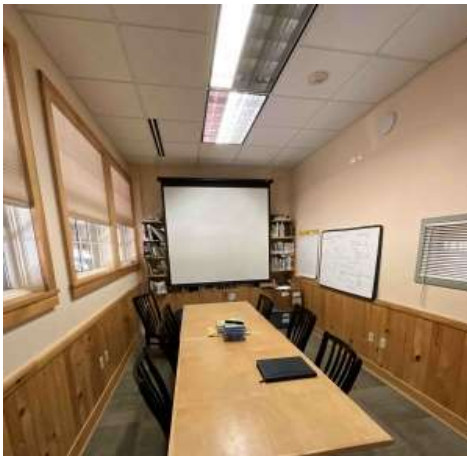
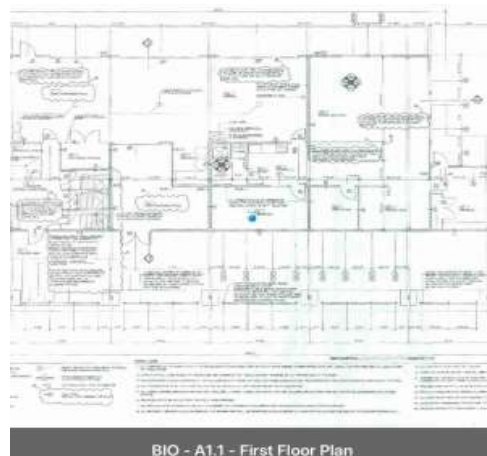
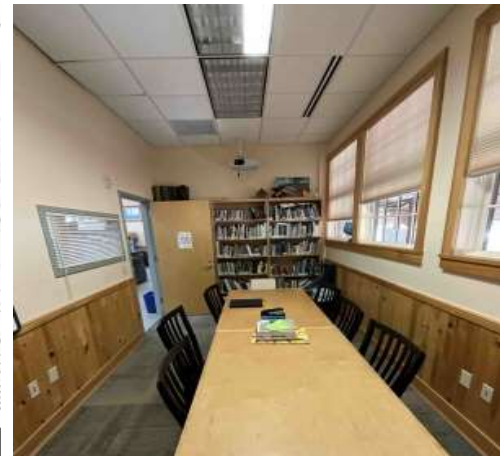
Bio Building	106	Conference	Arch	Overall pictures	011
--------------	-----	------------	------	------------------	-----

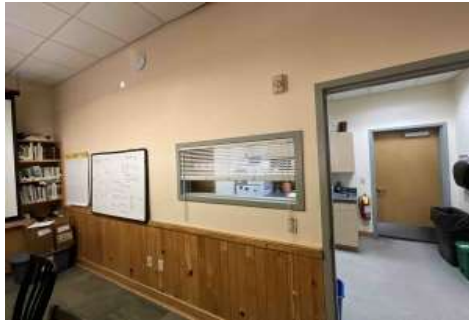
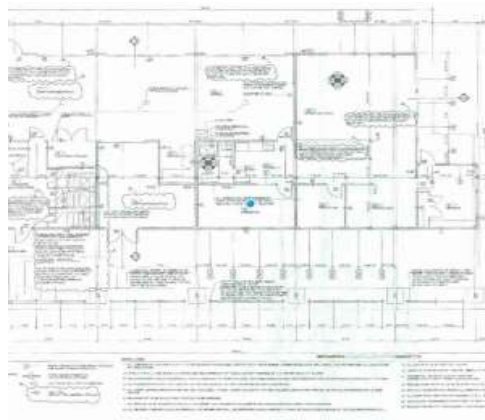
Bio Building	106	Conference	Arch	Sheetrock patch and paint	013
--------------	-----	------------	------	---------------------------	-----

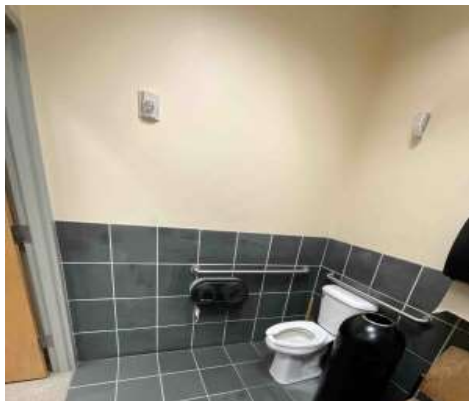
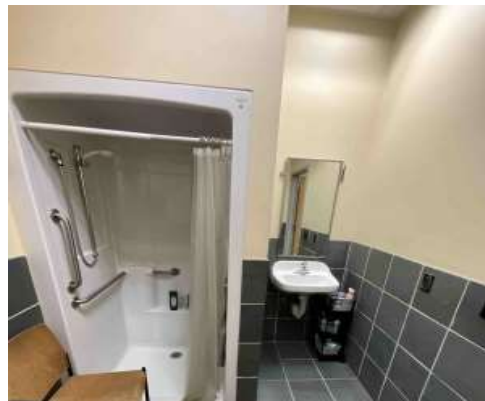
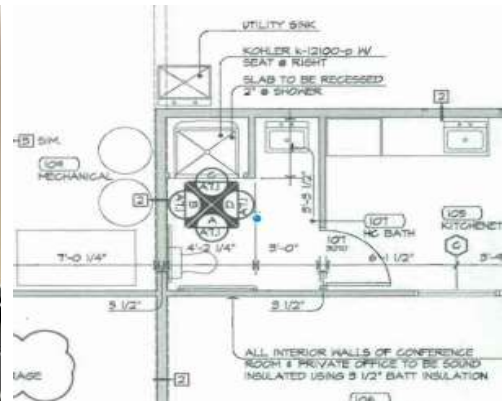
Bio Building	107	HC Bathroom	Arch	Slate wall and floor tile staining	014
--------------	-----	-------------	------	------------------------------------	-----

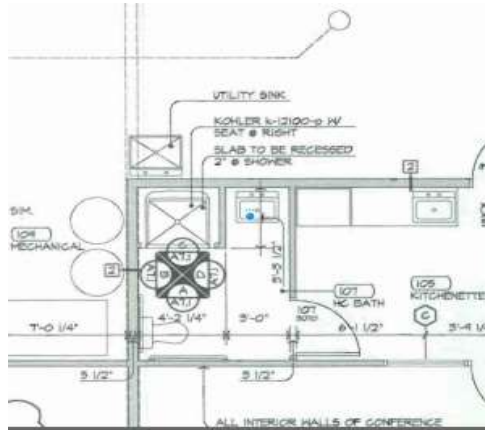
Bio Building	107	HC Bathroom	Arch	Mirror degradation	015
--------------	-----	-------------	------	--------------------	-----

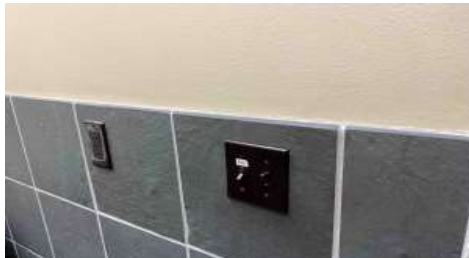
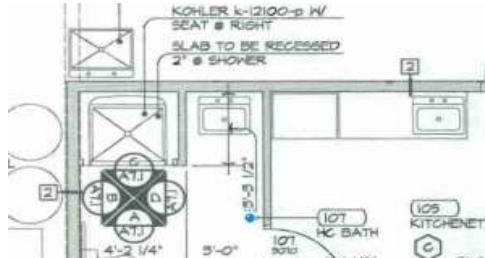
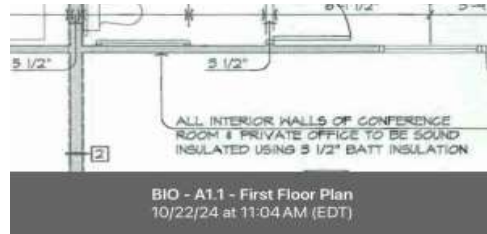
Bio Building	107	HC Bathroom	Elec	LIGHTING CONTROLS	057
--------------	-----	-------------	------	-------------------	-----

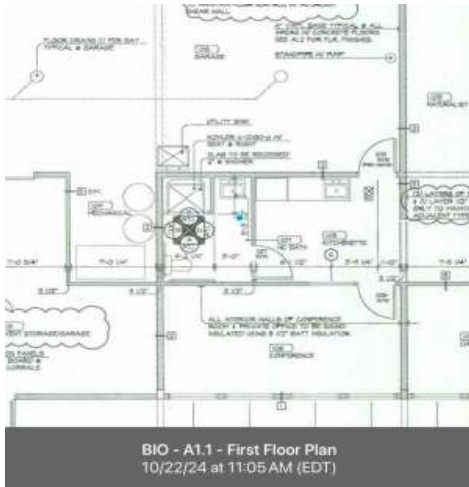
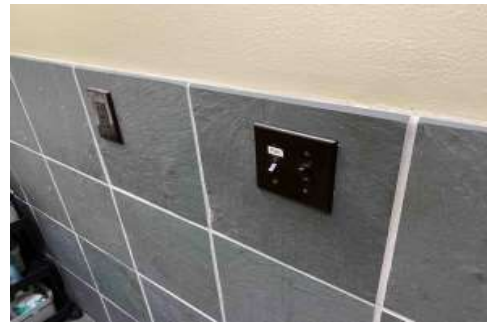
Bio Building	107	HC Bathroom	Elec	LIGHTING CONTROLLS	059
--------------	-----	-------------	------	--------------------	-----

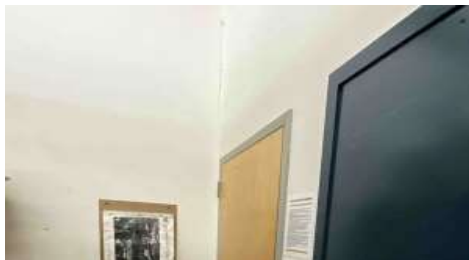
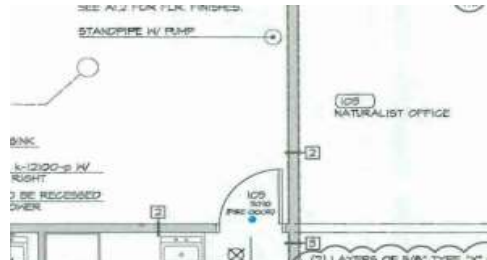
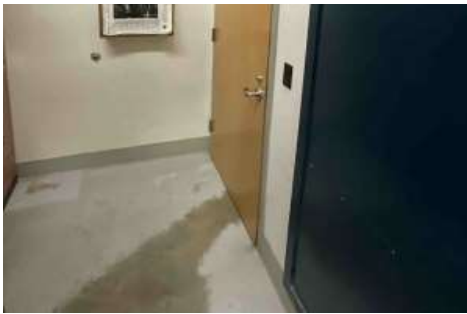
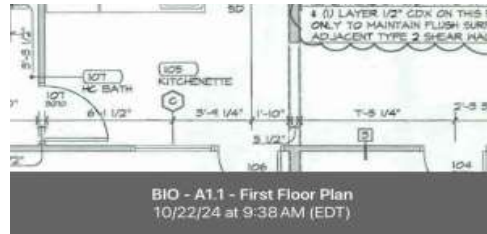
Bio Building	108	Garage	Arch	Fire Door not latching	018
--------------	-----	--------	------	------------------------	-----

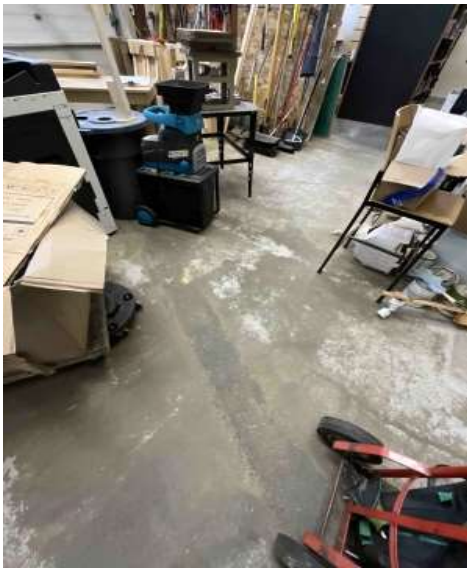
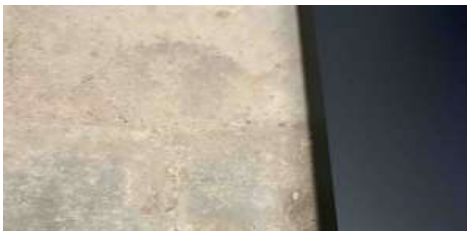
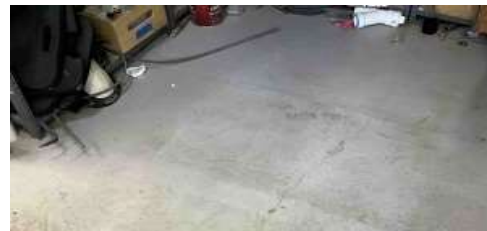
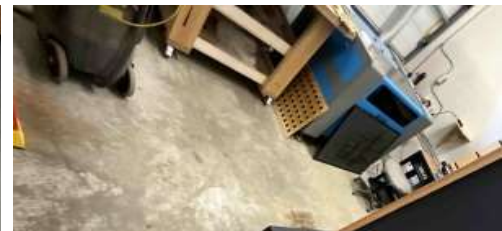
Bio Building	108	Garage	Arch	Floor seal required, minor cracking.	019
--------------	-----	--------	------	--------------------------------------	-----

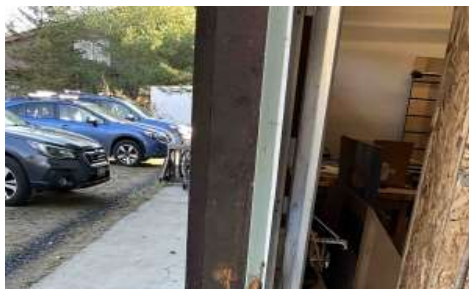
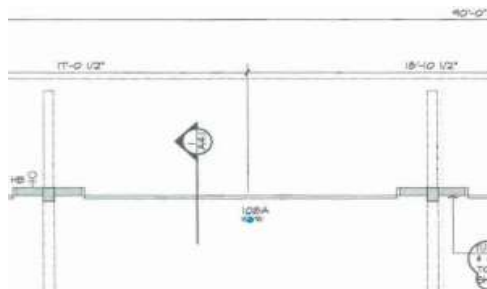
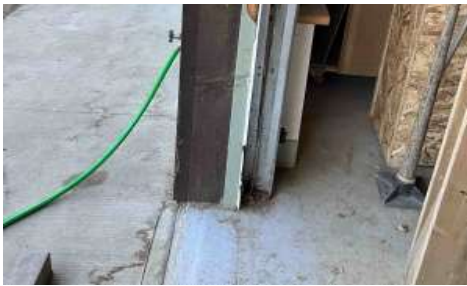
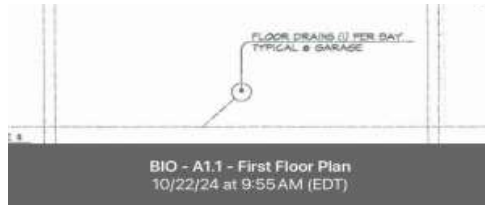
Bio Building	108	Garage	Arch	Exterior door 3-5 year replacement	027
--------------	-----	--------	------	------------------------------------	-----

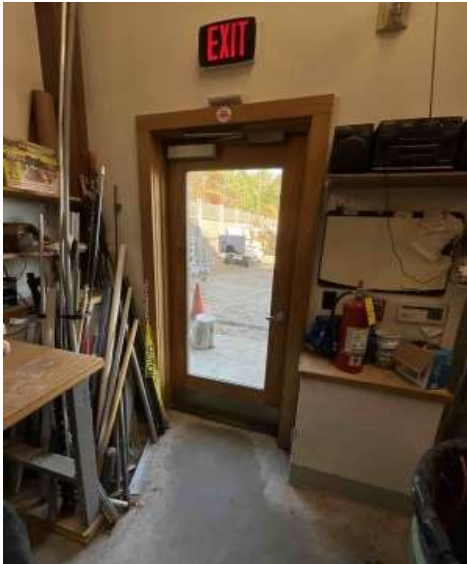
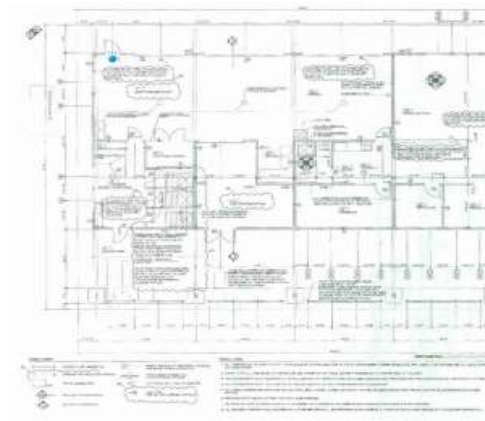
Bio Building	108	Garage	Arch	General picture	247
--------------	-----	--------	------	-----------------	-----

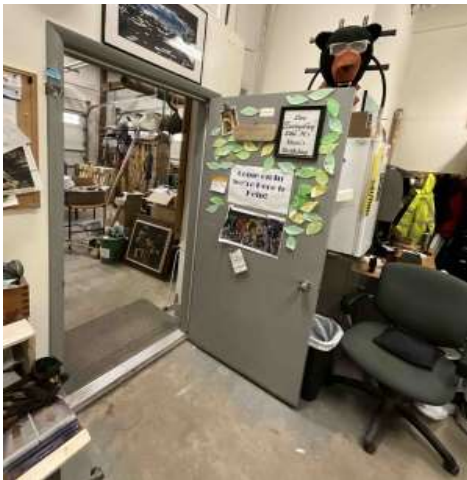
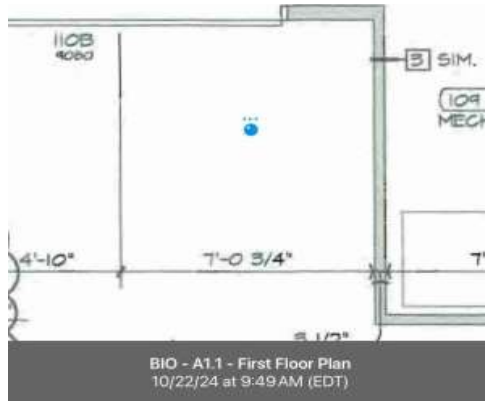
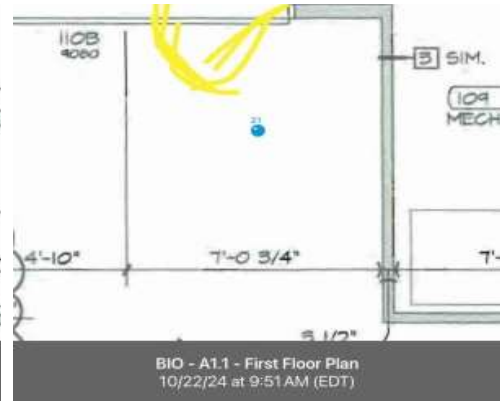
Bio Building	110	Event Storage/Garage	Arch	Overall pictures	022
--------------	-----	----------------------	------	------------------	-----

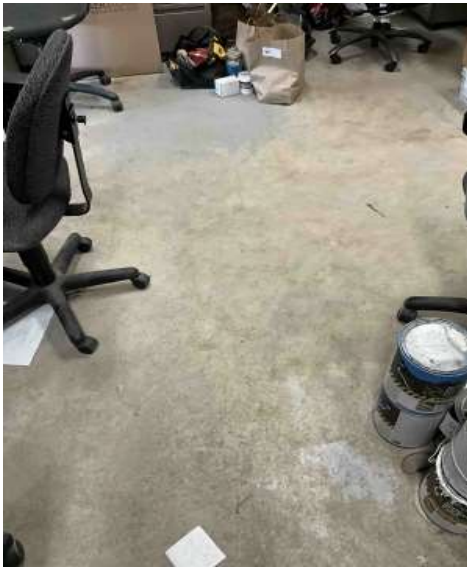
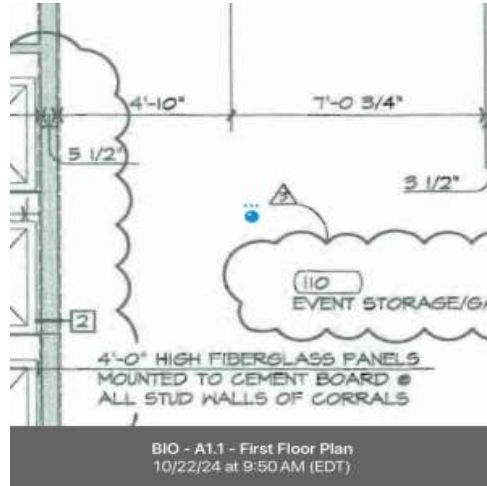
Bio Building	110	Event Storage/Garage	Arch	Floor seal required, minor cracking.	023
--------------	-----	----------------------	------	--------------------------------------	-----

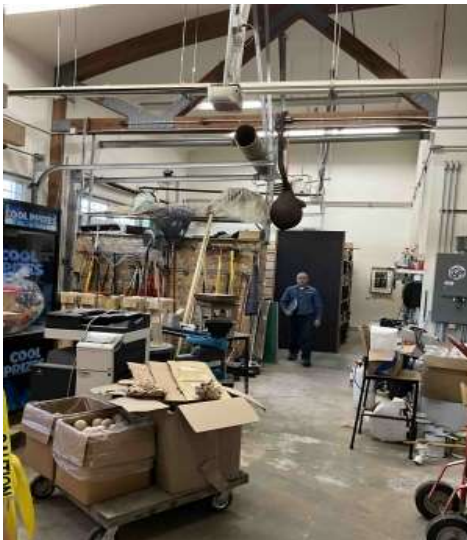
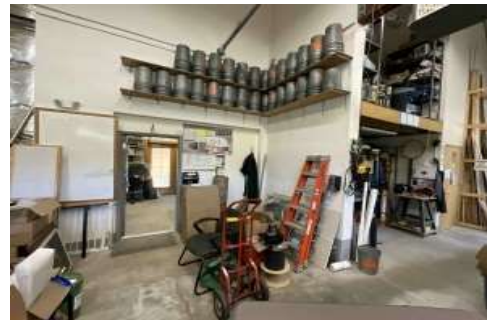
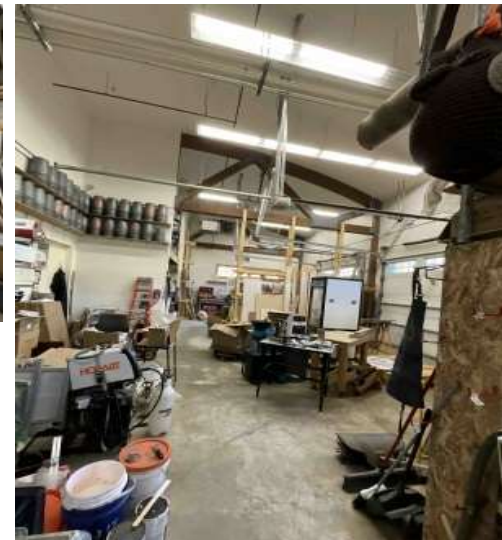
Bio Building	110	Event Storage/Garage	Arch	Overall pictures	026
--------------	-----	----------------------	------	------------------	-----

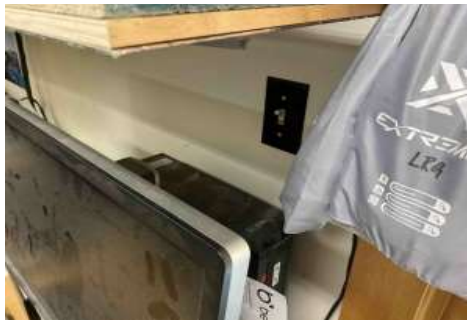
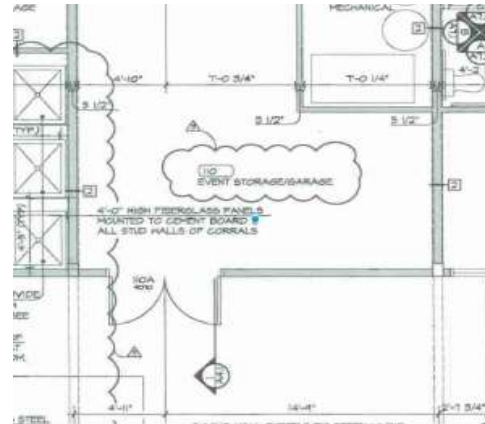
Bio Building	110	Event Storage/Garage	Elec	LIGHTING CONTROLLS	070
--------------	-----	----------------------	------	--------------------	-----

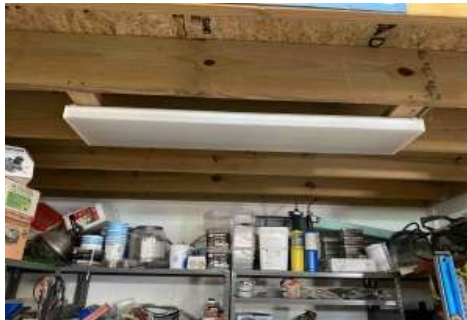
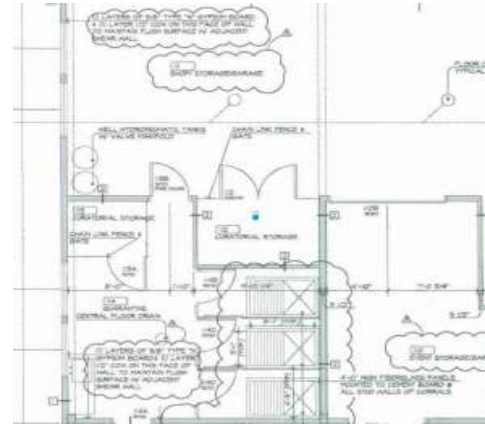
Bio Building	112	Curatorial Storage	Elec	NON-LED	072
--------------	-----	--------------------	------	---------	-----

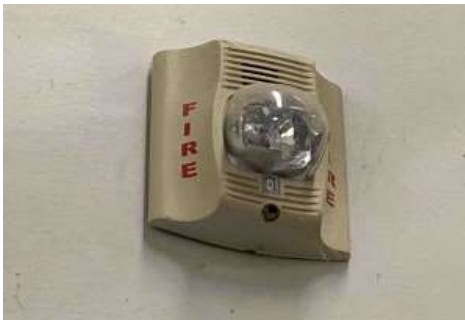
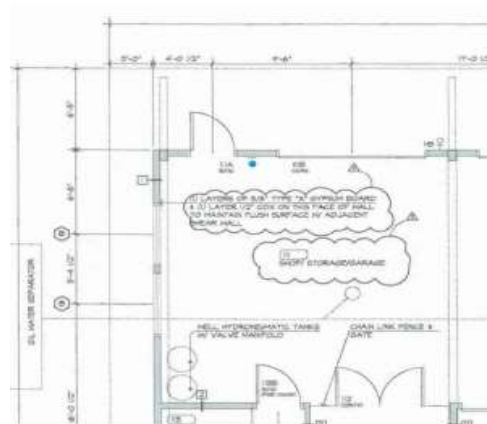
Bio Building	112	Curatorial Storage	Elec	FIRE ALARM ANTIQUATED	077
--------------	-----	--------------------	------	-----------------------	-----

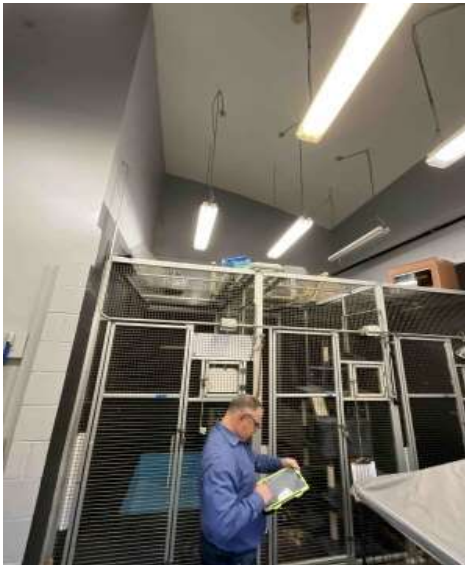
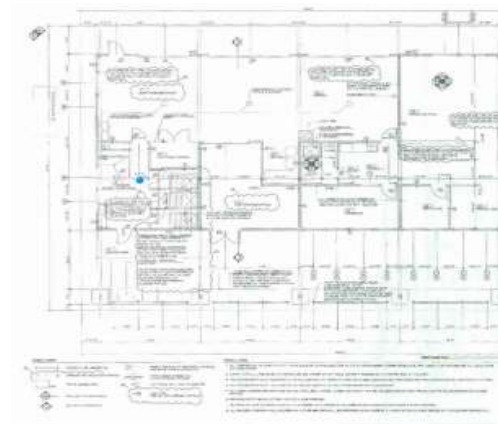
Bio Building	114	Quarantine	Arch	Floor seal required, minor cracking.	028
--------------	-----	------------	------	--------------------------------------	-----

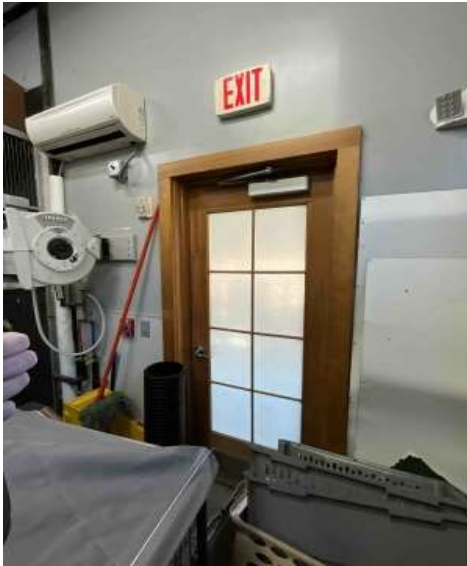
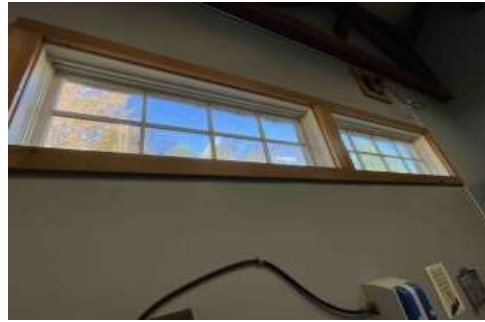
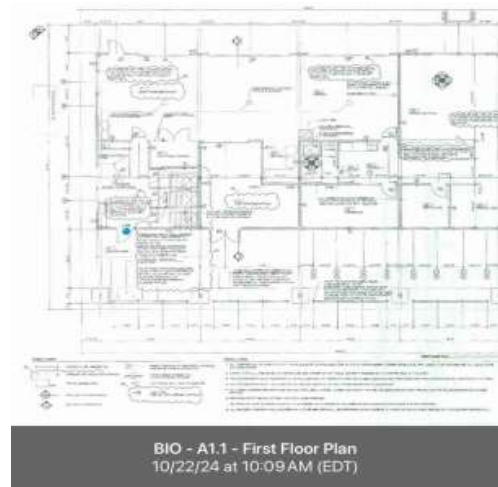
Building	Space Number	Space Name	Element	Description	ID
Bio Building	114	Quarantine	Arch	Exterior door 3-5 year replacement	029

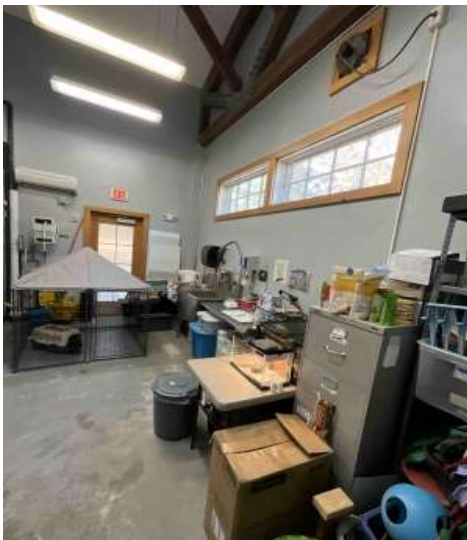
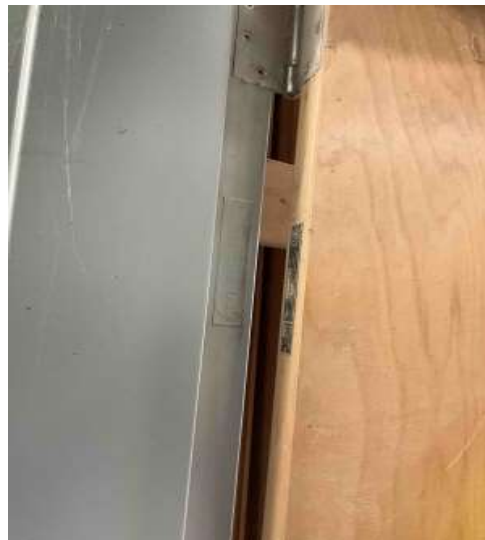
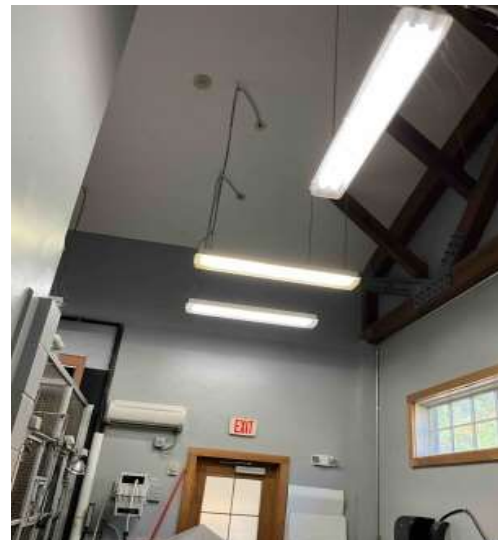
Bio Building	114	Quarantine	Arch	FR frame label painted over	030
--------------	-----	------------	------	-----------------------------	-----

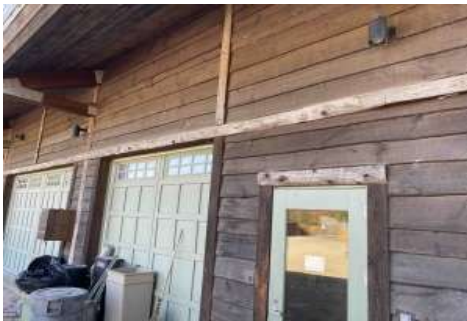
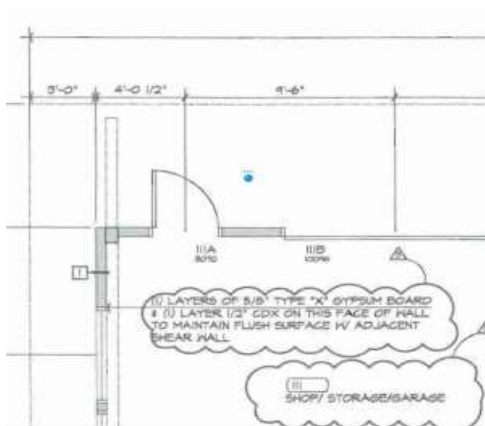
Bio Building	115	Outdoor Area	Elec	EXTERIOR EGRESS LIGHTING	080
--------------	-----	--------------	------	--------------------------	-----

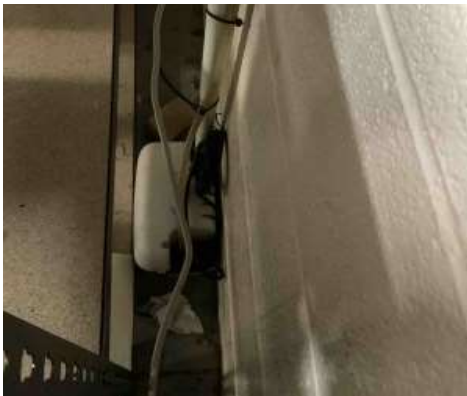
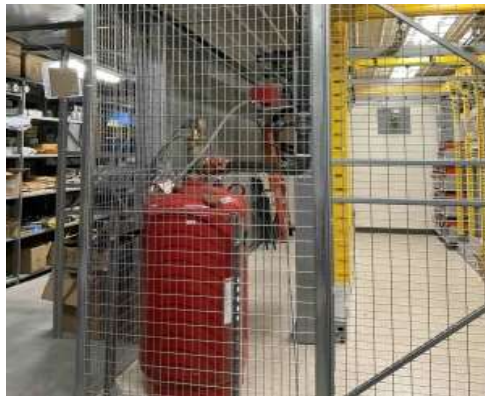
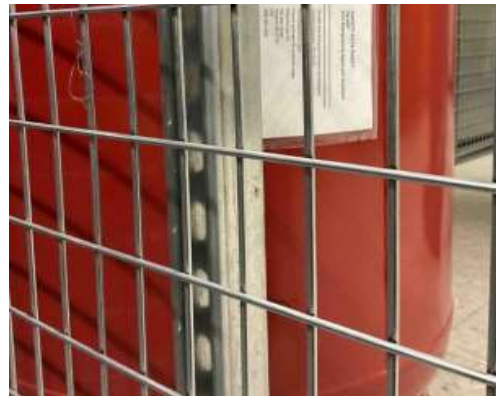
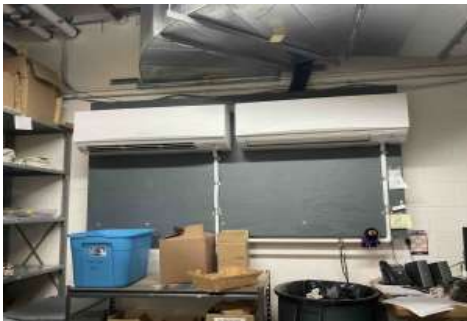
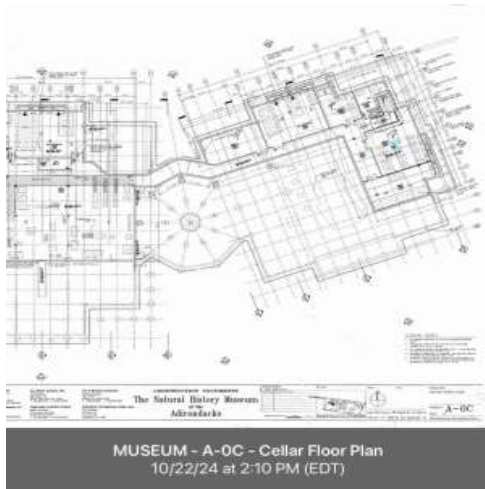
Museum	N/A		MPF	Fire pump age tbd; storage of materials in fire pump room	200
--------	-----	--	-----	---	-----

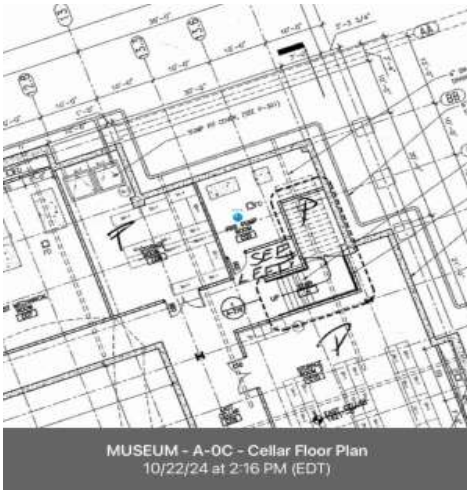
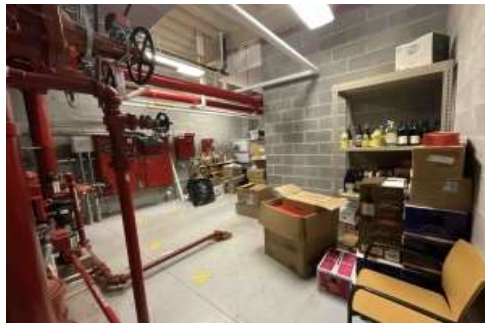
Museum	N/A		MPF	Several concealed sprinkler heads with missing covers, one with deflector above ceiling level; difficult access to Liebert unit for routine maintenance; check for potential sprinkler obstruction with AV cabinets - approx 6" clear	034
--------	-----	--	-----	---	-----

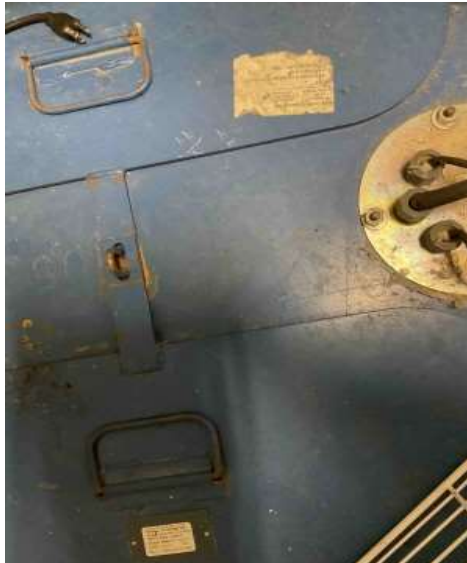
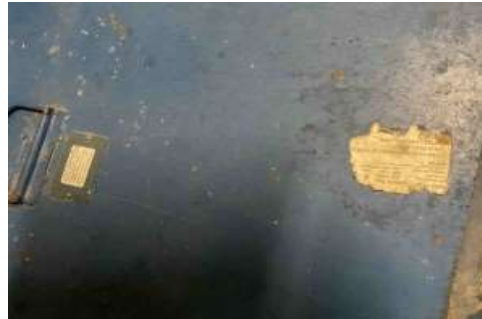
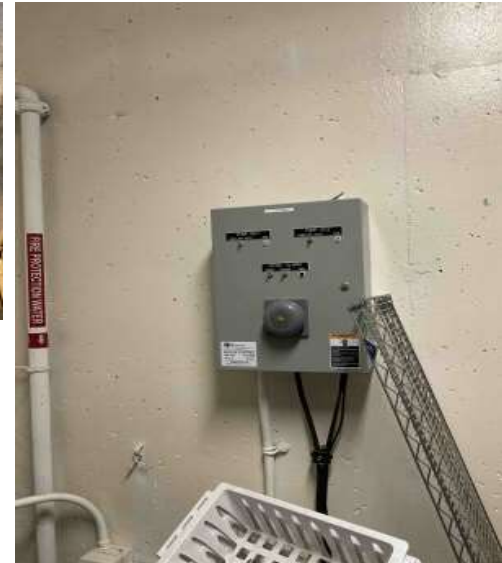
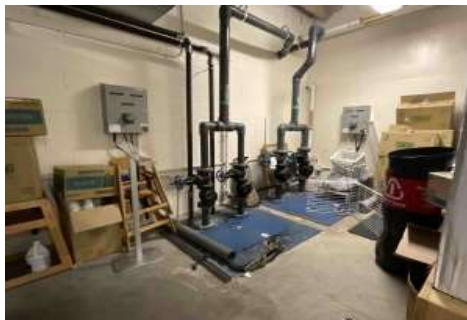
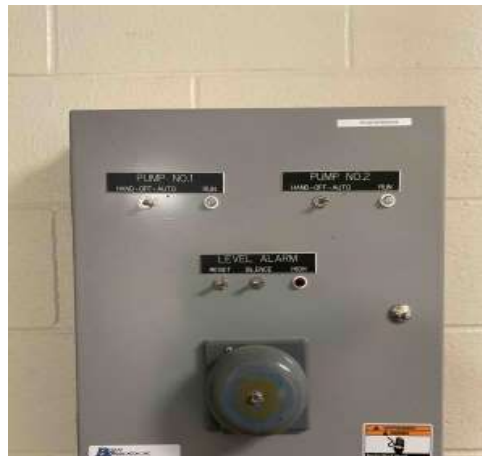
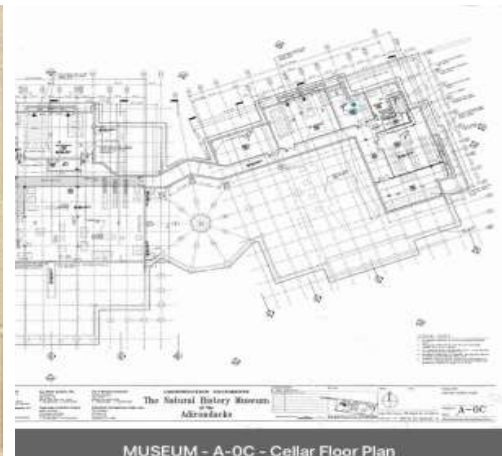
Museum		N/A	MPF	Lots of stored materials in MER. AHU-1 RA connection leaks, AHU-9 OA connection panel removed for RA due to coil freeze. Rust on top. Why is Theatre unit operating (-1)?	202
--------	--	-----	-----	---	-----

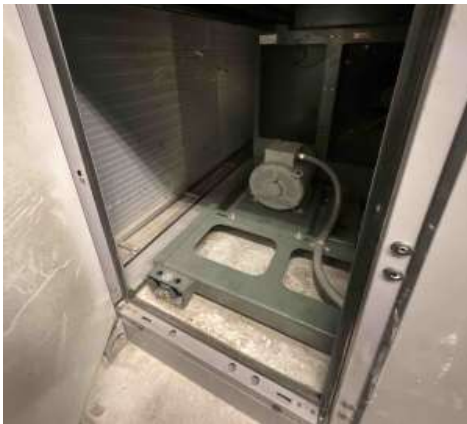
Museum		N/A	MPF	AHU-2 RAF rattling	203
--------	--	-----	-----	--------------------	-----
