Wild Center Property Condition Assessment

LaBella Project No.: 2244417
Prepared On: 11/6/2024

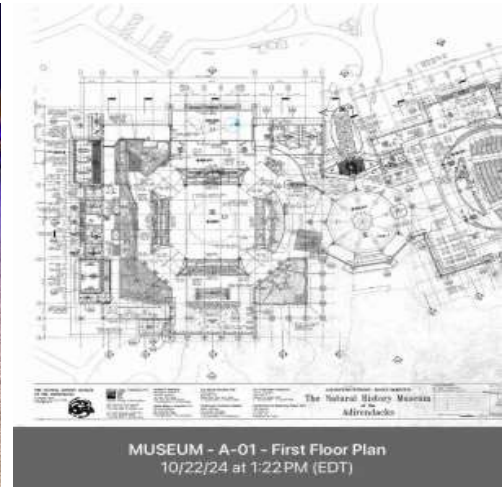
Museum	N/A	Arch	Carpet replacement in 2-3 years mismatch patch area	223
--------	-----	------	---	-----

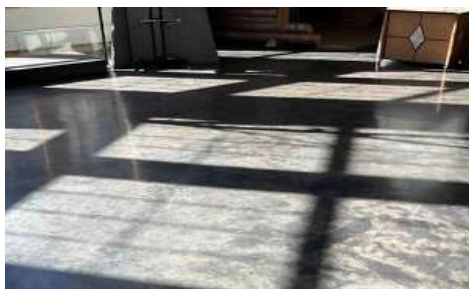
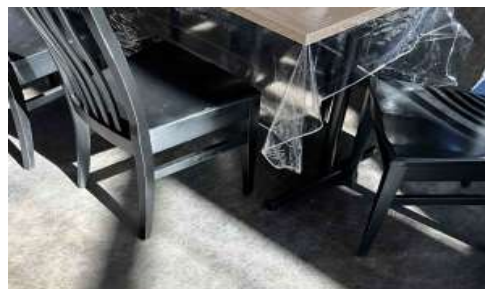
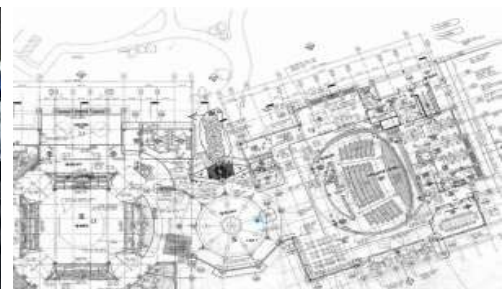
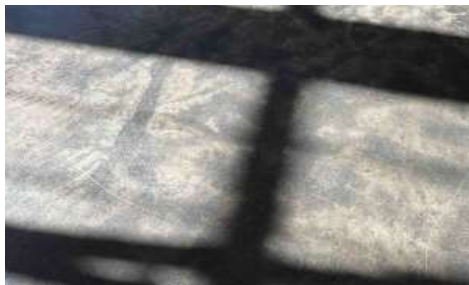
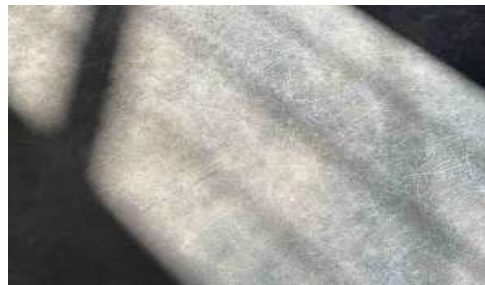
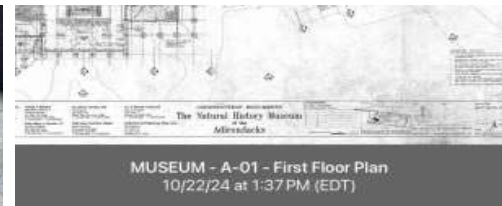
Museum	N/A	Arch	Flooring needs resealing	227
--------	-----	------	--------------------------	-----

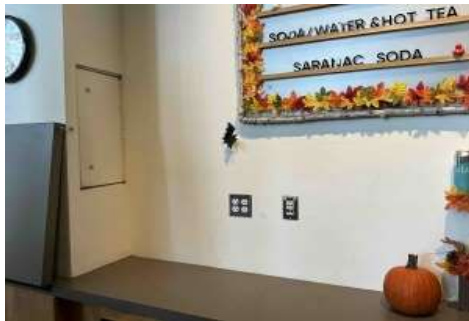
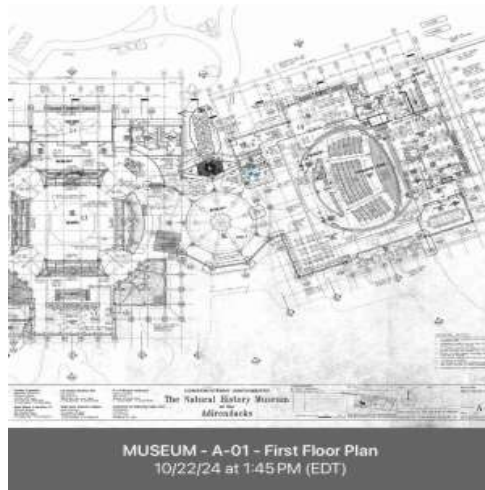
Museum	N/A		Arch	Patch and paint back wall	230
--------	-----	--	------	---------------------------	-----

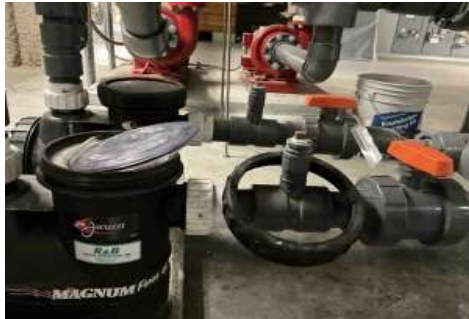
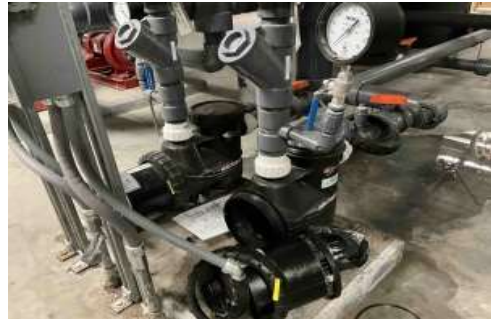
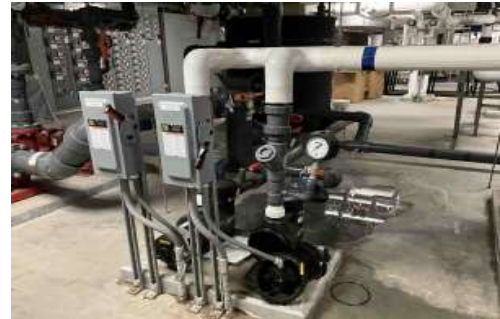
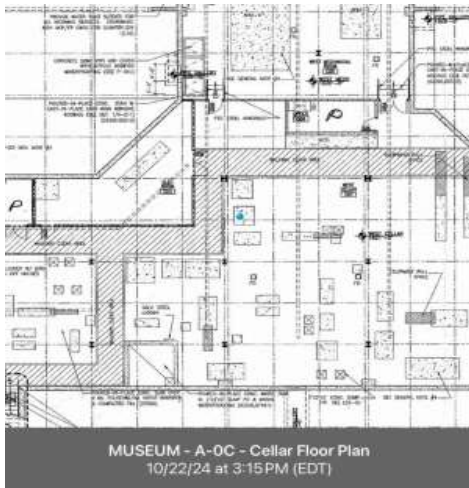
Museum	N/A		MPF	Aquatic pump active repair for otter falls life safety	239
--------	-----	--	-----	--	-----

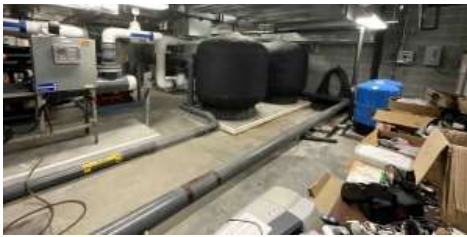
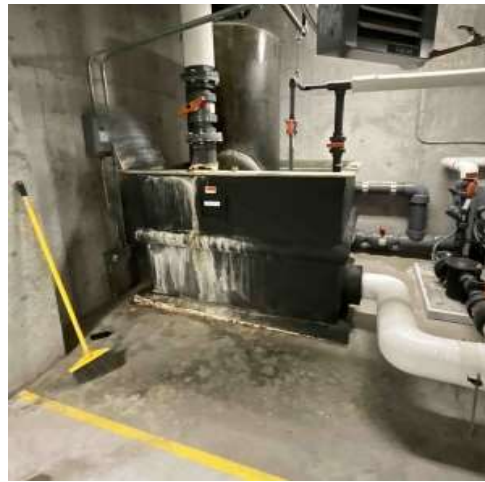
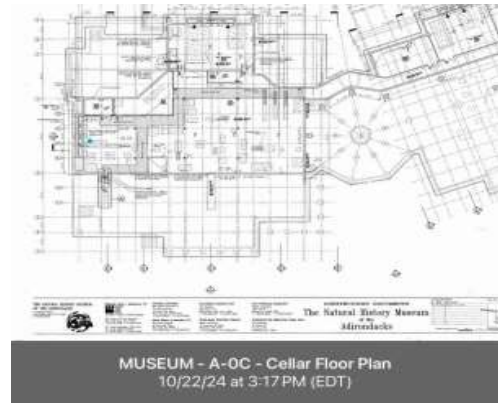
Museum	N/A		MPF	Trout pool leak	240
--------	-----	--	-----	-----------------	-----

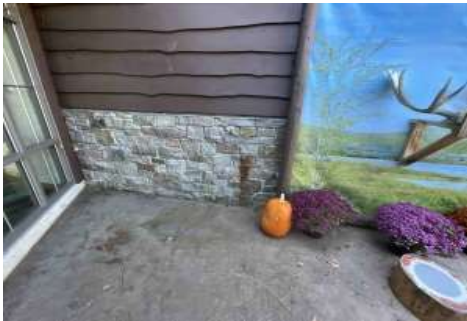
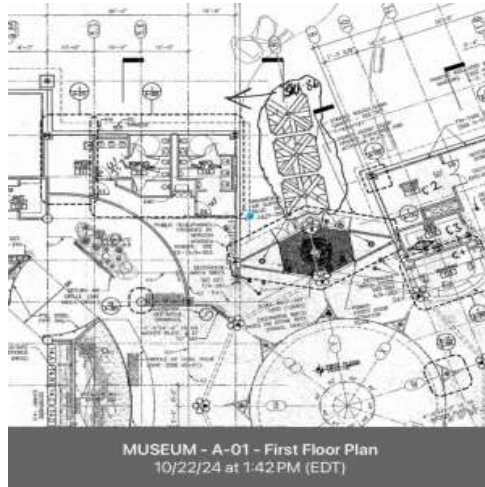
Museum	000	Exterior	Siding	Damaged Paint	120
--------	-----	----------	--------	---------------	-----

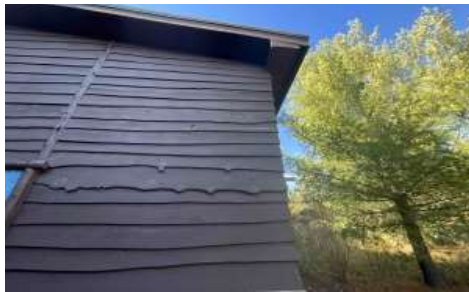
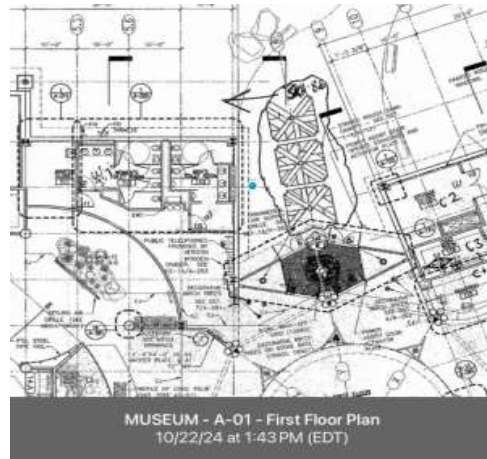
Museum	000	Exterior	Siding	Cracking	123
--------	-----	----------	--------	----------	-----

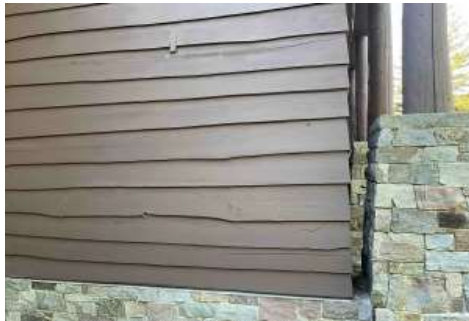
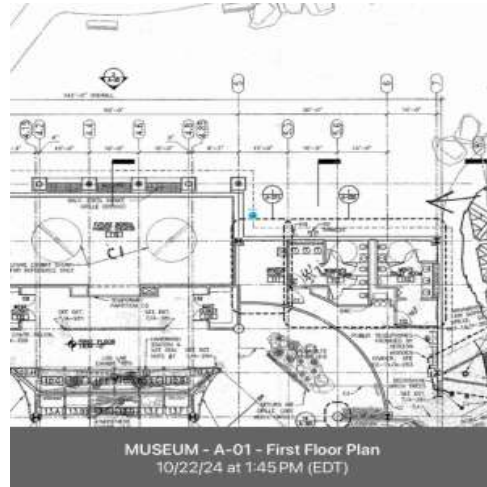
Museum	000	Exterior	Siding	Damaged Paint	124
--------	-----	----------	--------	---------------	-----

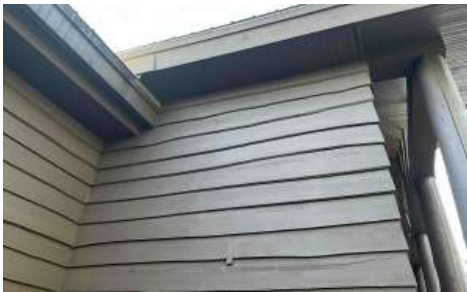
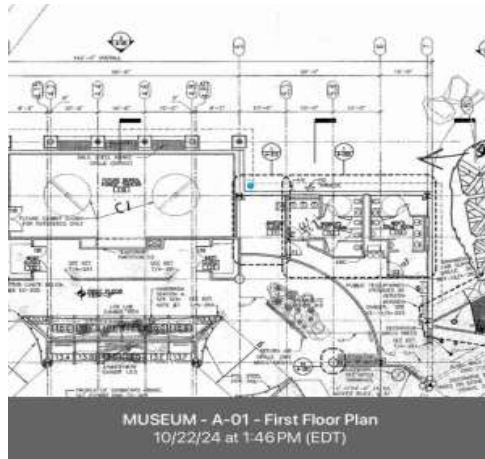
Museum	000	Exterior	Soffit	Seal holes	127
--------	-----	----------	--------	------------	-----

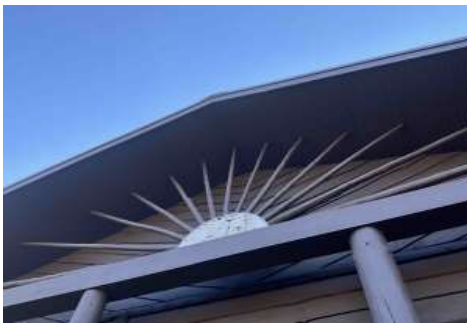
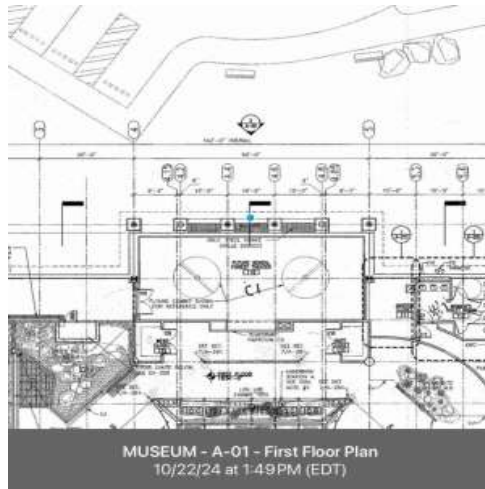
Museum	000	Exterior	MPF	Active leak	128
--------	-----	----------	-----	-------------	-----

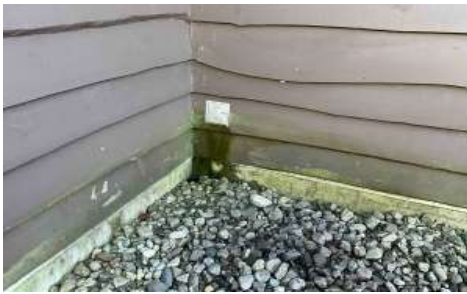
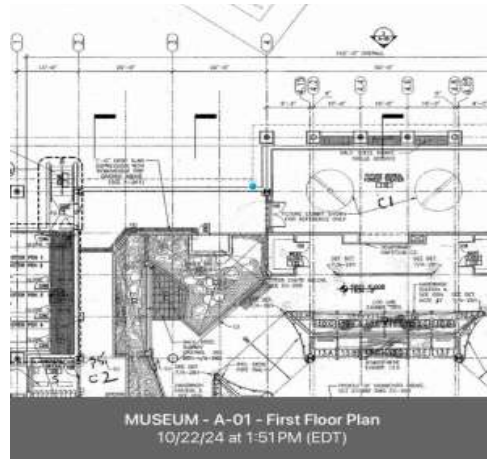
Museum	000	Exterior	Siding	Damaged Paint	133
--------	-----	----------	--------	---------------	-----

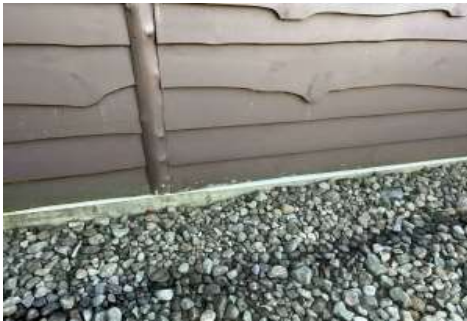
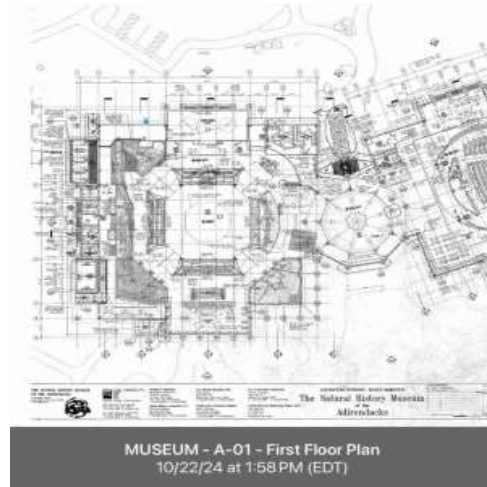
Museum	000	Exterior	General	Good condition	141
--------	-----	----------	---------	----------------	-----

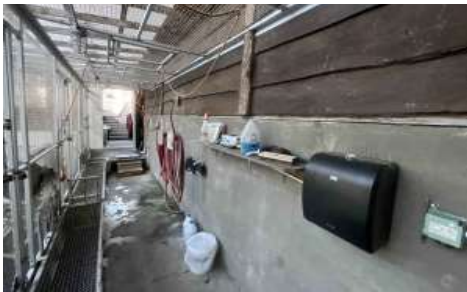
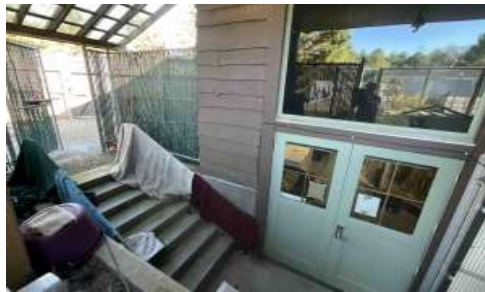
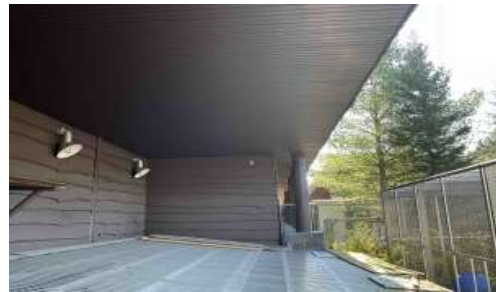
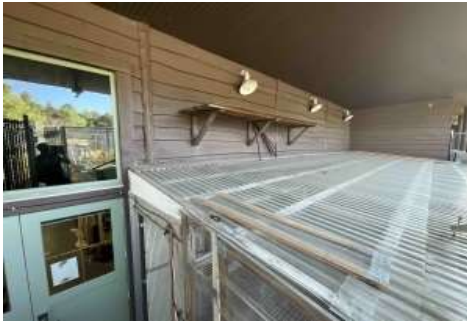
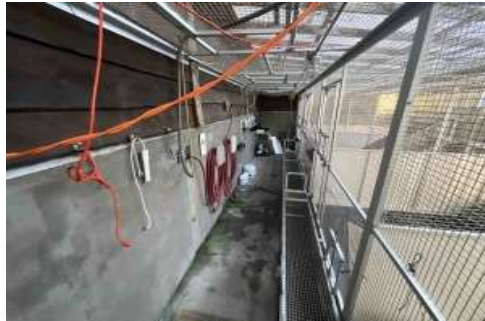
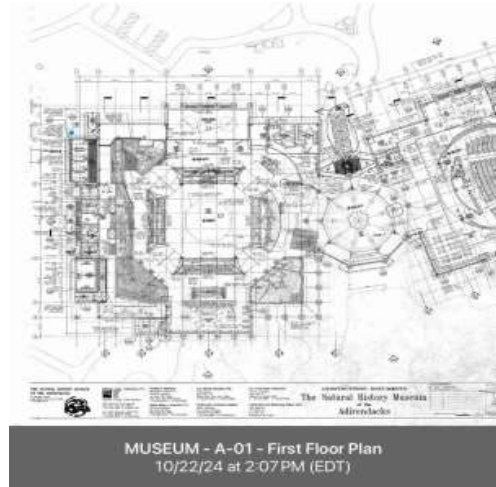
Museum	000	Exterior	General	Good condition	143
--------	-----	----------	---------	----------------	-----

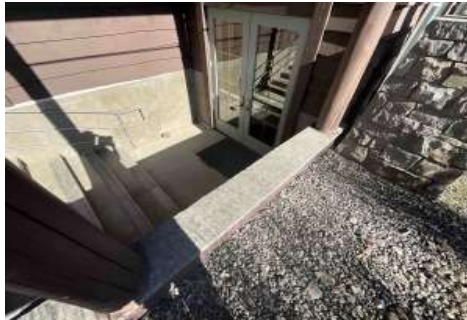
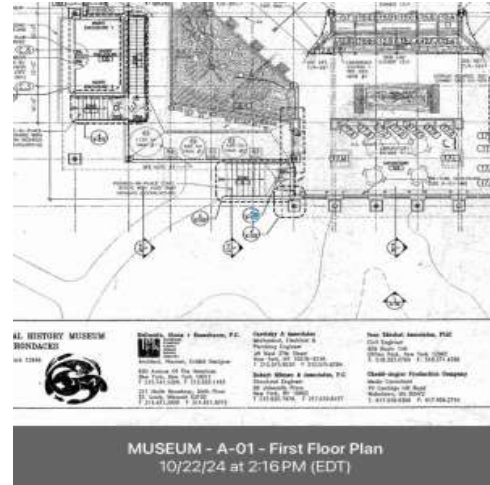
Museum	000	Exterior	Siding	Damaged window trim	155
--------	-----	----------	--------	---------------------	-----

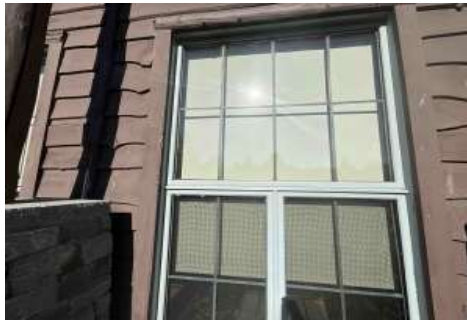
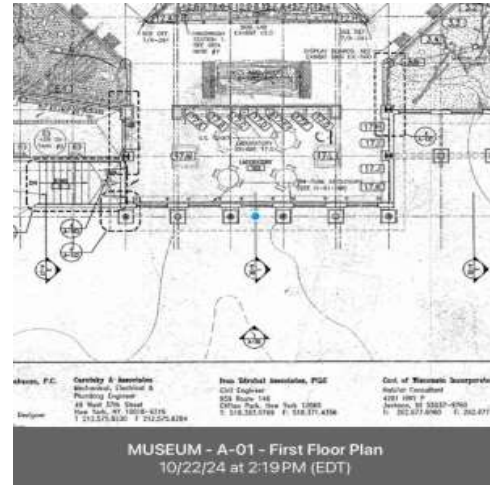
Building	Space Number	Space Name	Element	Description	ID
Museum	000	Exterior	Siding	Damaged Paint	156

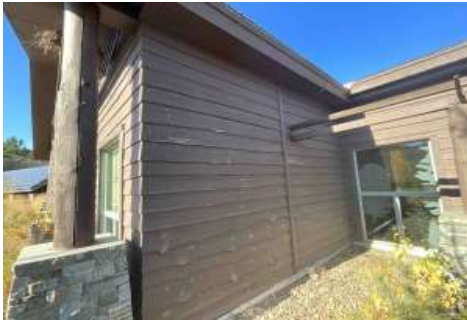
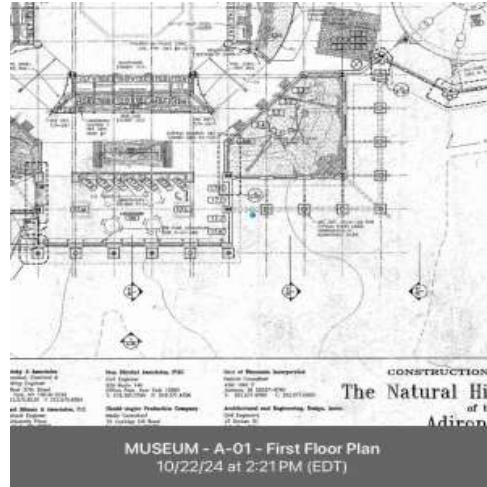
Museum	000	Exterior	Siding	Damaged Paint	158
--------	-----	----------	--------	---------------	-----

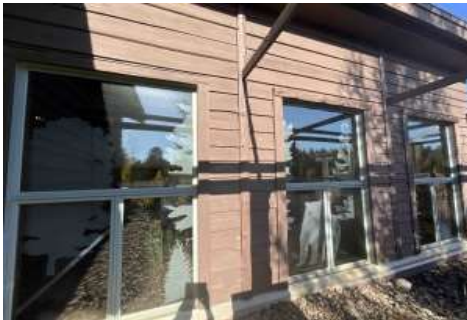
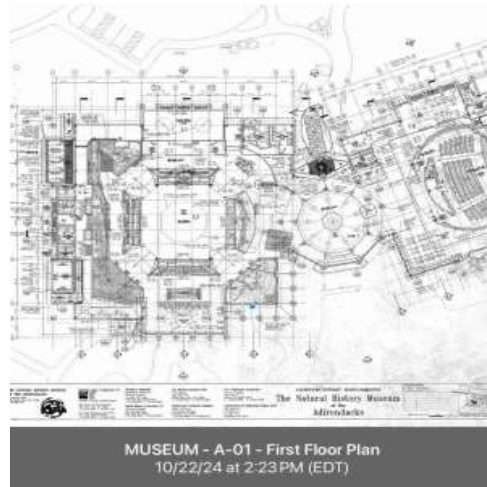
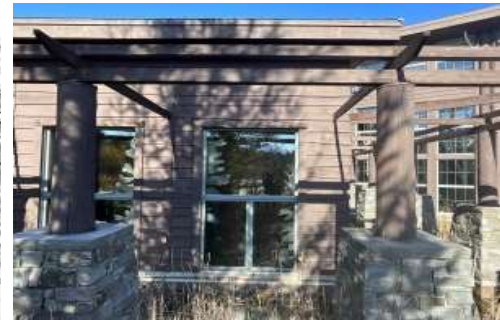
Museum	000	Exterior	Siding	Ripped off bldg	159
--------	-----	----------	--------	-----------------	-----

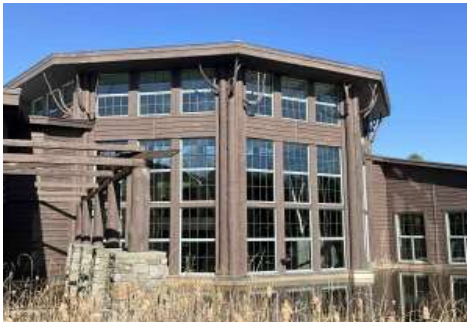
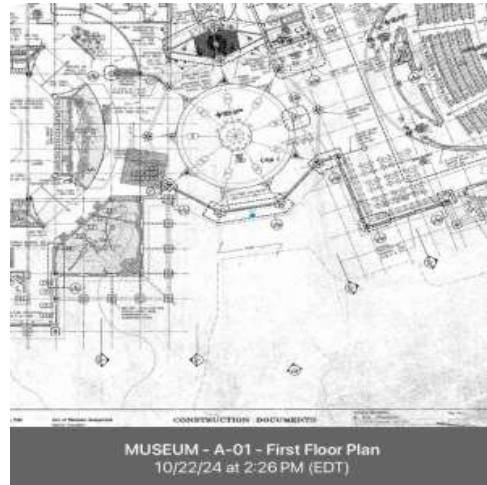
Museum	000	Exterior	Siding	Damaged Paint	160
--------	-----	----------	--------	---------------	-----

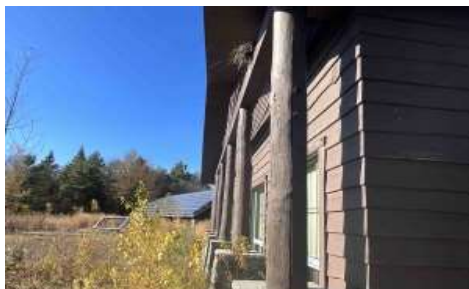
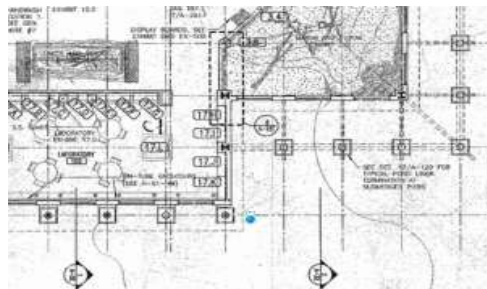
Museum	000	Exterior	Wood Column wrap	Stretching Seam , typ	163
--------	-----	----------	------------------	-----------------------	-----

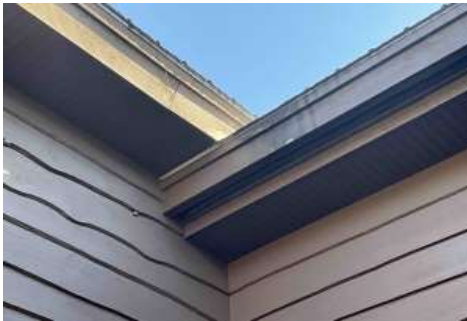
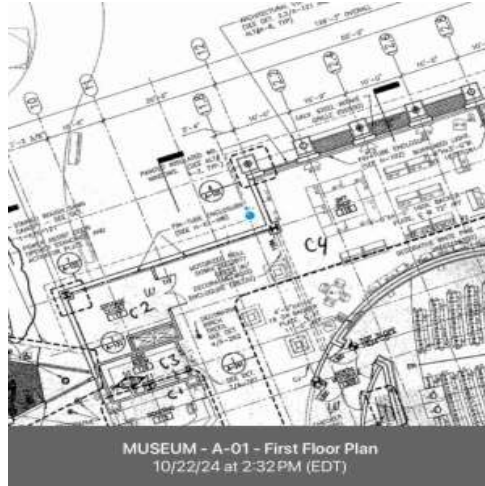
Museum	000	Exterior	Facia Board	Damaged Paint	164
--------	-----	----------	-------------	---------------	-----

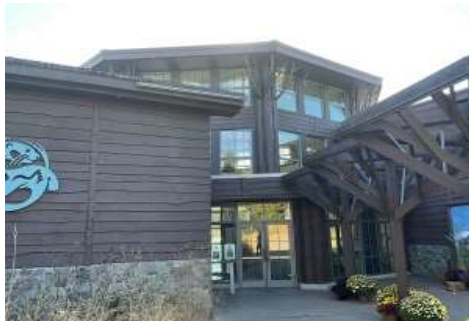
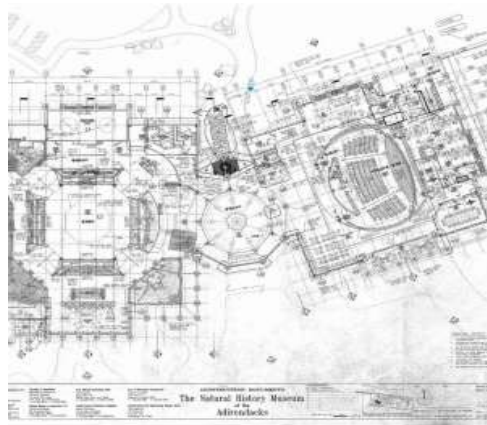
Museum	000	Exterior	Window	Damaged Weatherstripping	169
--------	-----	----------	--------	--------------------------	-----

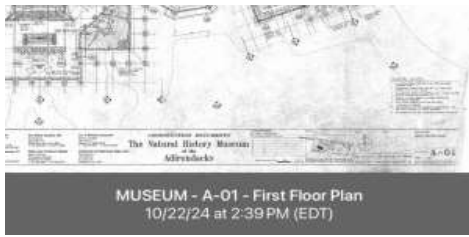
Museum	000	Exterior	Facia Board	Damaged Paint	176
--------	-----	----------	-------------	---------------	-----

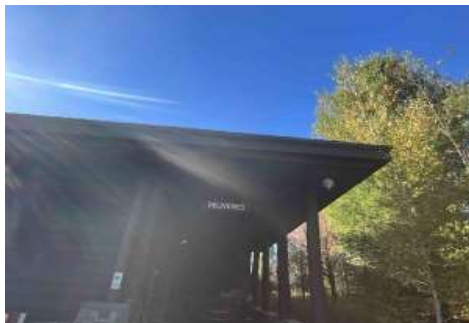
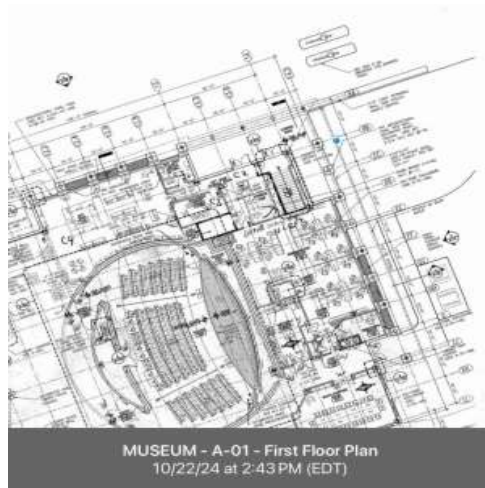
Museum	000	Exterior	Siding	Damaged Paint	177
--------	-----	----------	--------	---------------	-----

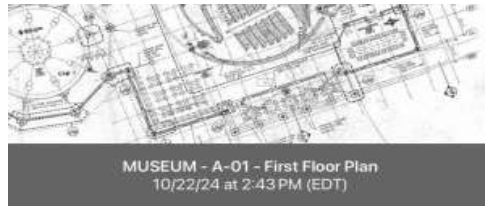
Museum	000	Exterior	Soffit	Holes, Damaged trim	181
--------	-----	----------	--------	---------------------	-----

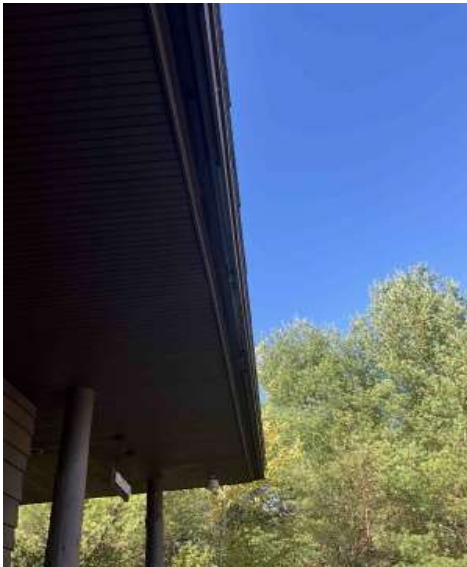
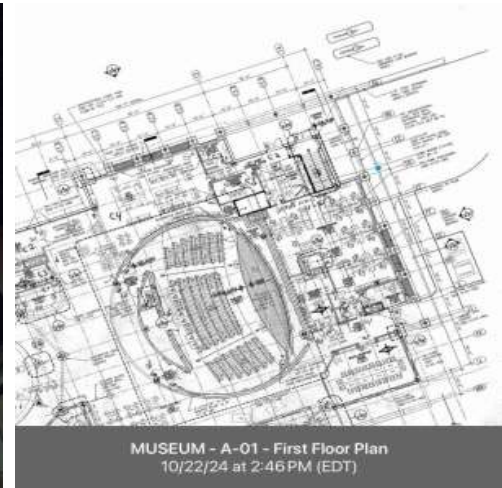
Museum	000	Exterior	Siding	Damaged Paint	183
--------	-----	----------	--------	---------------	-----

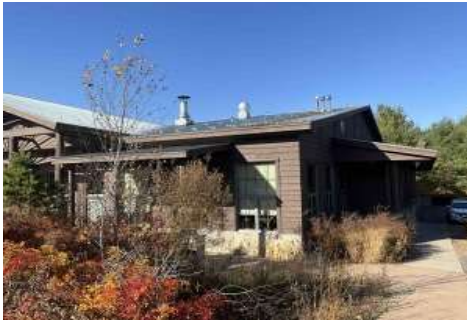
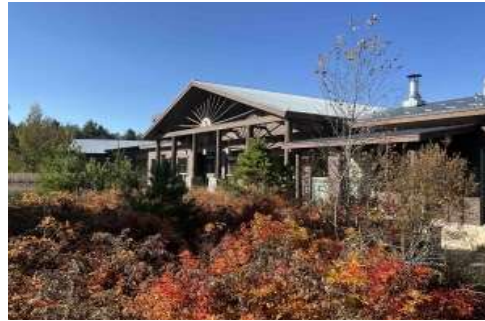
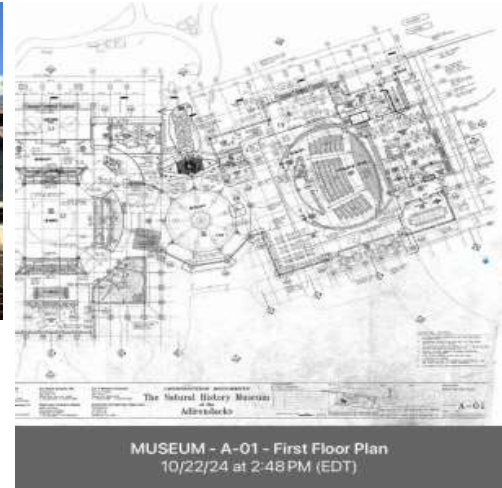
Museum	000	Exterior	General	Ok	185
--------	-----	----------	---------	----	-----

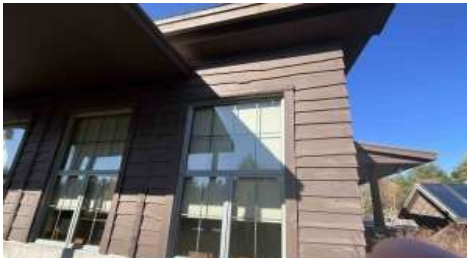
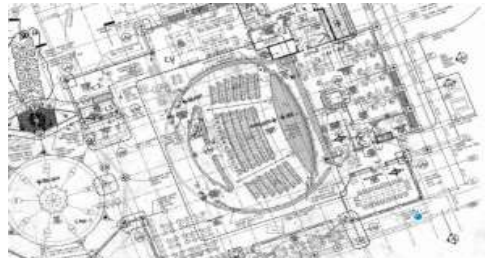
Museum	000	Exterior	Siding	Damaged Paint	186
--------	-----	----------	--------	---------------	-----

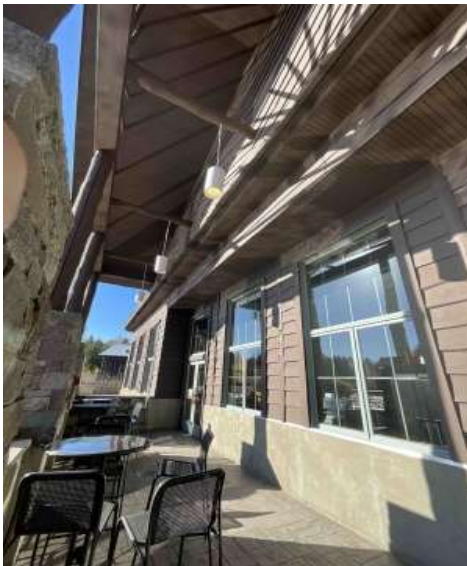
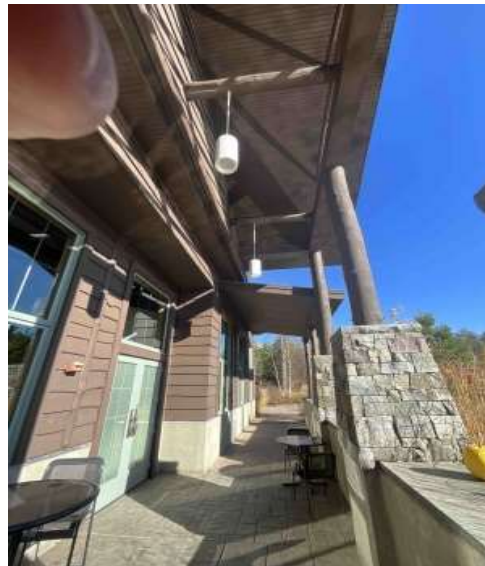
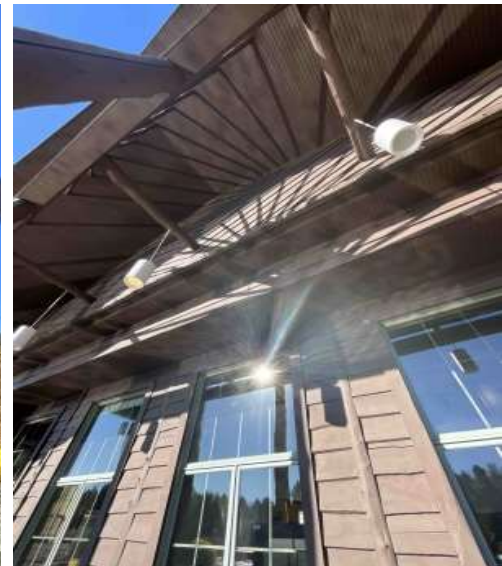
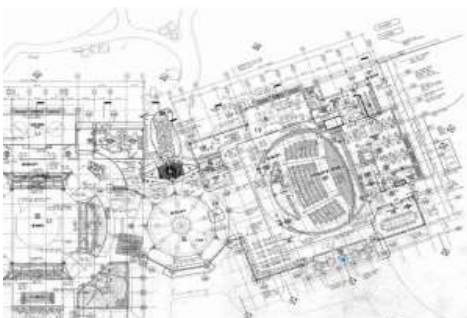
Museum	000	Exterior	General	Ok	190
--------	-----	----------	---------	----	-----

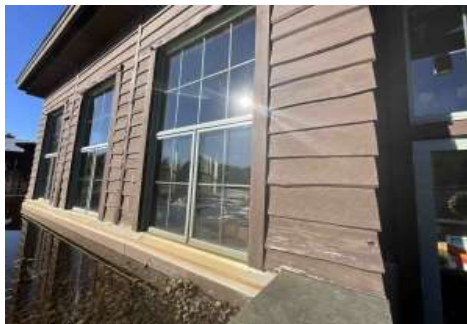
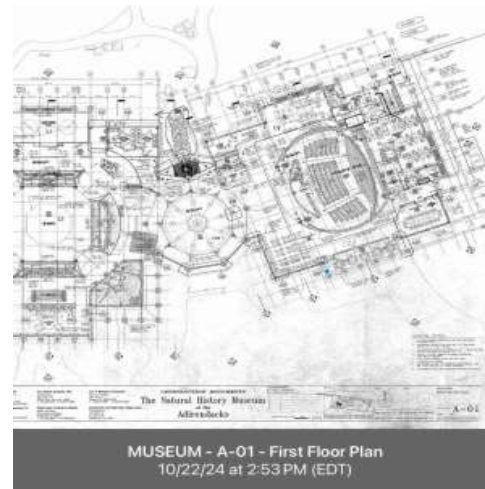
Museum	000	Exterior	Siding	Damaged Paint	193
--------	-----	----------	--------	---------------	-----

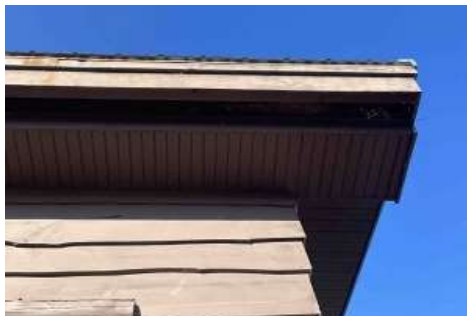
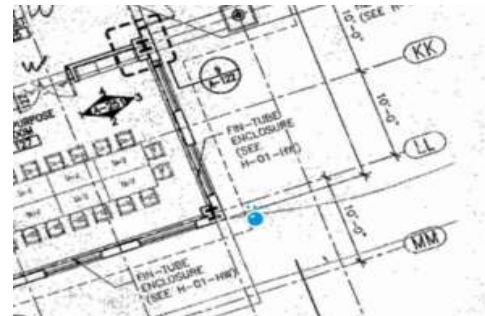
Museum	000	Exterior	Soffit	Holes	194
--------	-----	----------	--------	-------	-----

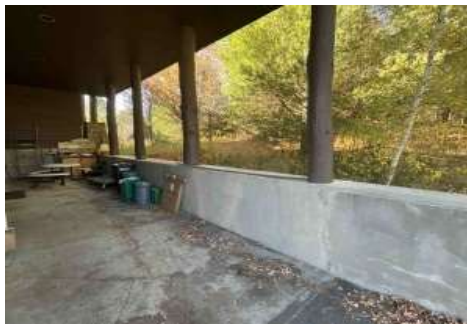
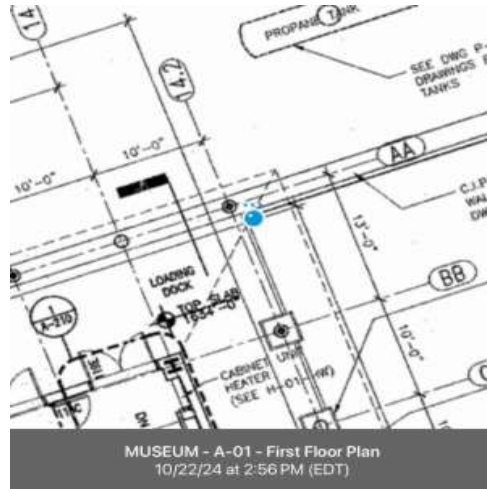
Museum	000	Exterior	Retaining Wall	Cracking	195
--------	-----	----------	----------------	----------	-----

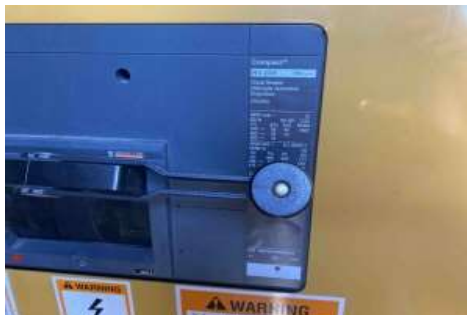
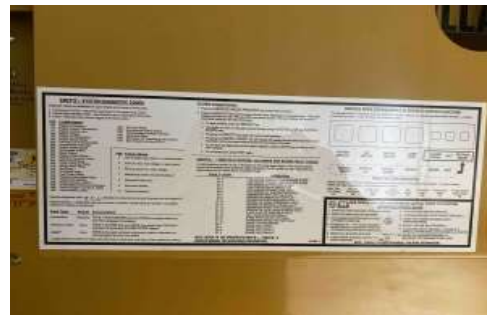
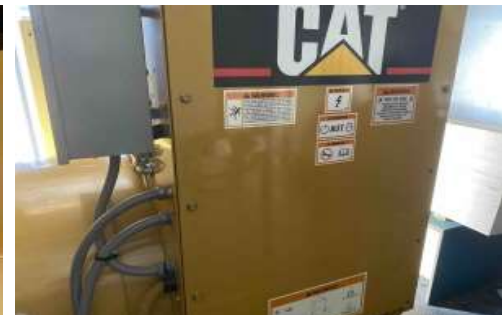
Museum	001	Overall Site	Elec	GENERAL	157
--------	-----	--------------	------	---------	-----

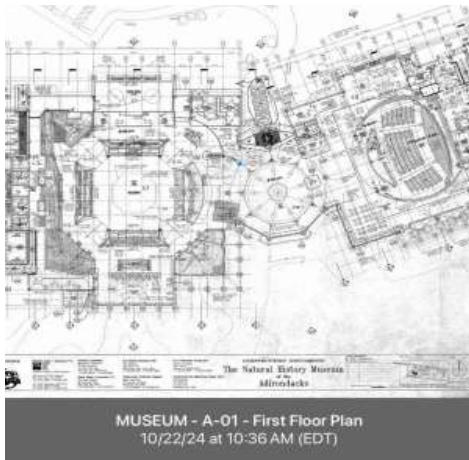
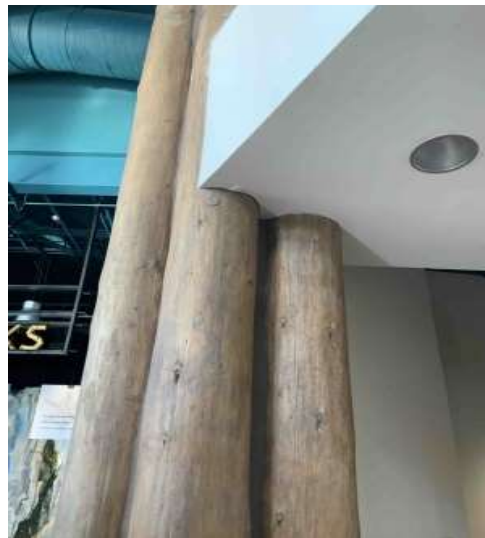
Museum	101	Great Hall	Ceiling	Cracking drywall / paint	035
--------	-----	------------	---------	--------------------------	-----

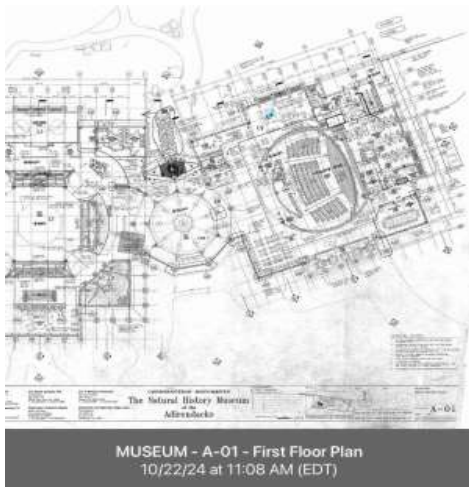
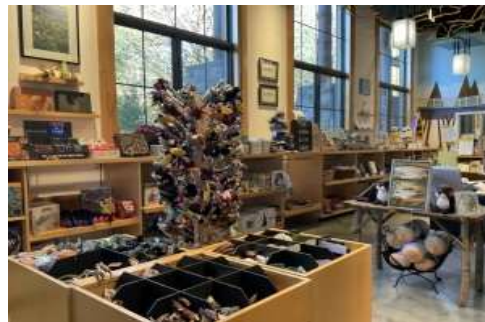
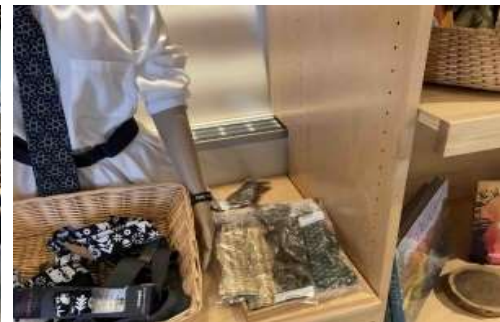
Museum	101	Great Hall	MPF	Finned tube blocked by display shelf; excessive air noise	060
--------	-----	------------	-----	---	-----

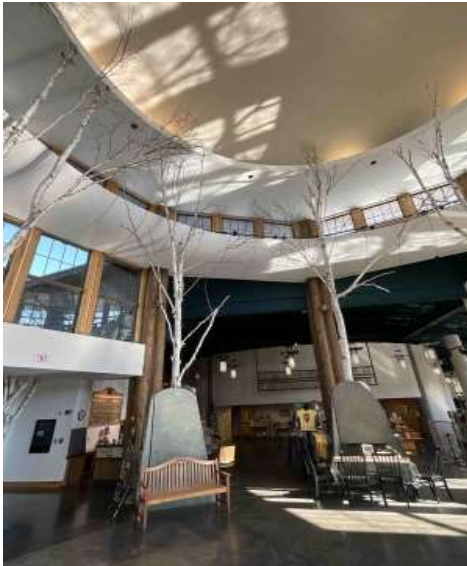
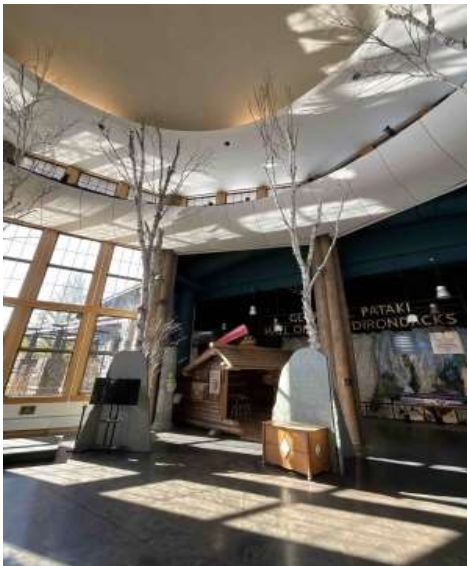
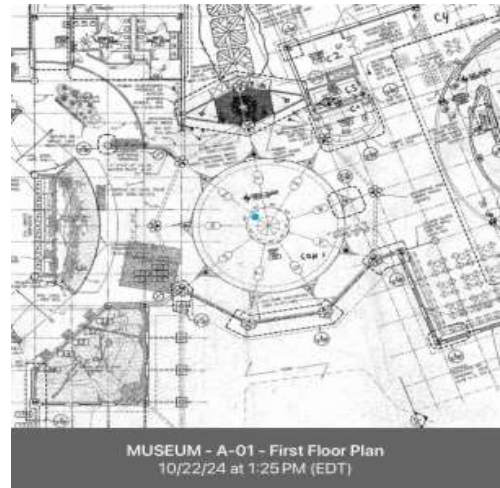
Building	Space Number	Space Name	Element	Description	ID
Museum	101	Great Hall	Arch	White birch tree replacement	224

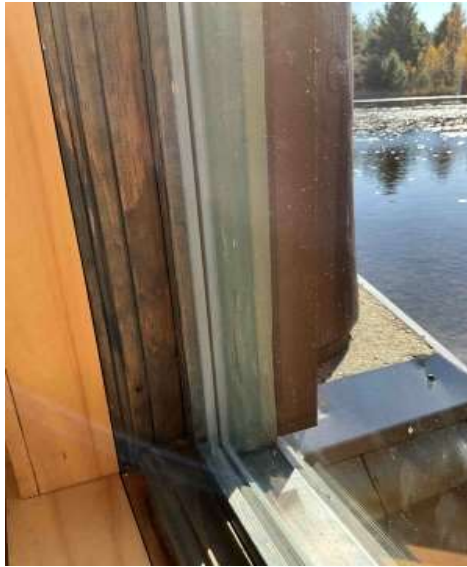
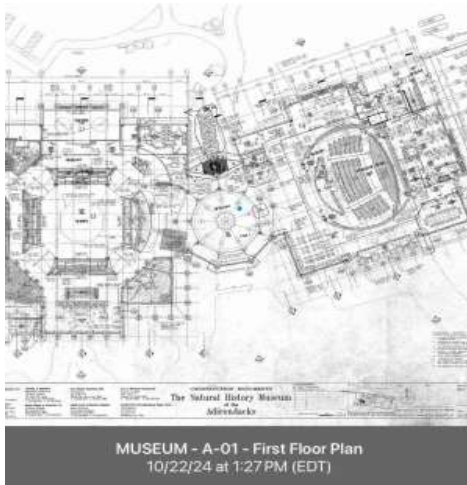
Building	Space Number	Space Name	Element	Description	ID
Museum	101	Great Hall	Arch	Window refinishing to start Replacement in 5 years estimate	225

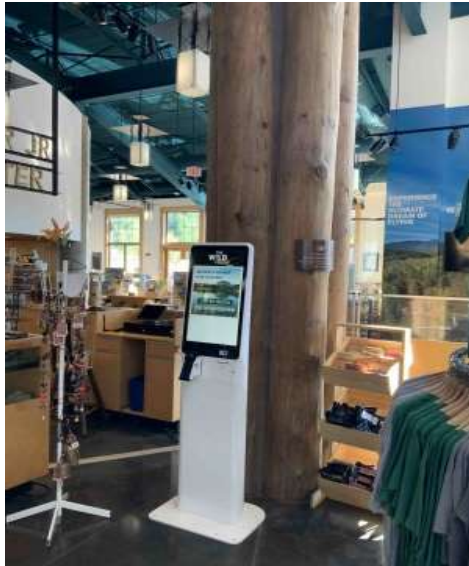
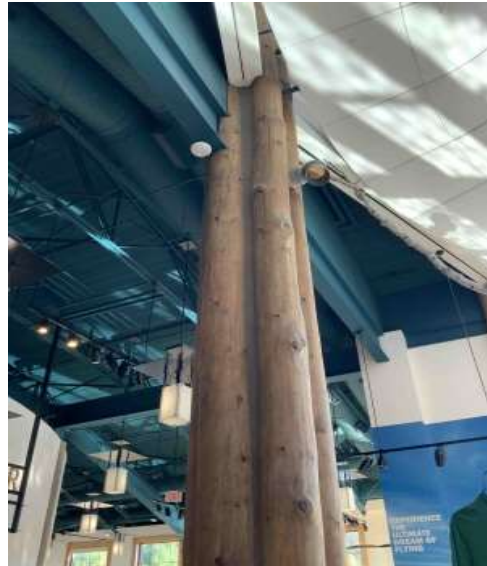
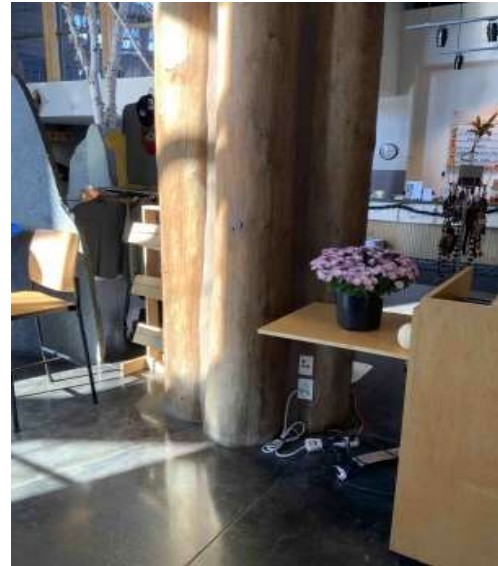
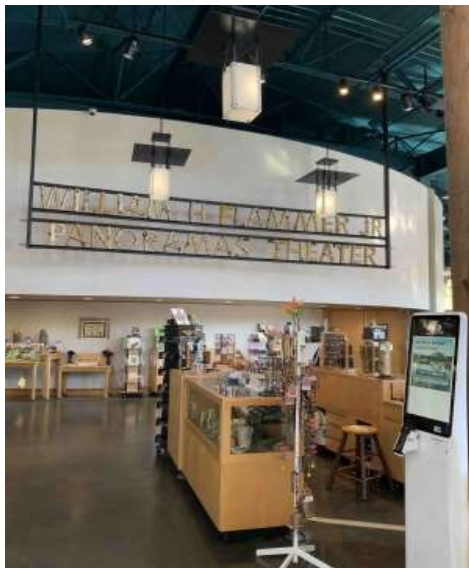
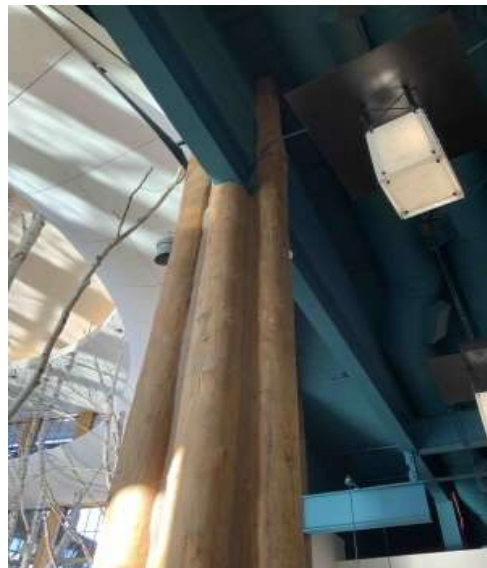
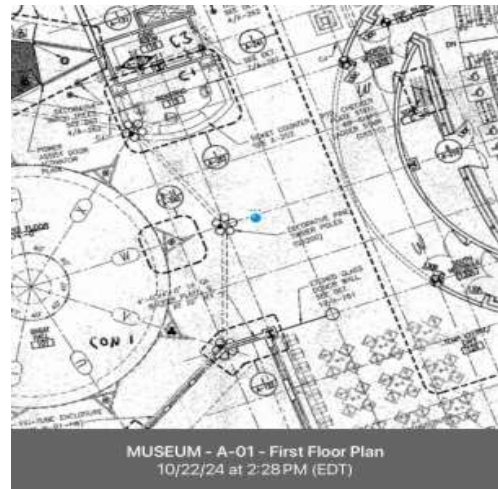
Building	Space Number	Space Name	Element	Description	ID
Museum	101	Great Hall	General Interior Condition	General interior conditions	257

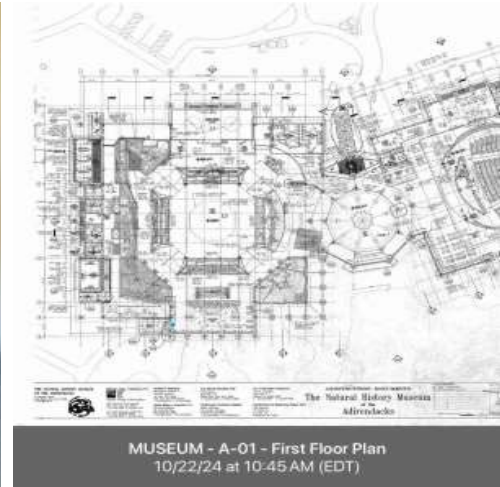
Museum	102	Laboratory	Exterior Door	Weather sealing issues	036
--------	-----	------------	---------------	------------------------	-----

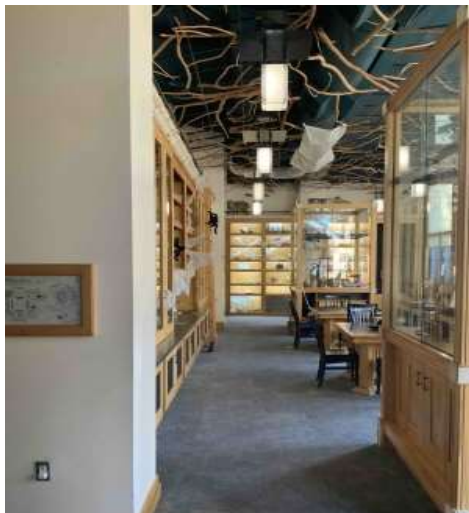
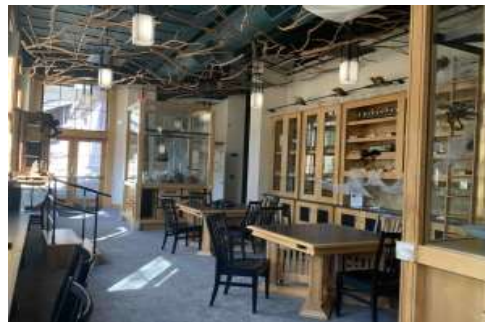
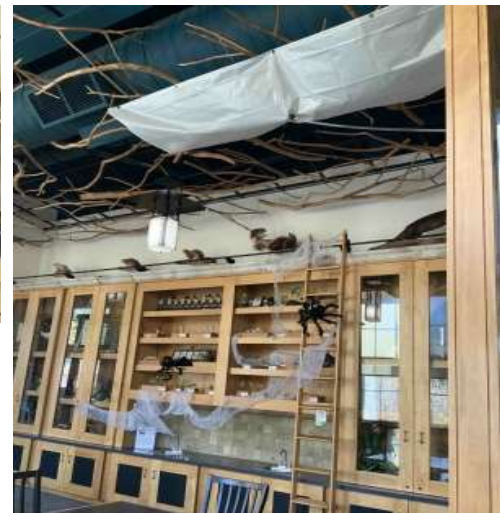
Museum	102	Laboratory	General Interior Space	General interior condition	037
--------	-----	------------	------------------------	----------------------------	-----

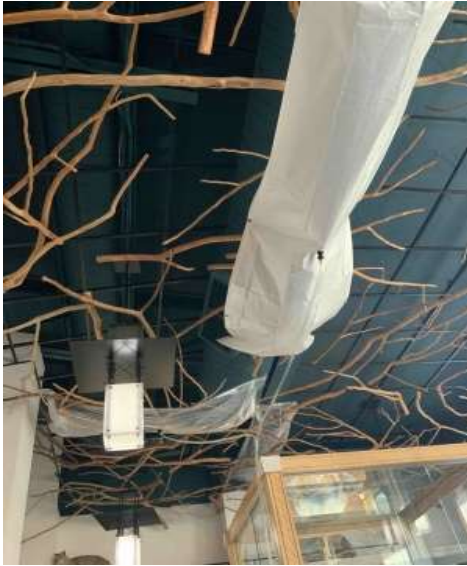
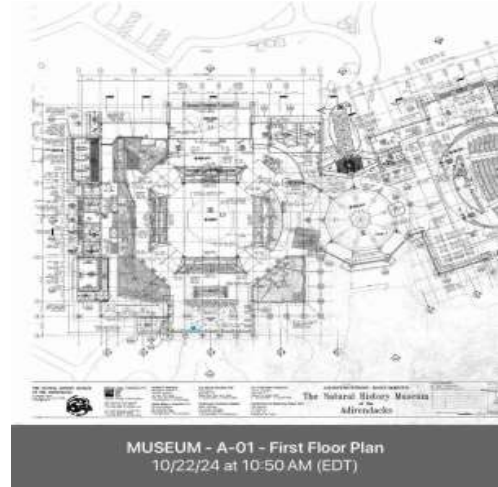
Museum	102	Laboratory	Ceiling	Water infiltration issues	040
--------	-----	------------	---------	---------------------------	-----

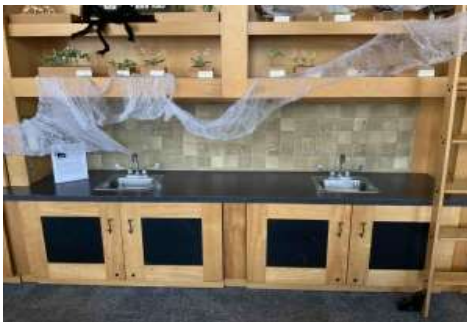
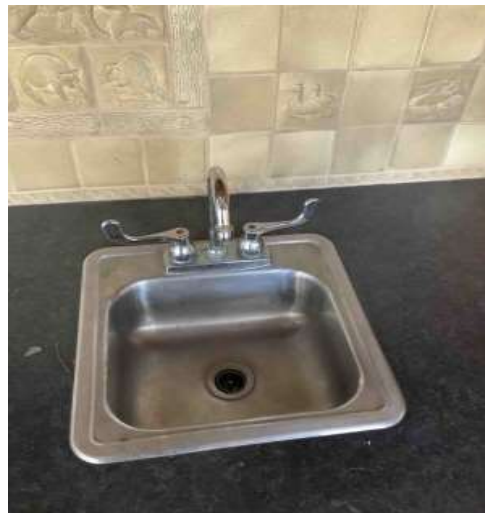
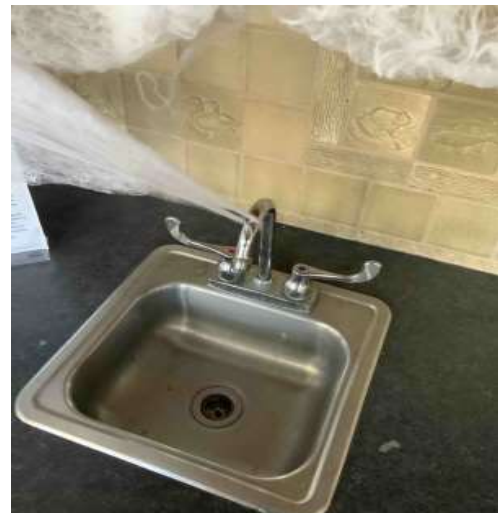
Museum	102	Laboratory	Interior Finishes	Plumbing fixtures outdated	042
--------	-----	------------	-------------------	----------------------------	-----

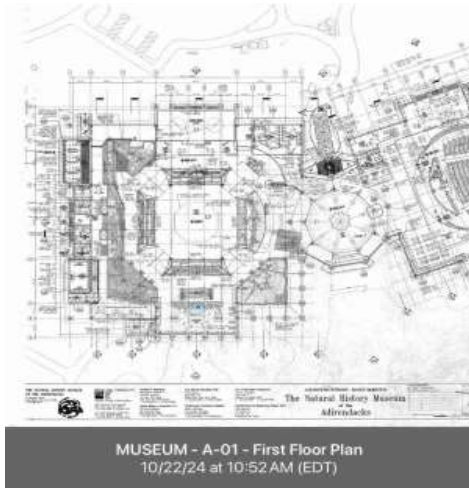
Museum	102	Laboratory	Floor	Carpet tiles in good/fair condition	045
--------	-----	------------	-------	-------------------------------------	-----

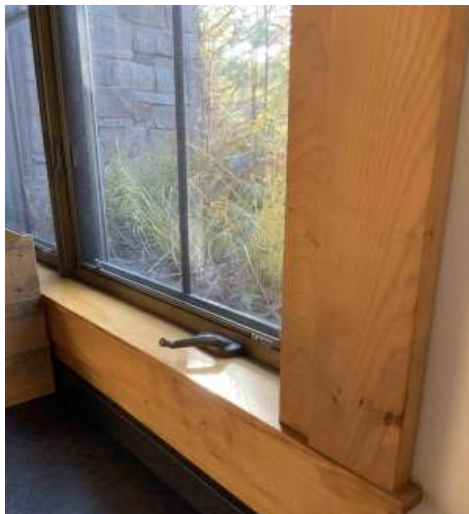
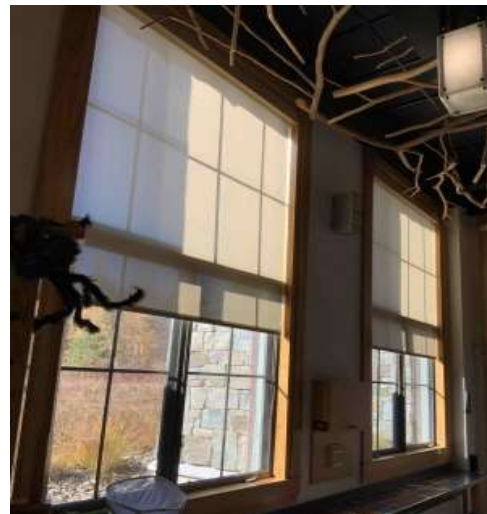
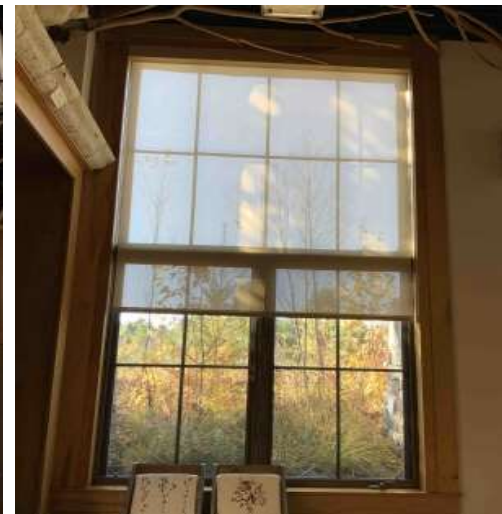
Museum	102	Laboratory	Windows	Potential issues with adjacencies to ground and wet conditions	056
--------	-----	------------	---------	--	-----

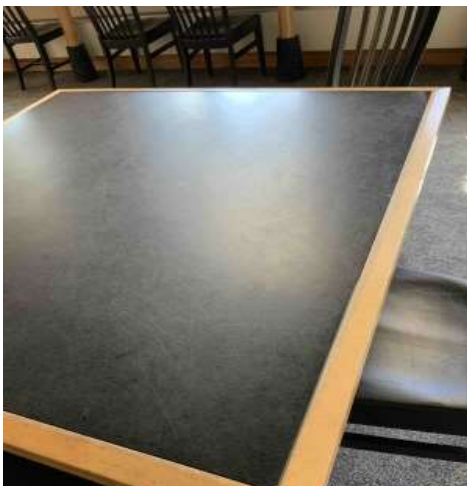
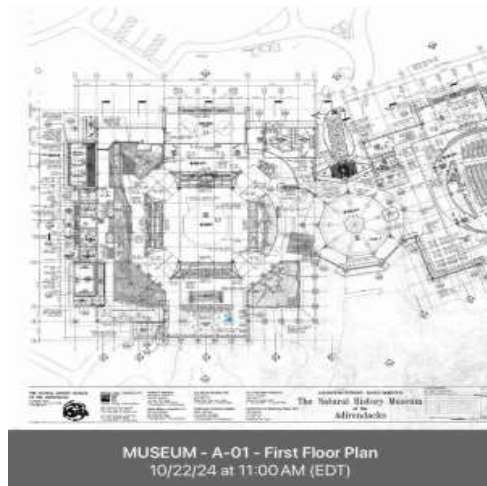
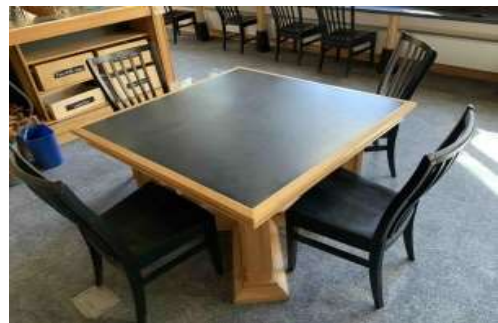
Museum	102	Laboratory	Interior Finishes	Furniture condition fair	069
--------	-----	------------	-------------------	--------------------------	-----
