Wild Center Property Condition Assessment

LaBella Project No.: 2244417
Prepared On: 11/6/2024

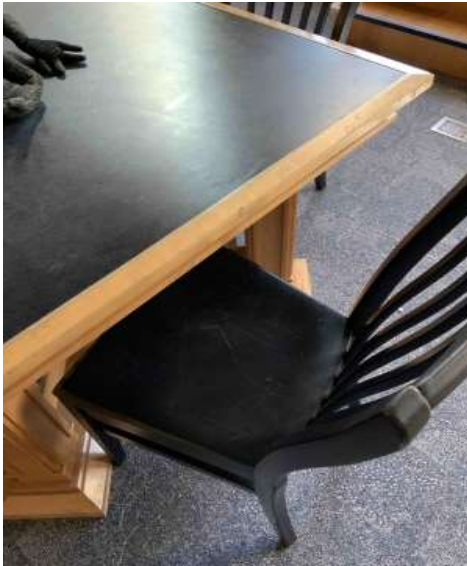
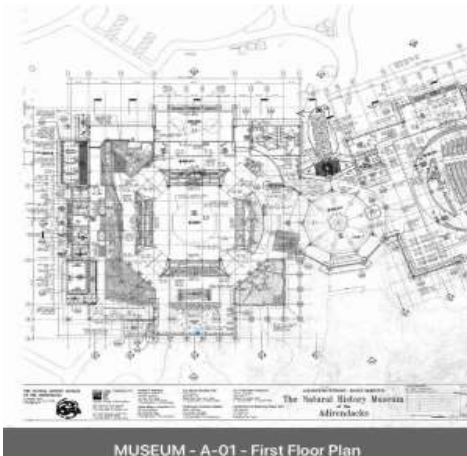
Museum	102	Laboratory	Interior Finishes	Countertops in good/fair condition	085
--------	-----	------------	-------------------	------------------------------------	-----

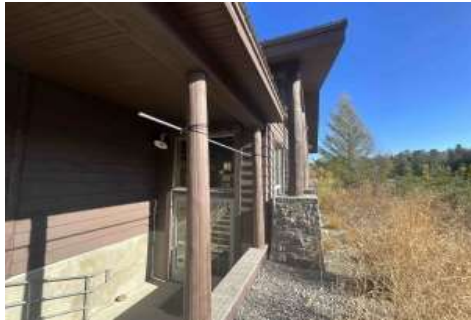
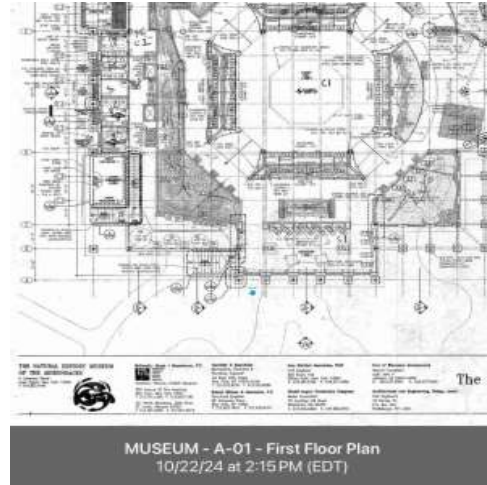
Museum	102	Laboratory	Wood Column wrap	Stretching Seam , typ	150
--------	-----	------------	------------------	-----------------------	-----

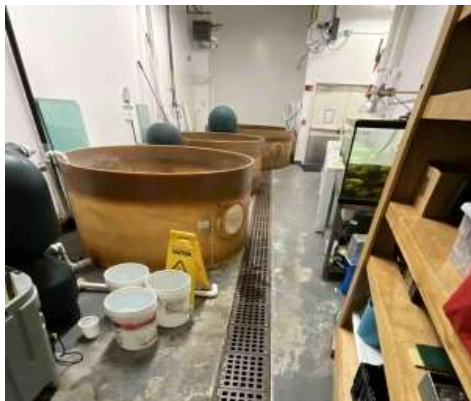
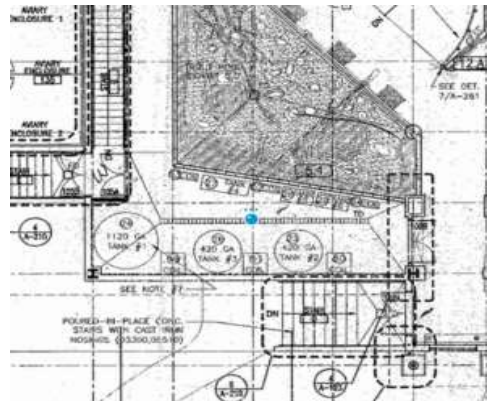
Museum	105	Back of House	Arch	Seal floor	206
--------	-----	---------------	------	------------	-----

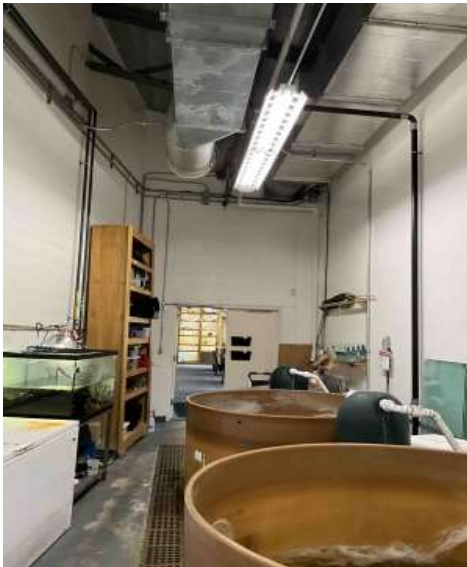
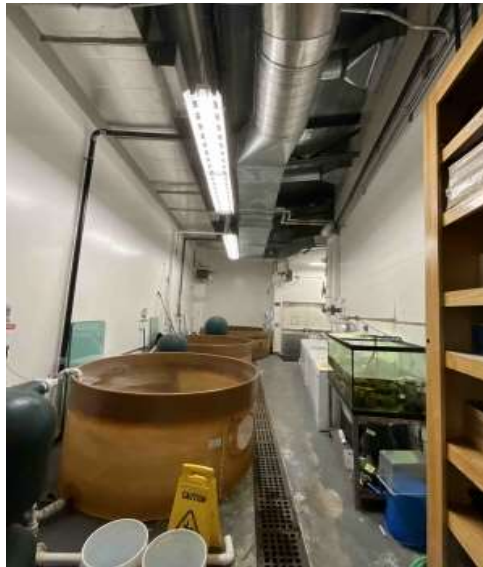
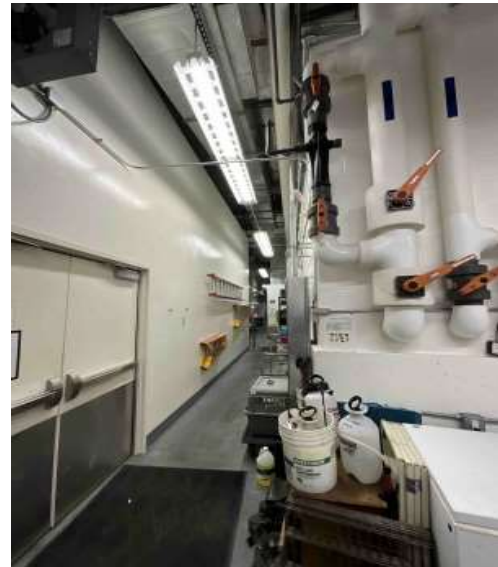
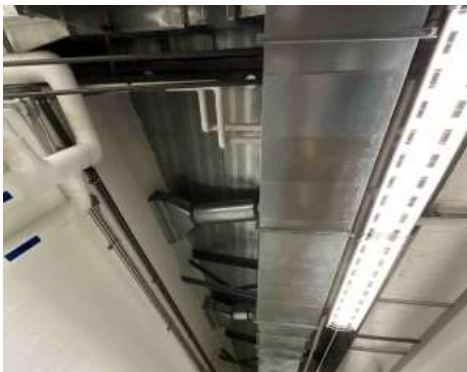
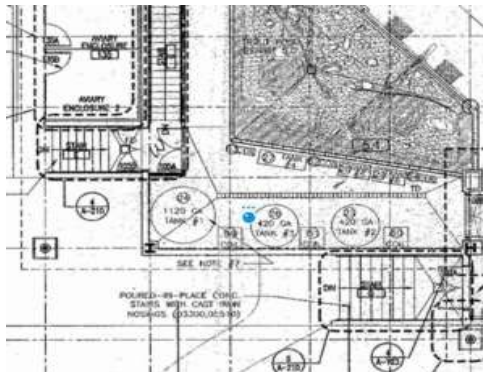
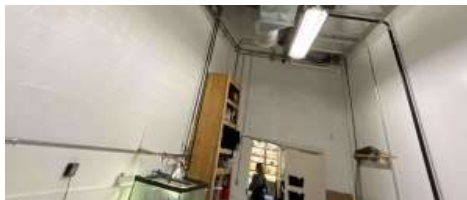
Museum	105	Back of House	Arch	Overall pictures	207
--------	-----	---------------	------	------------------	-----

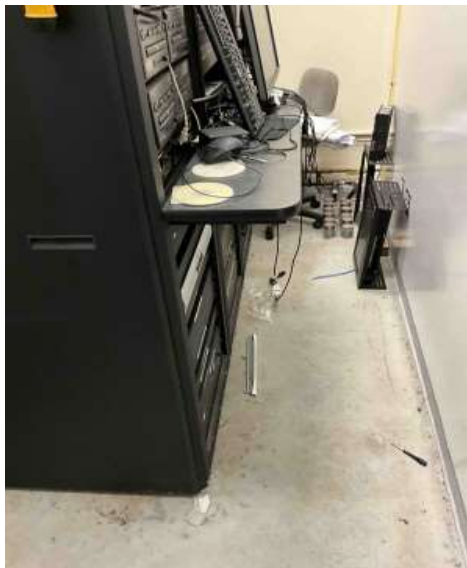
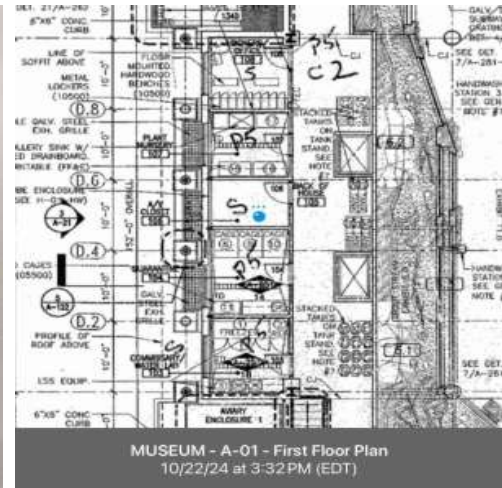
Museum	105	Back of House	Arch	Floor sealing, paint	243
--------	-----	---------------	------	----------------------	-----

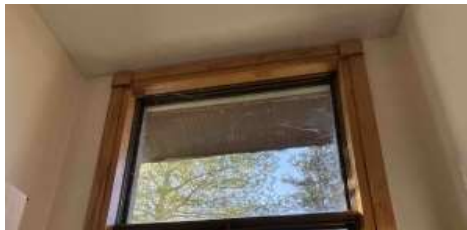
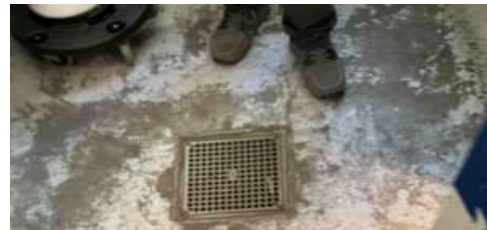
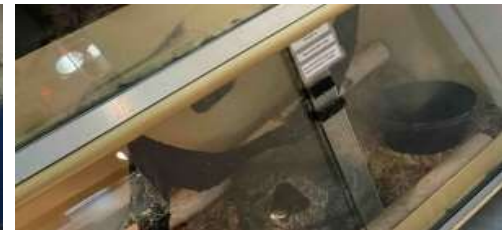
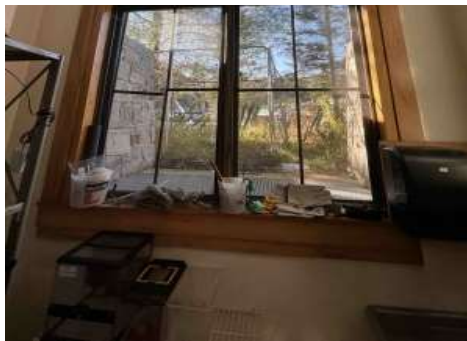
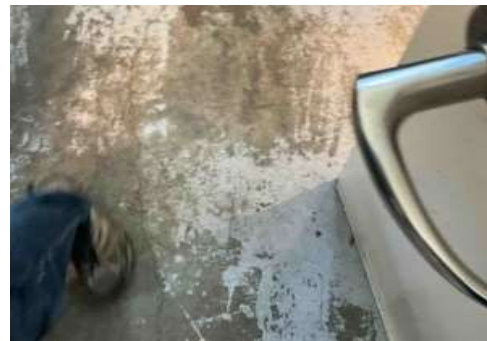
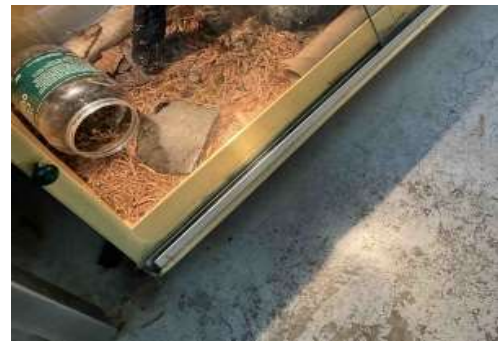
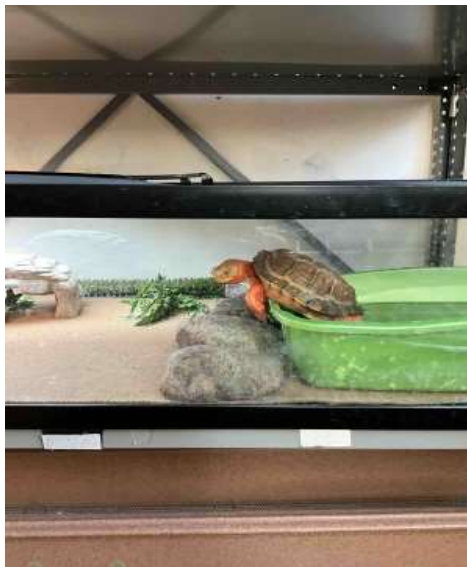
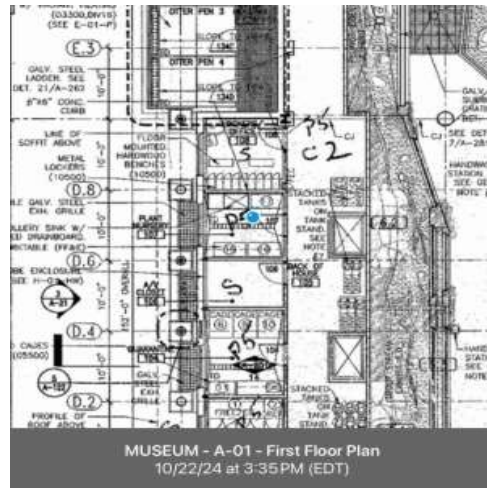
Museum	105	Back of House	Arch	Floor seal, damaged window	244
--------	-----	---------------	------	----------------------------	-----

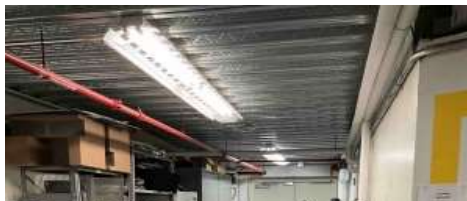
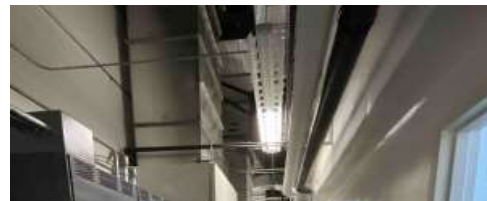
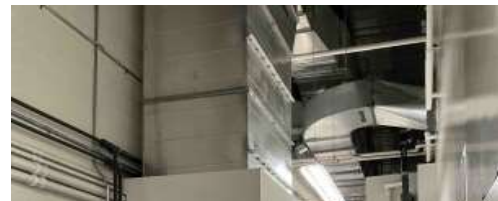
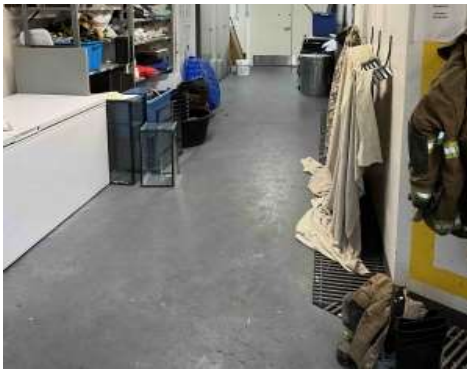
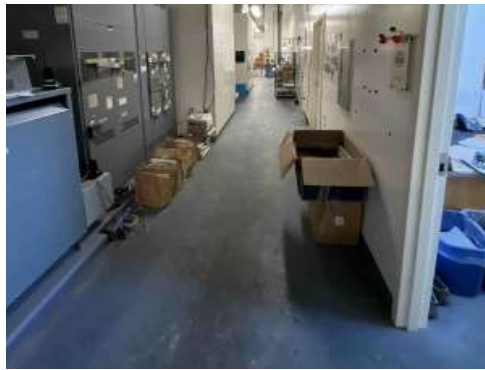
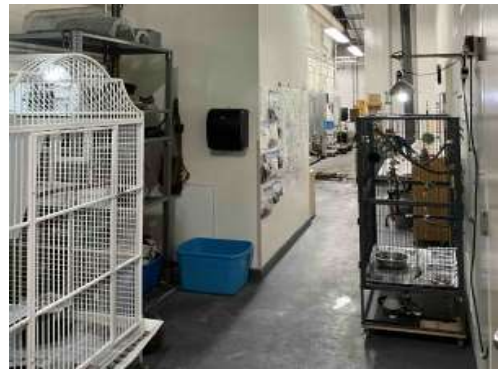
Museum	105	Back of House	Arch	General picture	246
--------	-----	---------------	------	-----------------	-----

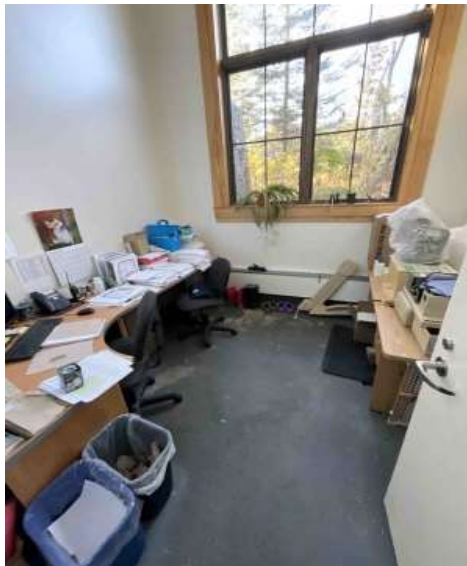
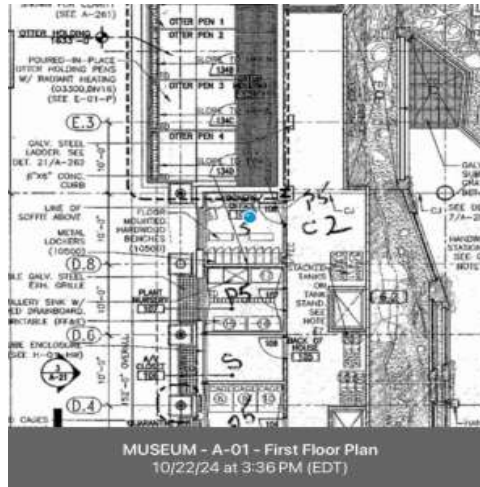
Museum	106	A/V Closet	Arch	Floor seal	245
--------	-----	------------	------	------------	-----

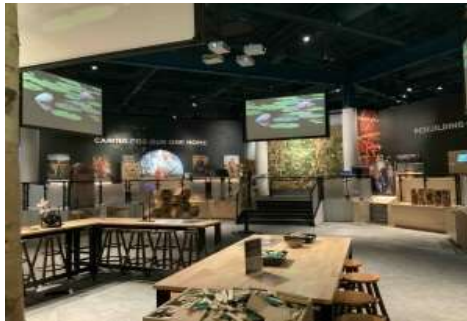
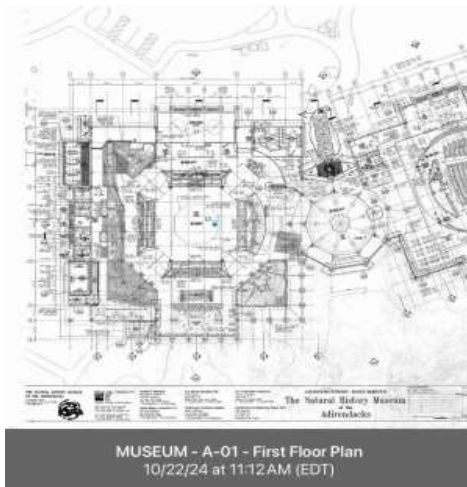
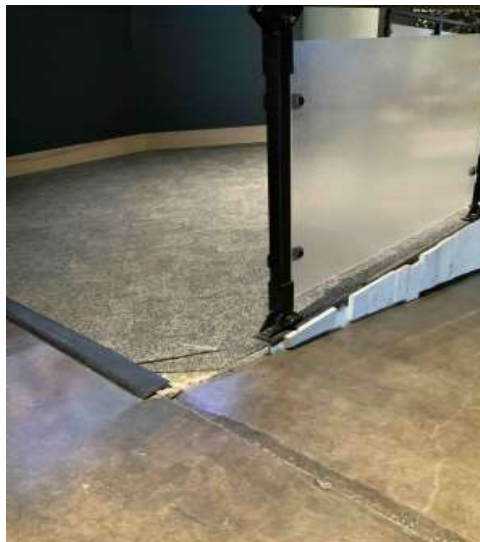
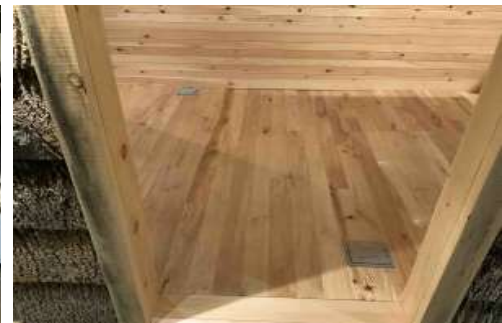
Museum	109	Exhibit Hall	Floor	Carpet tiles in good/fair condition. Transitions from concrete to carpet	098
--------	-----	--------------	-------	--	-----

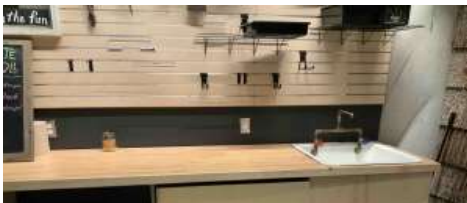
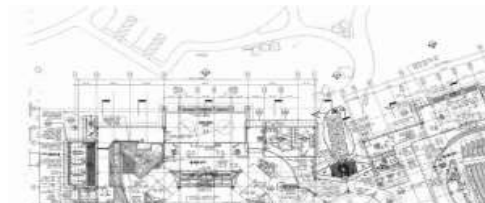
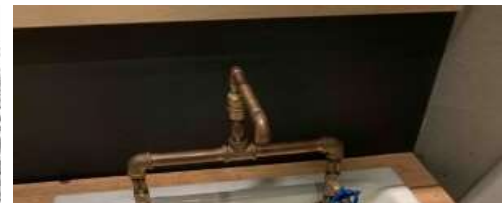
Museum	109	Exhibit Hall	Interior Finishes	Plumbing fixtures / sink	121
--------	-----	--------------	-------------------	--------------------------	-----

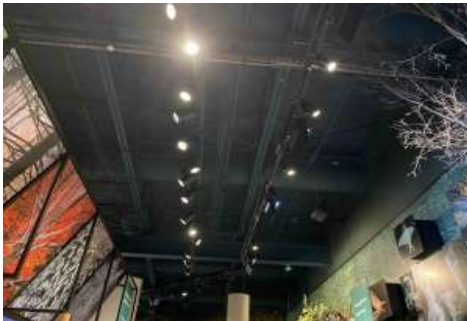
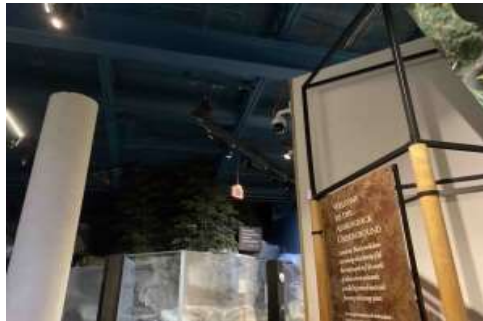
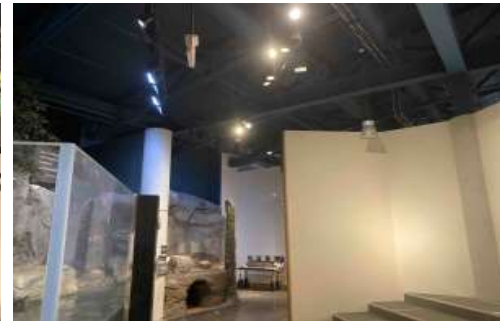
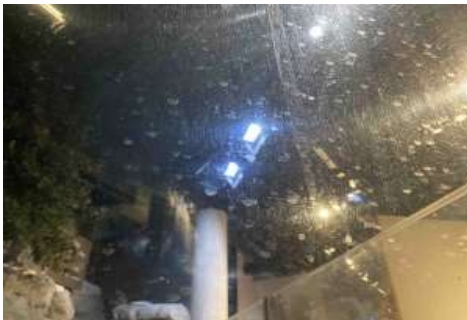
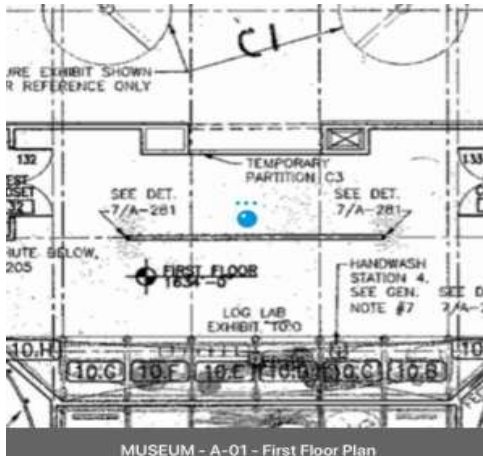
Museum	109	Exhibit Hall	Elec	EXHIBIT LIGHTING NOT LED	175
--------	-----	--------------	------	--------------------------	-----

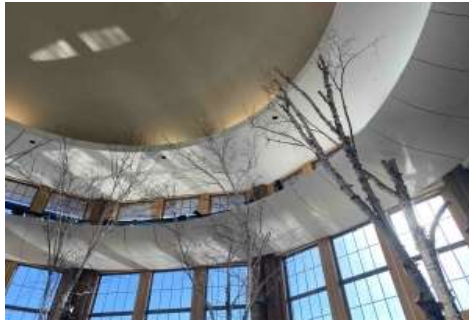
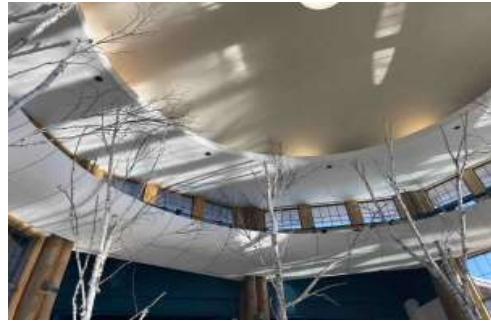
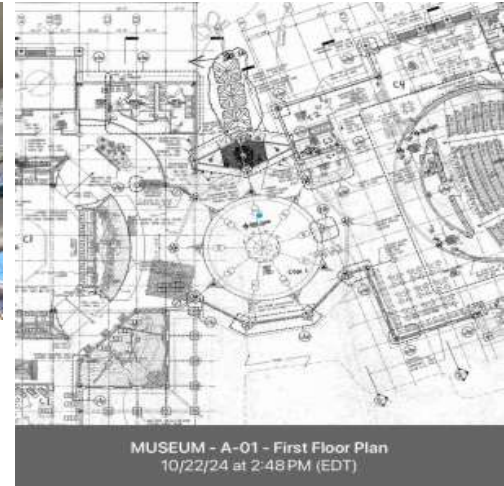
Museum	109	Exhibit Hall	Elec	NON LED LIGHTING	184
--------	-----	--------------	------	------------------	-----

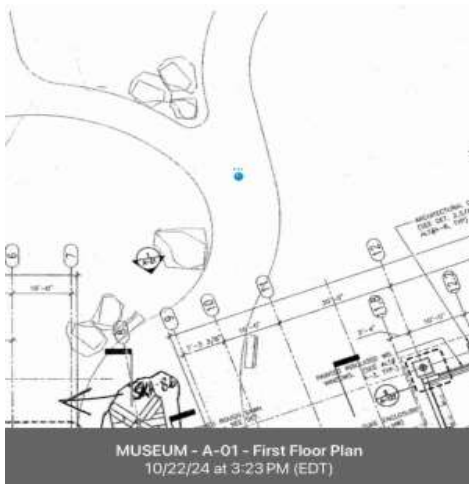
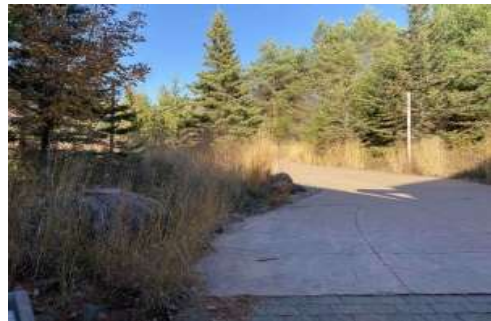
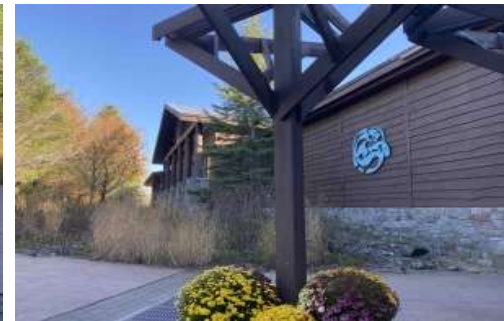
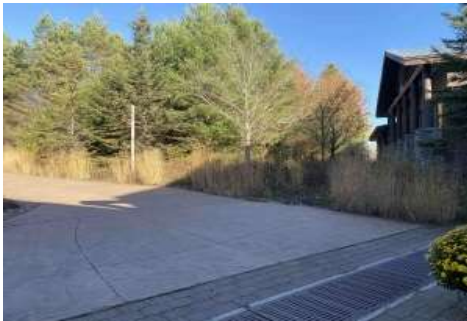
Museum	109	Exhibit Hall	Elec	PATHWAY LIGHTING	197
--------	-----	--------------	------	------------------	-----

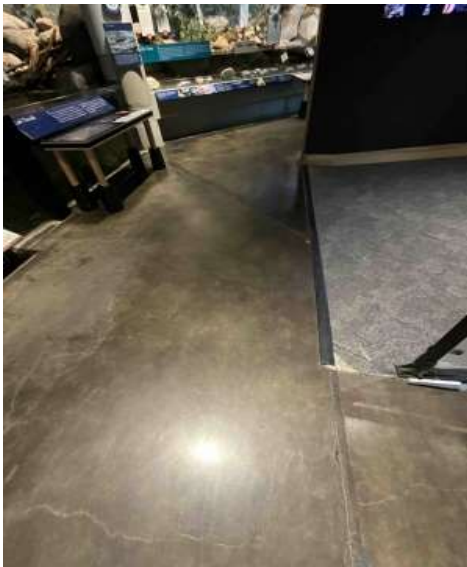
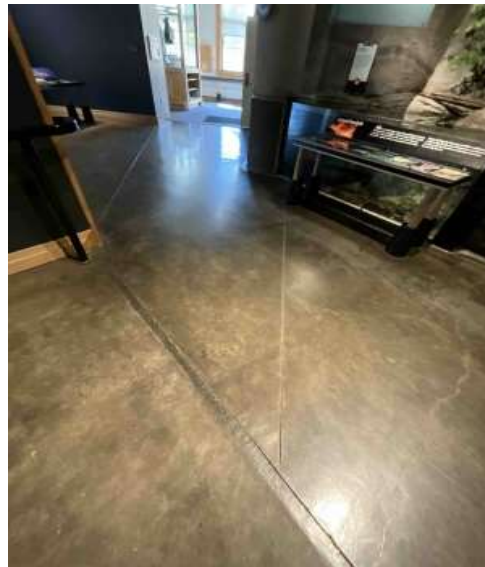
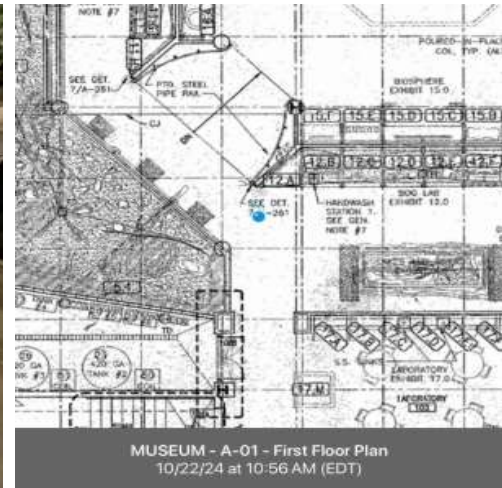
Museum	109	Exhibit Hall	Arch	Floor sealing on a schedule	208
--------	-----	--------------	------	-----------------------------	-----

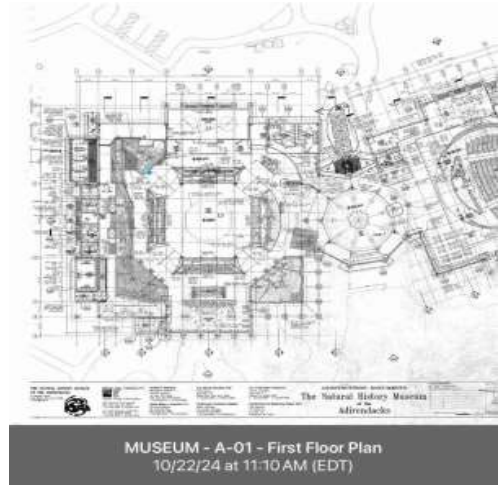
Museum	109	Exhibit Hall	Arch	Gaskets at glass enclosures	210
--------	-----	--------------	------	-----------------------------	-----

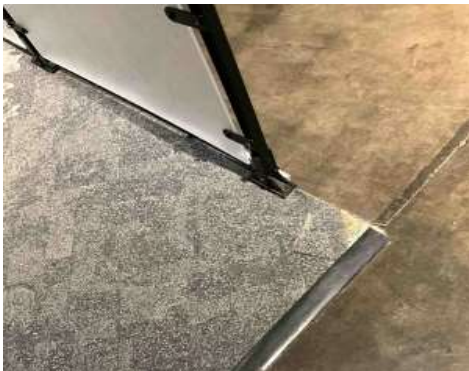
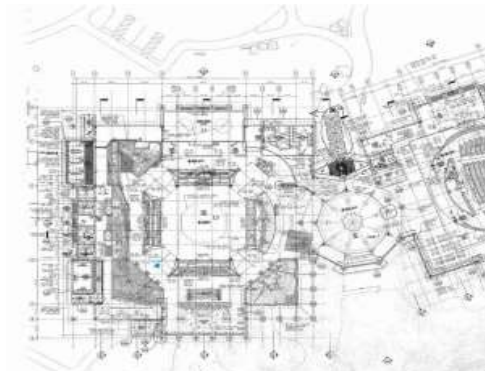
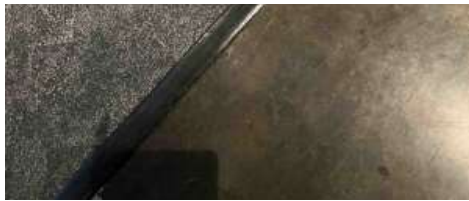
Museum	109	Exhibit Hall	Arch	Carpet damage at ramp corner	211
--------	-----	--------------	------	------------------------------	-----

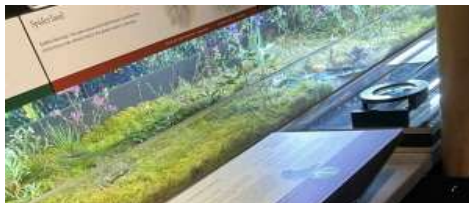
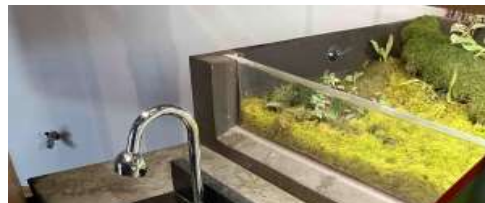
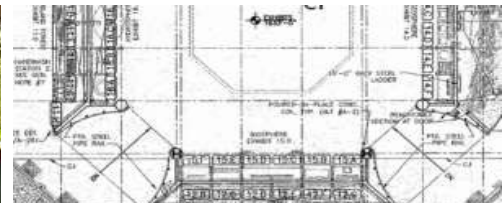
Museum	109	Exhibit Hall	Arch	Countertop at bog exhibit stained	213
--------	-----	--------------	------	-----------------------------------	-----

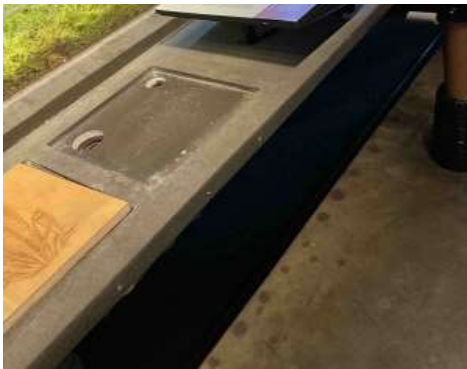
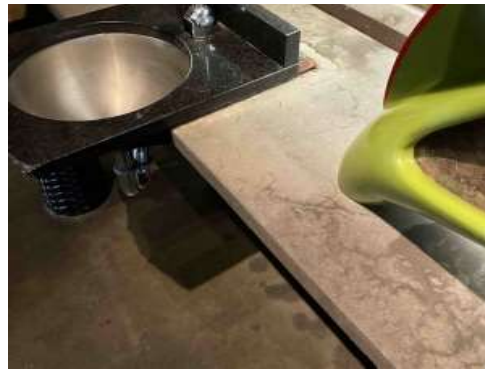
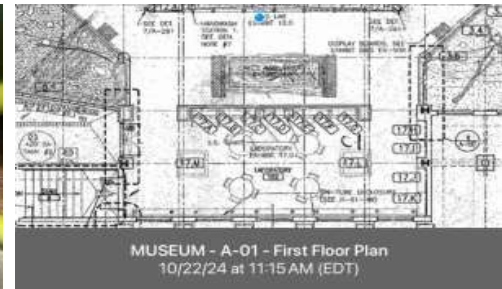
Museum	109	Exhibit Hall	Arch	Rusted undermount at sink location	214
--------	-----	--------------	------	------------------------------------	-----

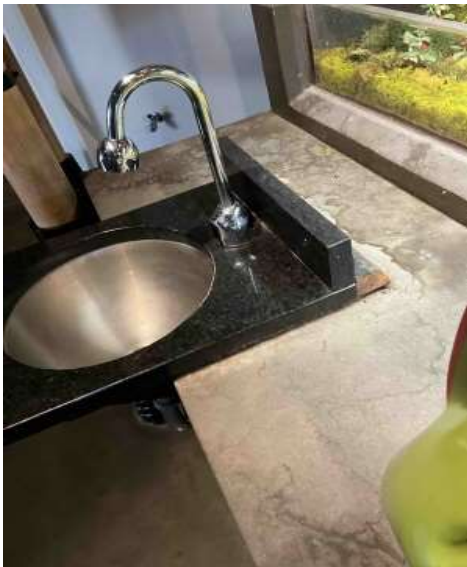
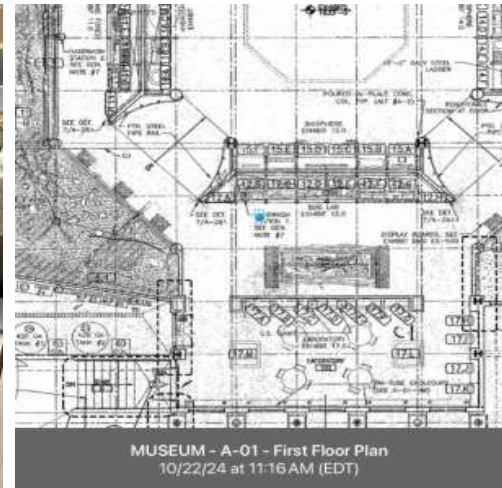
Museum	109	Exhibit Hall	Arch	Roof leak evidence	215
--------	-----	--------------	------	--------------------	-----

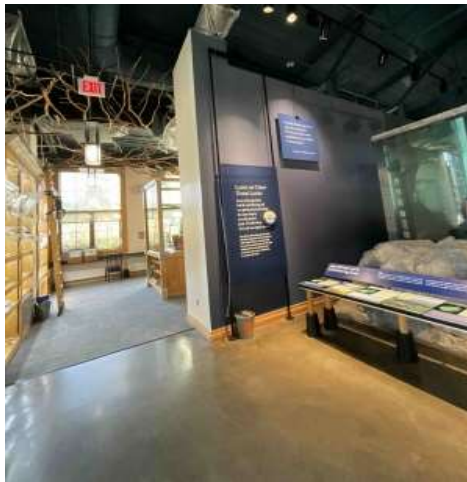
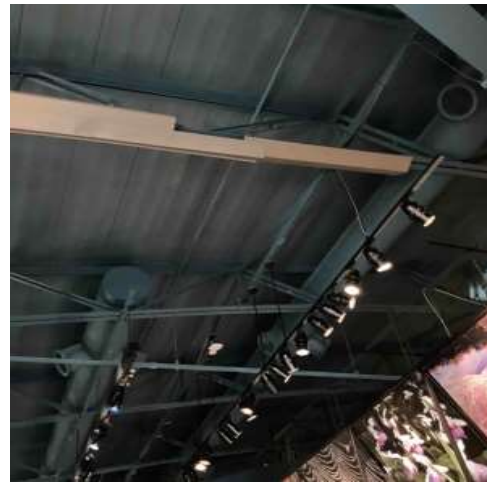
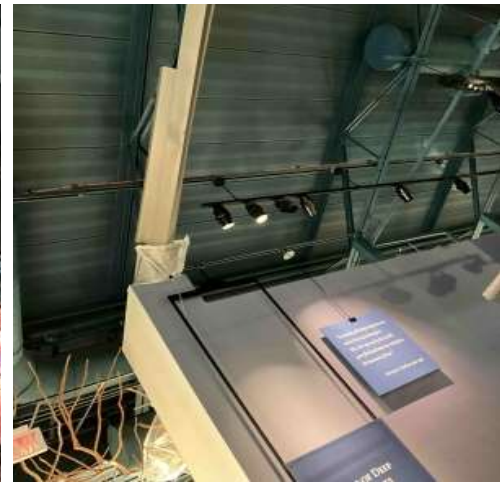
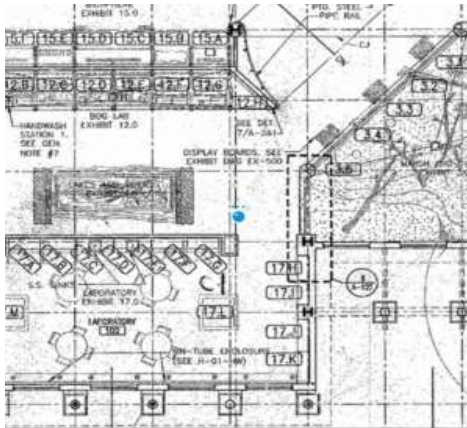
Museum	109	Exhibit Hall	Arch	Sheetrock patch and paint	216
--------	-----	--------------	------	---------------------------	-----

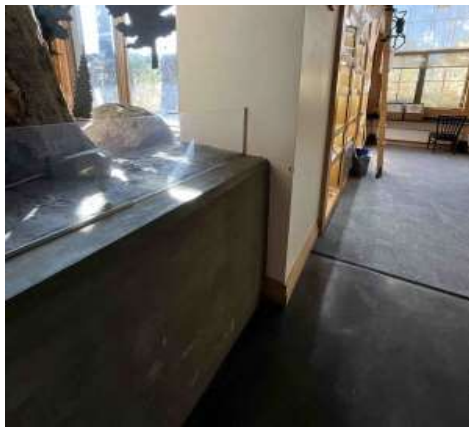
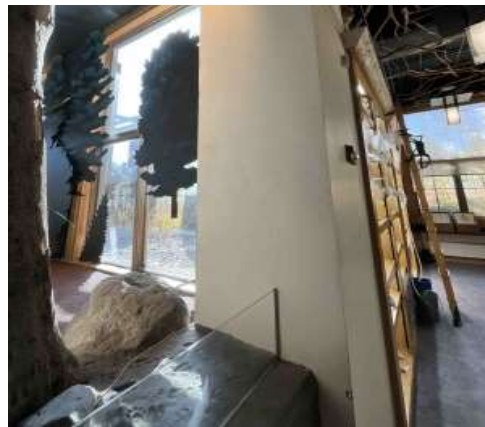
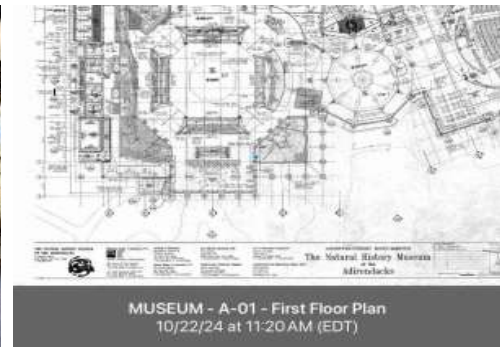
Museum	109	Exhibit Hall	Arch	Wood window deterioration significant concern	217
--------	-----	--------------	------	---	-----

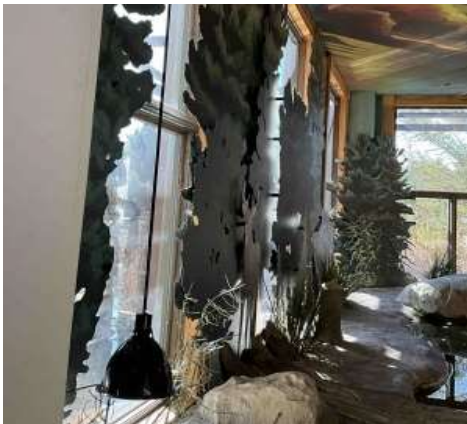
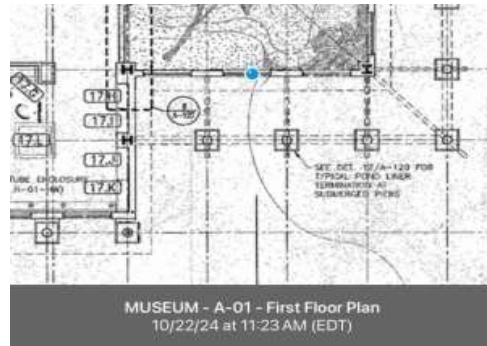
Museum	N/A		Ceiling	Exposed to above	117
--------	-----	--	---------	------------------	-----

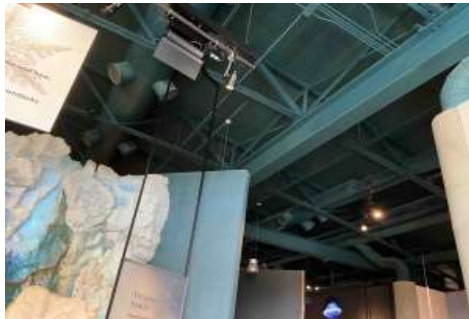
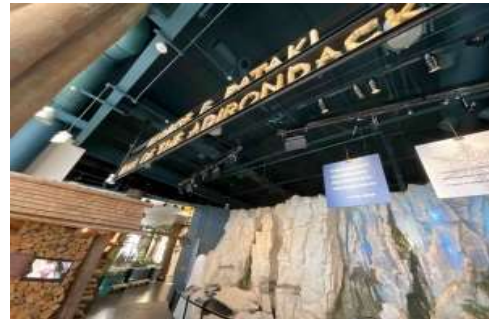
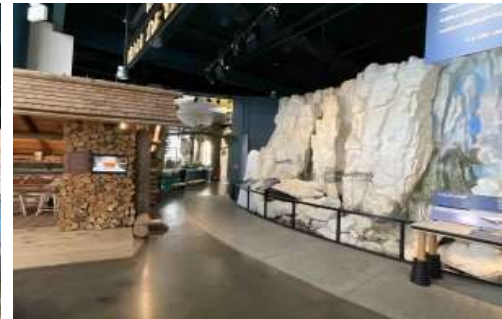
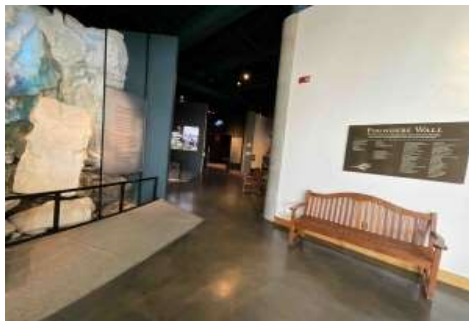
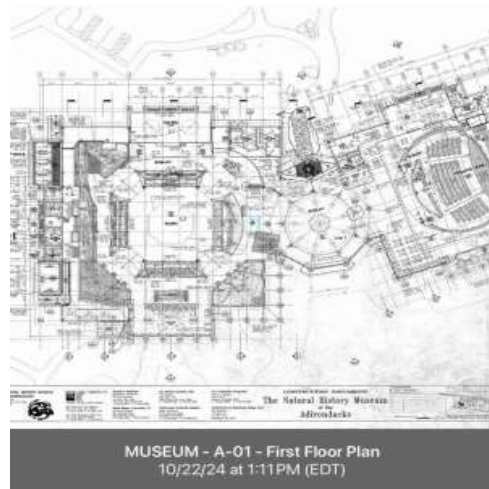
Museum	109	Exhibit Hall	Arch	Evidence of water infiltration Refinish sills	226
--------	-----	--------------	------	--	-----

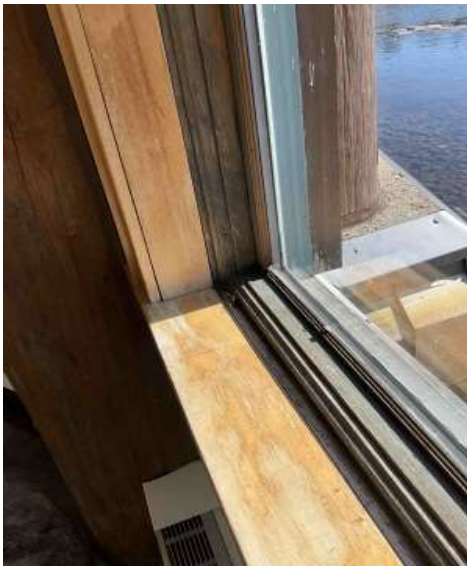
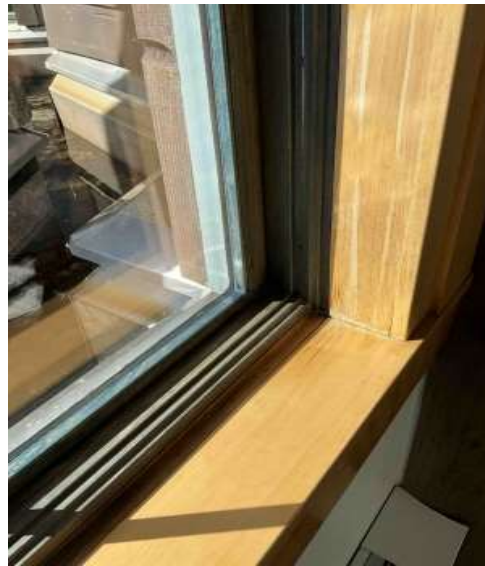
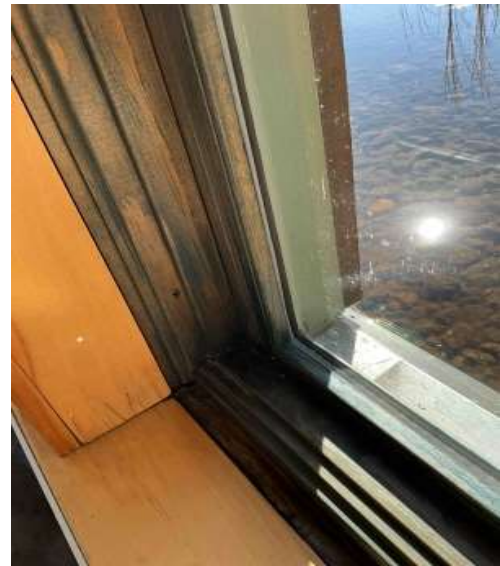
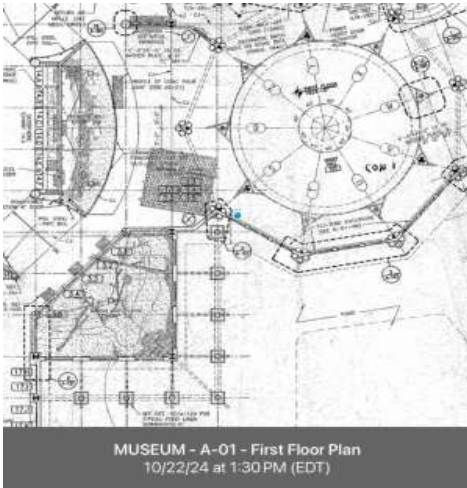
Museum	110	Future Boreal Forest Theater	Arch	Nano wall seal replacement	219
--------	-----	------------------------------	------	----------------------------	-----

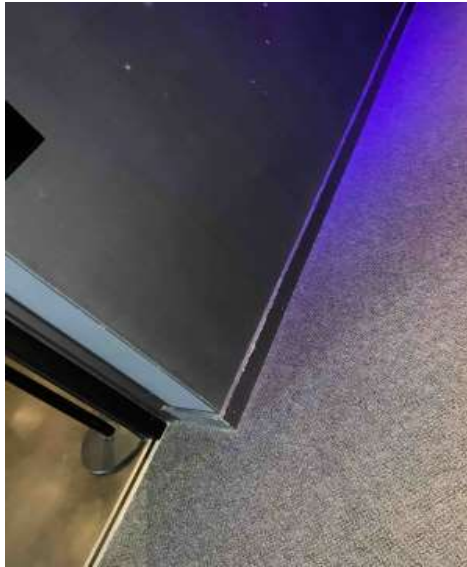
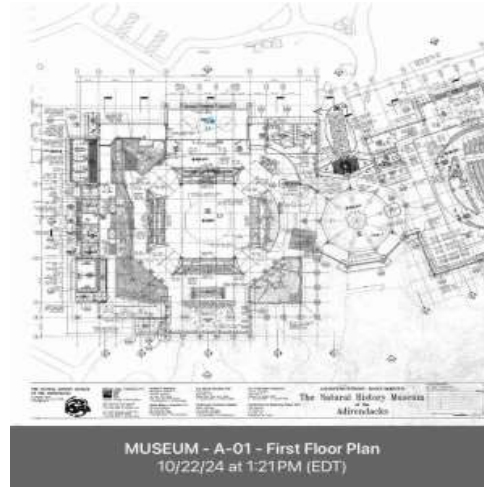
Museum	110A - boreal storage		Arch	Door patch and paint hardware function does not allow for exiting Room config not as shown on plans	220
--------	-----------------------	--	------	--	-----

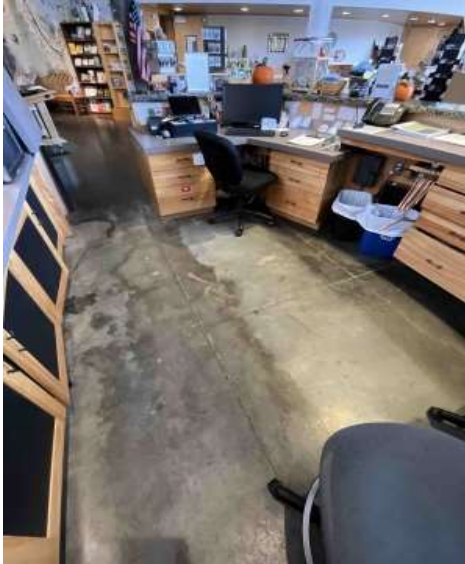
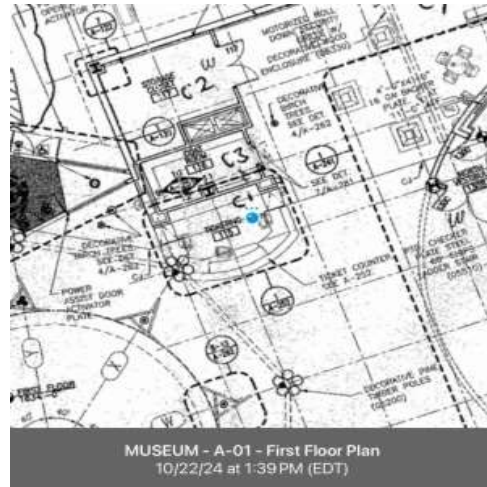
Museum	115	Ticketing	Arch	Flooring needs resealing	228
--------	-----	-----------	------	--------------------------	-----

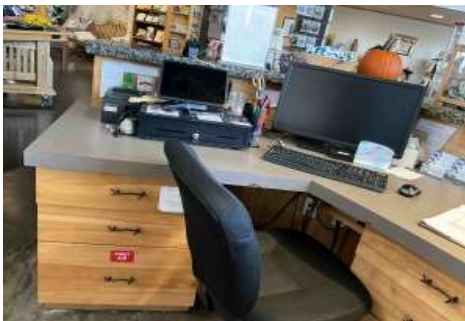
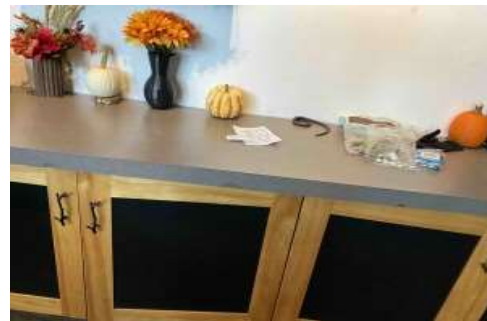
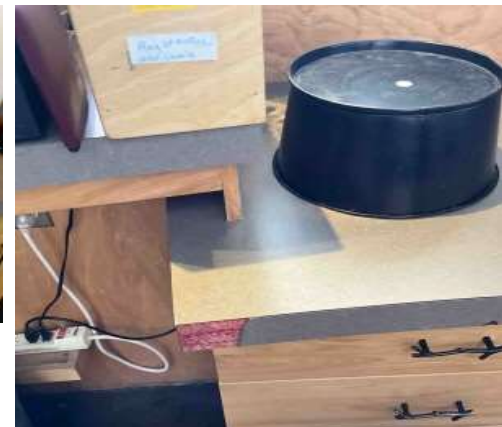
Museum	115	Ticketing	Arch	Laminate countertop needs replacement/relaminate. Vertical face compromised	229
--------	-----	-----------	------	---	-----

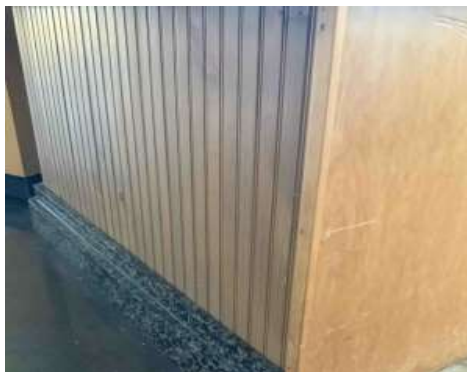
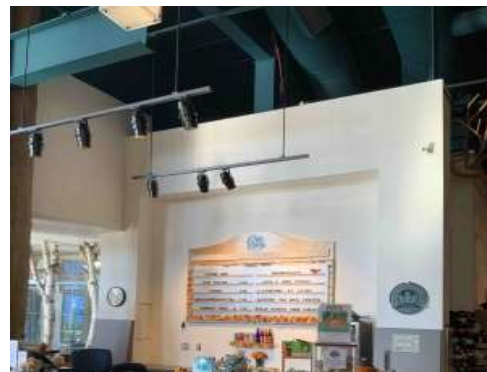
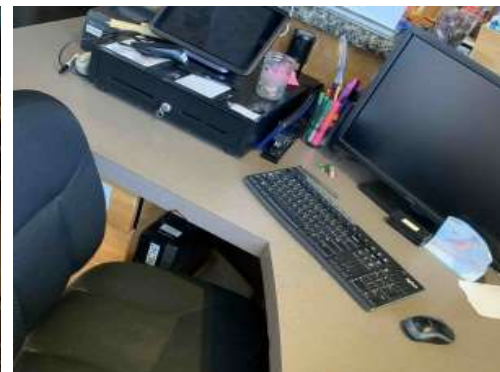
Museum	115	Ticketing	General Interior Condition	General interior conditions - floor fair, countertop fair,	256
--------	-----	-----------	----------------------------	--	-----

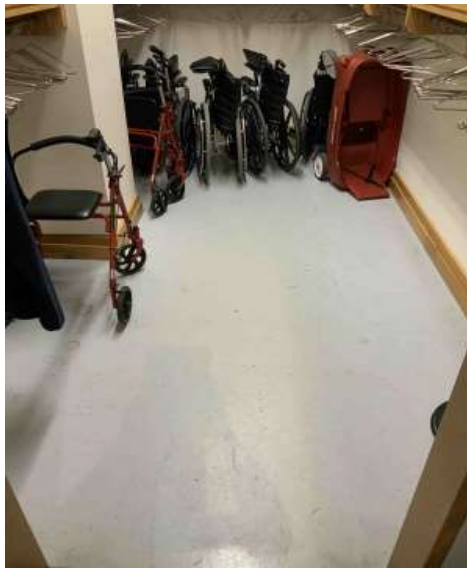
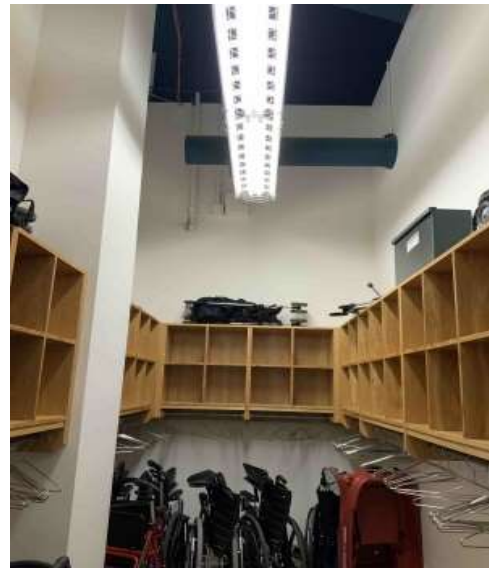
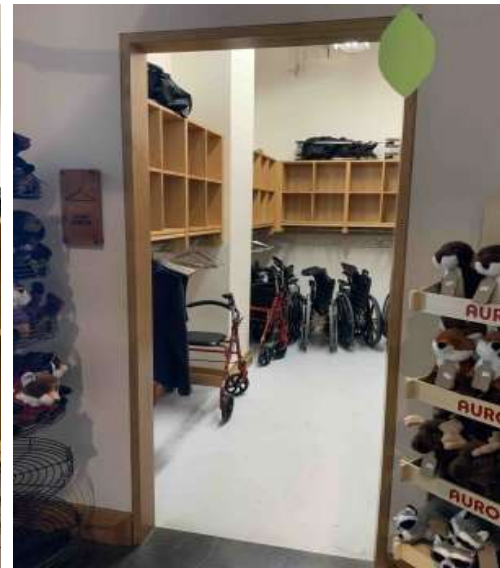
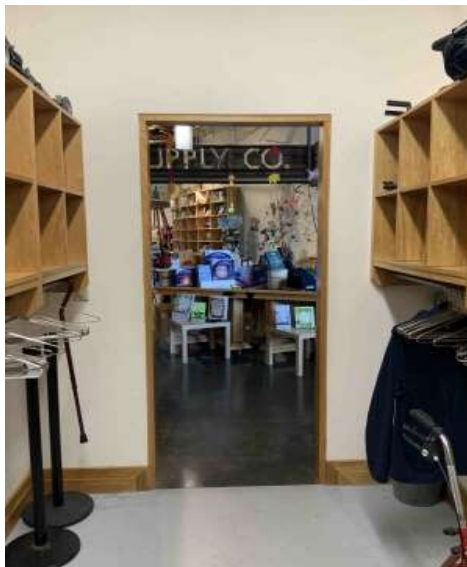
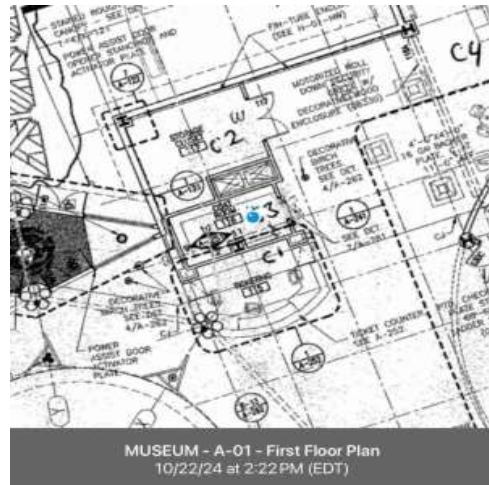
Building	Space Number	Space Name	Element	Description	ID
Museum	116	Coat Room	General Interior Condition	General interior conditions - floor repaint, no door, framed opening,	255

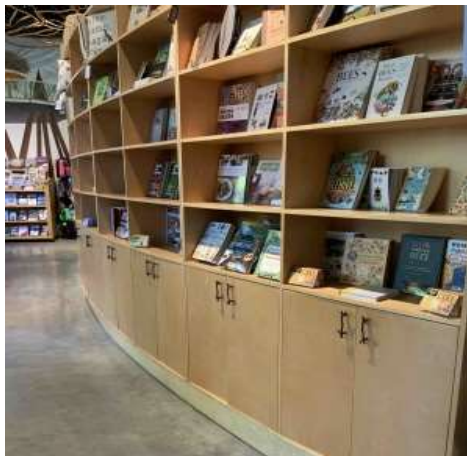
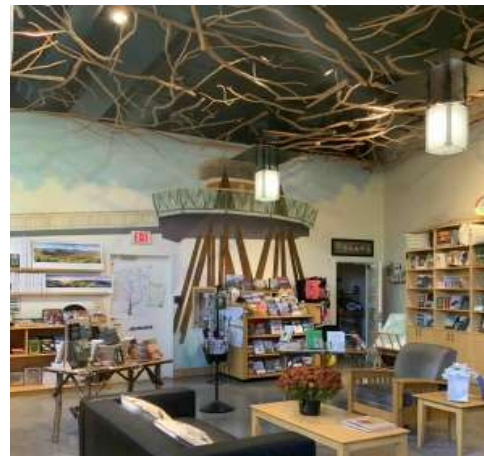
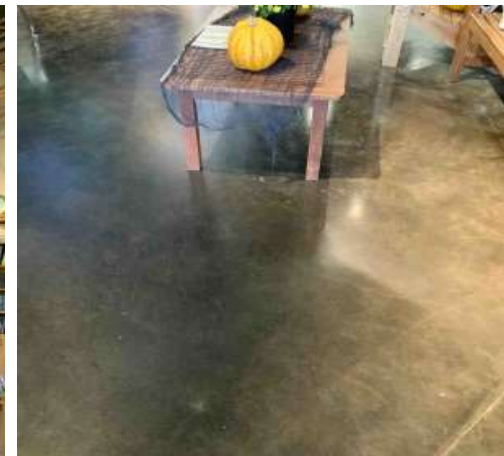
Museum	118	Gift Shop	General Interior Condition	General interior conditions - good overall	253
--------	-----	-----------	----------------------------	--	-----

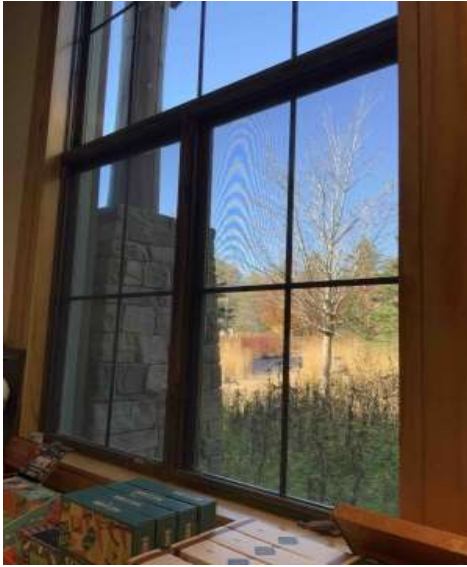
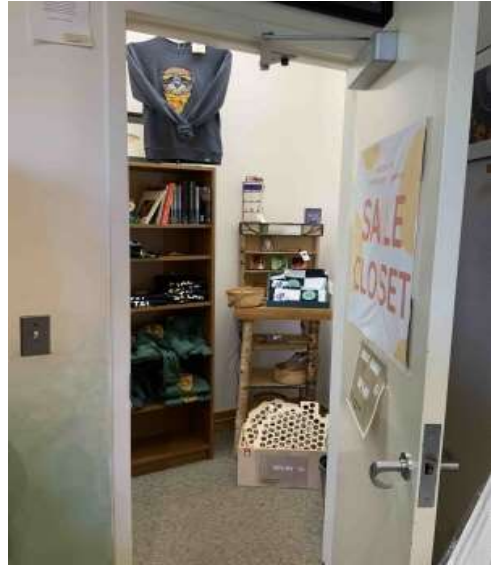
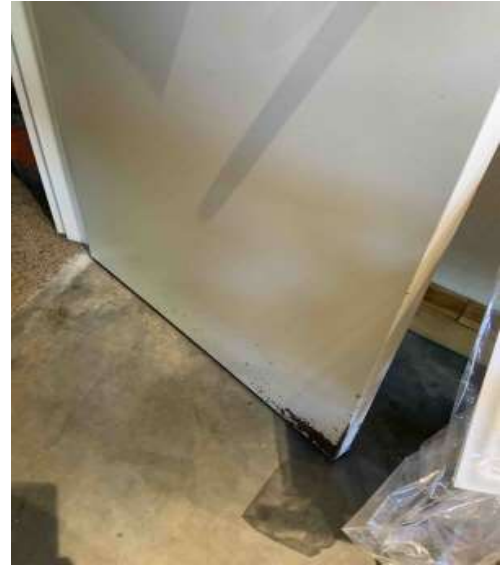
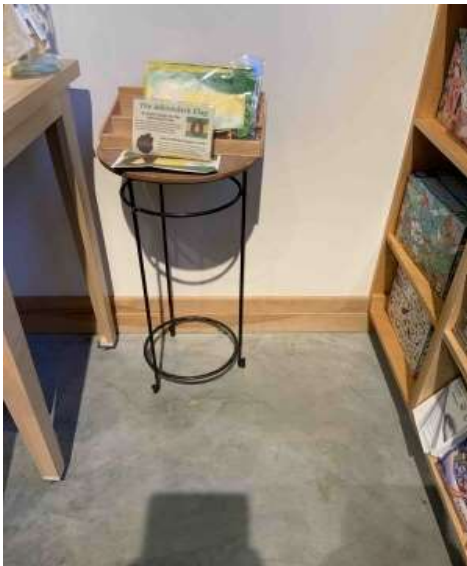
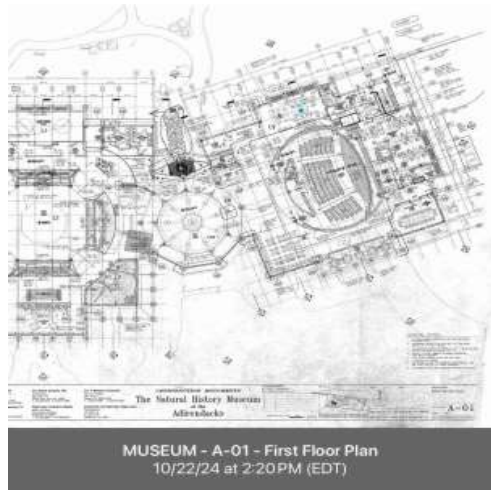
Building	Space Number	Space Name	Element	Description	ID
Museum	119	Gift Shop Storage Room MPF		Space is break room and not storage as labeled.	095

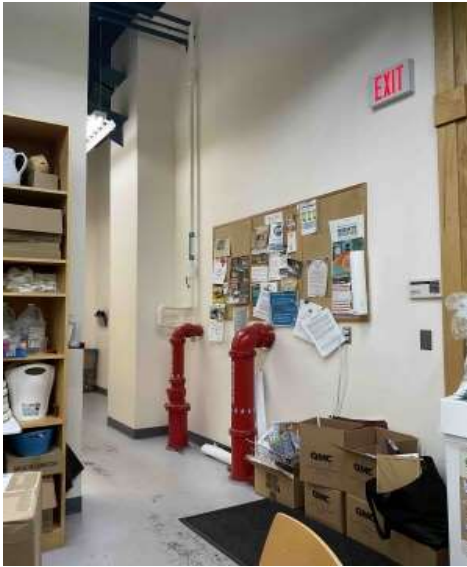
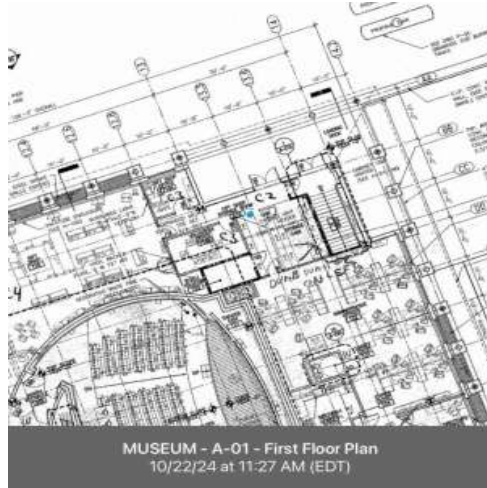
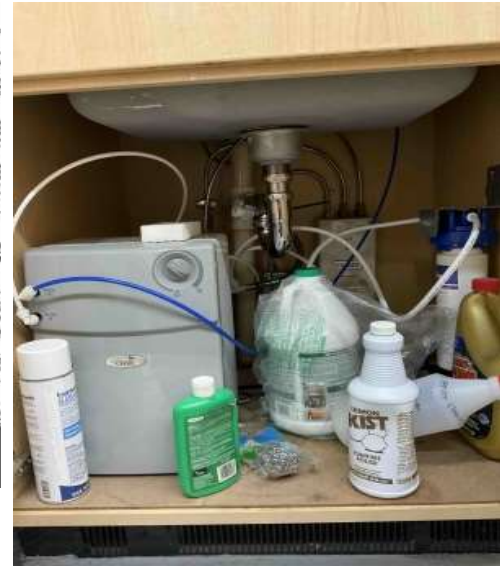
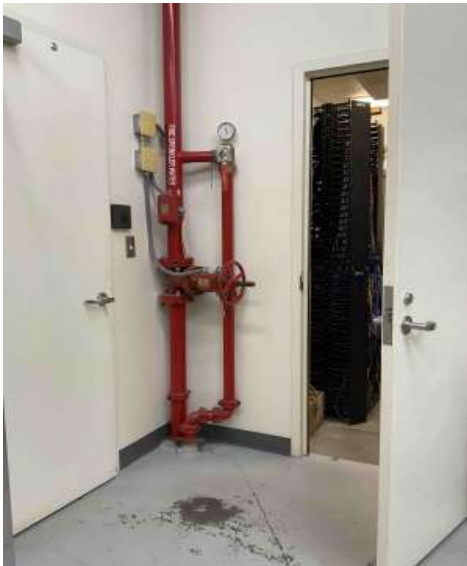
Museum	119	Gift Shop Storage Room MPF	Unisex toilet		097
--------	-----	----------------------------	---------------	--	-----
