Wild Center Property Condition Assessment

LaBella Project No.: 2244417
Prepared On: 11/6/2024

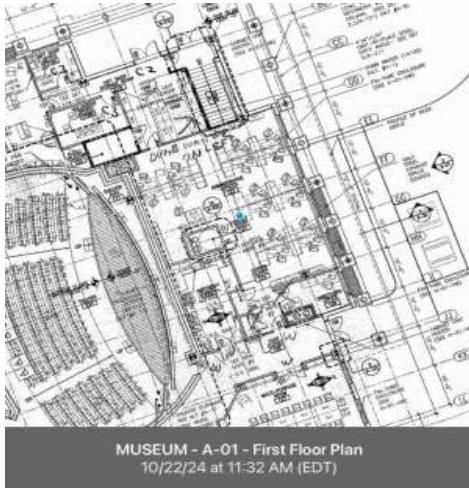
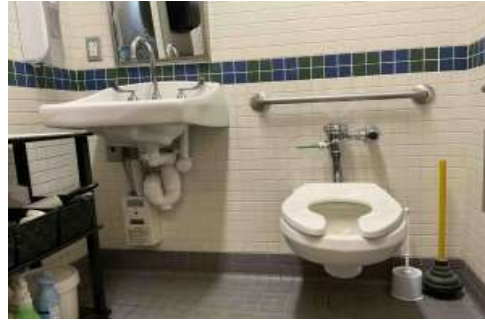
Museum	119	Gift Shop Storage Room Arch	General interior conditions - exterior door, floor needs repaint,		162
--------	-----	-----------------------------	---	--	-----

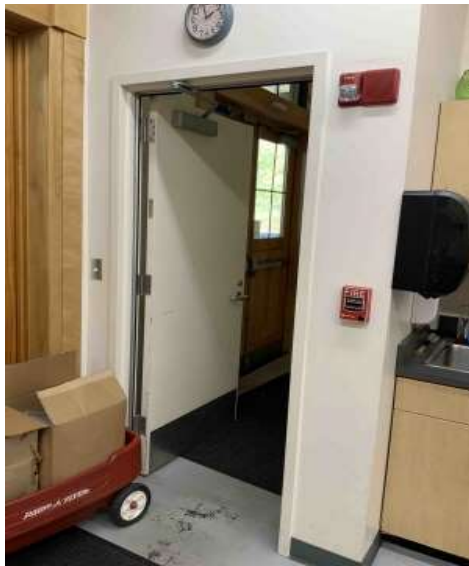
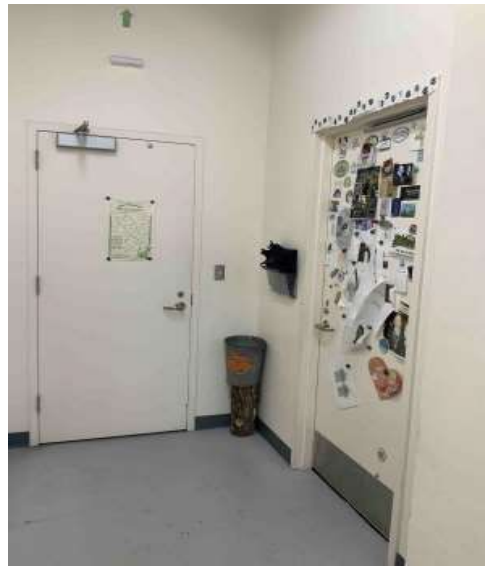
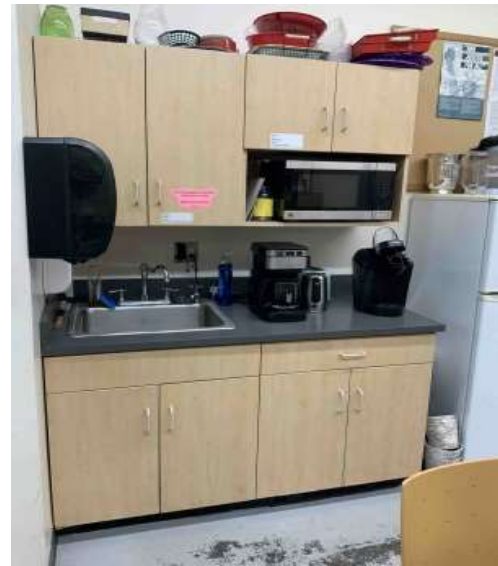
Museum	119	Gift Shop Storage Room MPF		Perimeter fin tube blocked in several locations; reported poor indoor temp; SA grilles blocked in several locations	204
--------	-----	----------------------------	--	---	-----

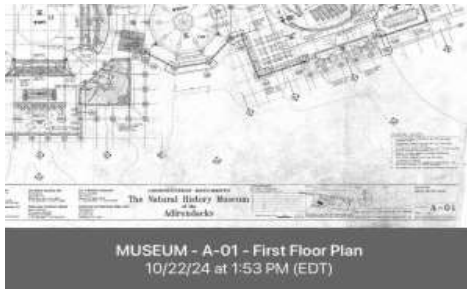
Museum	119A	Gift Shop Office	Arch	LOCKED	205
--------	------	------------------	------	--------	-----

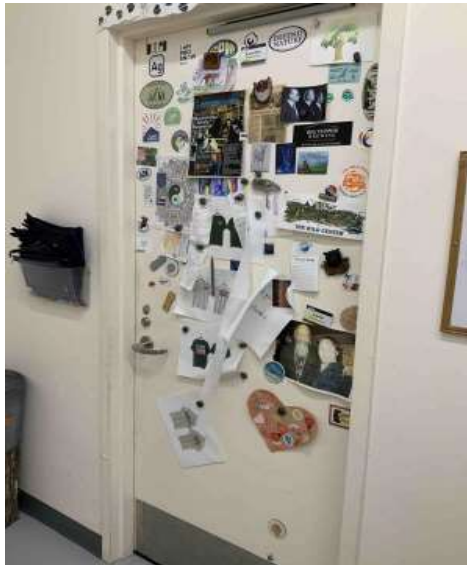
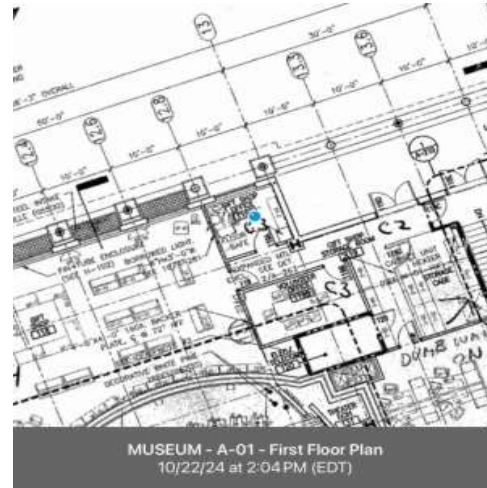
Museum	119B	Volunteer Office	General Interior Condition	General interior conditions - carpet replace, ceiling good; door good	174
--------	------	------------------	----------------------------	---	-----

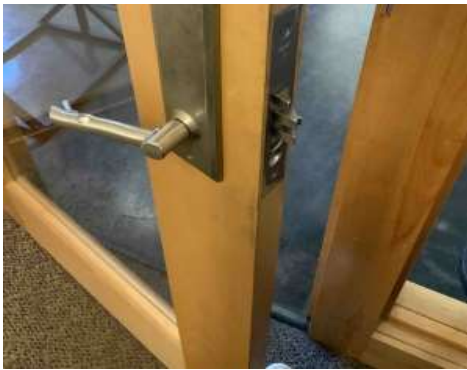
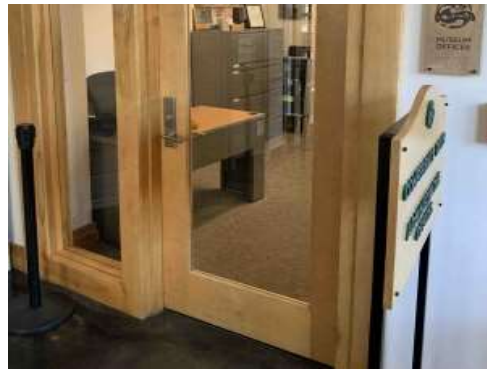
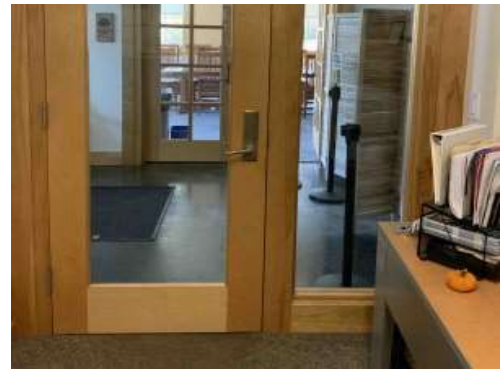
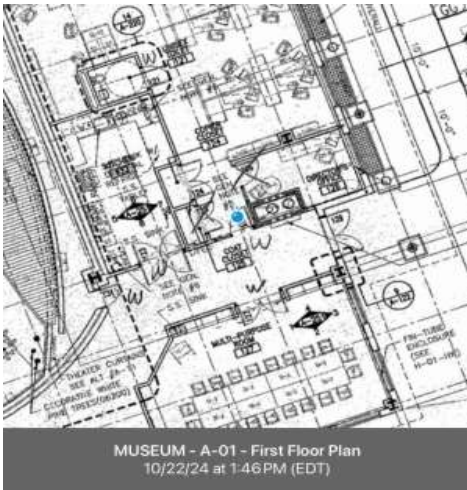
Museum	122	Administrative Offices	General Interior Condition	General interior conditions	149
--------	-----	------------------------	----------------------------	-----------------------------	-----

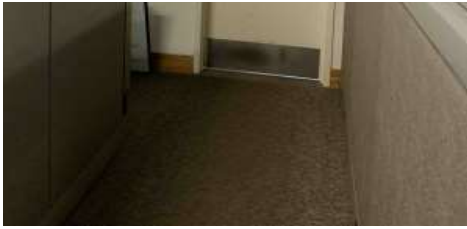
Museum	122	Administrative Offices	Floor	Carpet in poor condition	151
--------	-----	------------------------	-------	--------------------------	-----

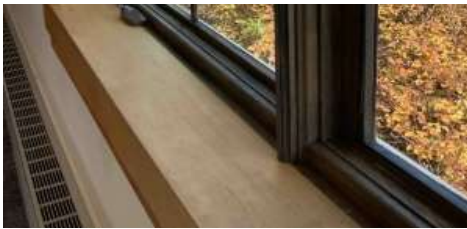
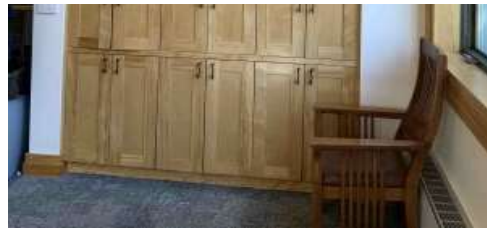
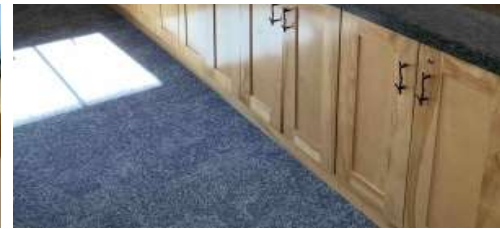
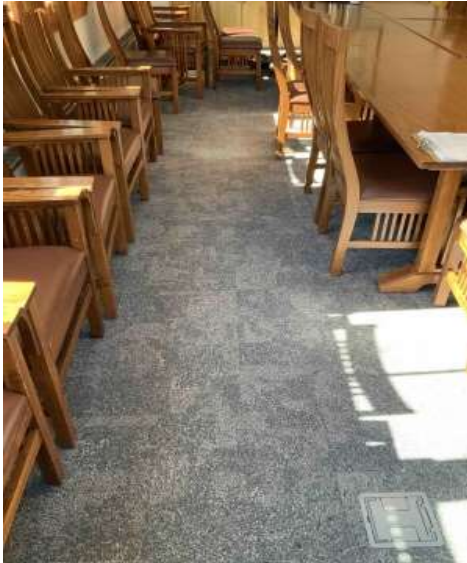
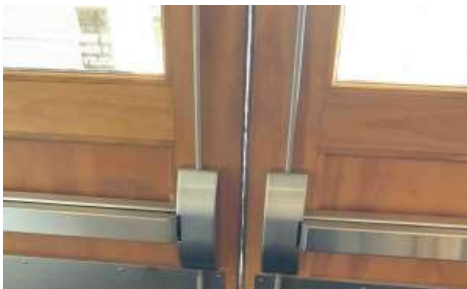
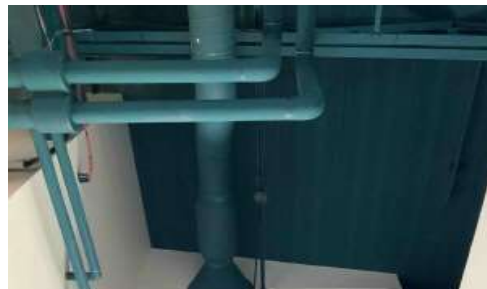
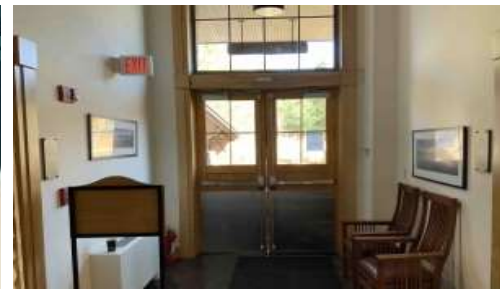
Museum	127A Hall	General Interior Space	General interior conditions - exterior door weather sealing, paint fair	145
--------	-----------	------------------------	---	-----

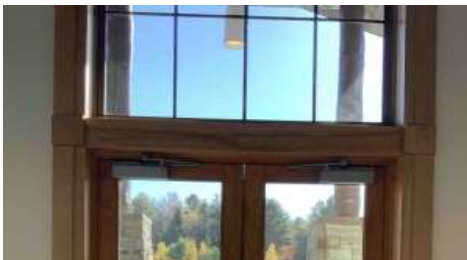
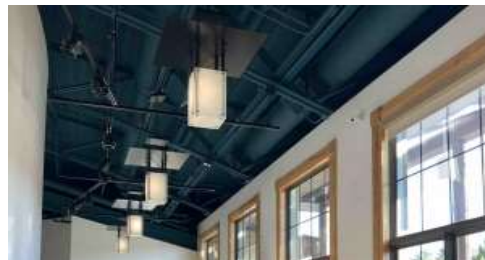
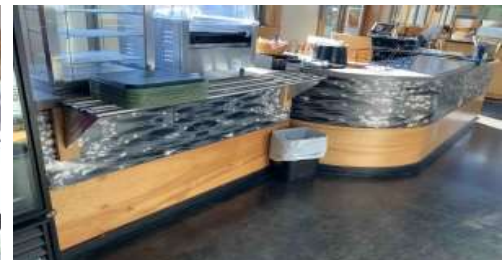
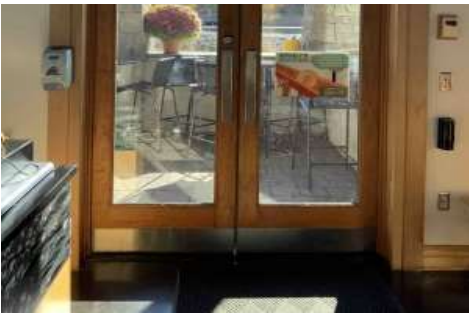
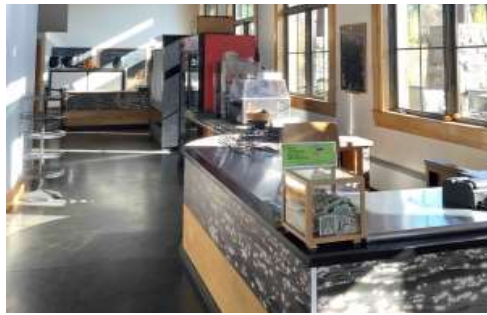
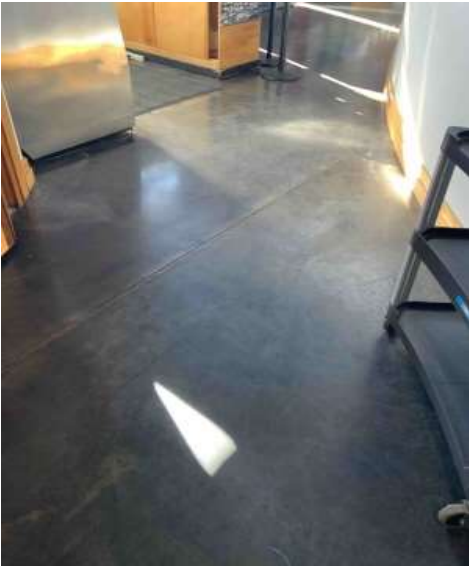
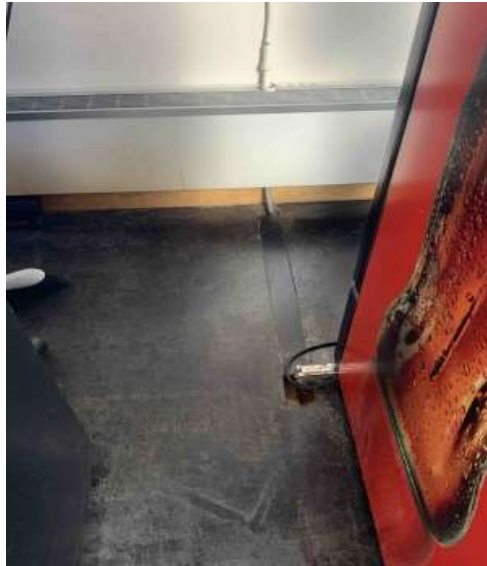
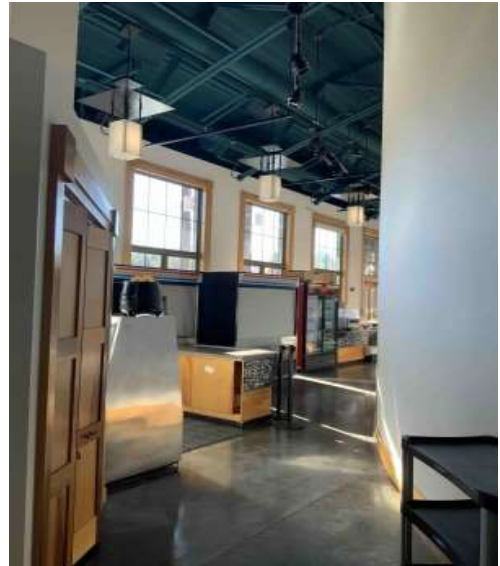
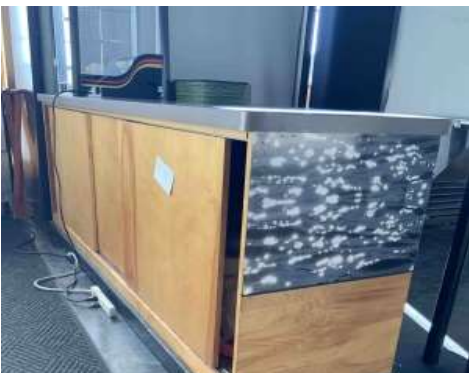
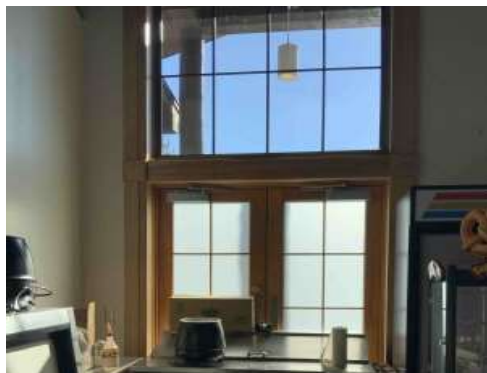
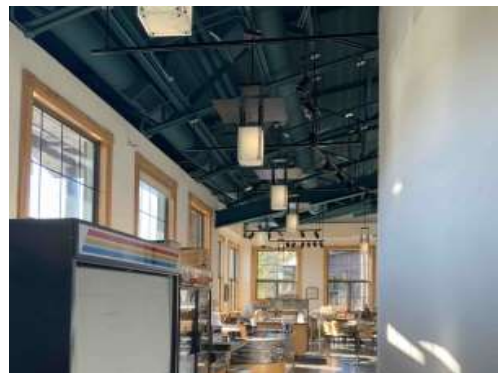
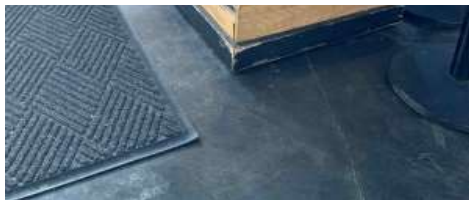
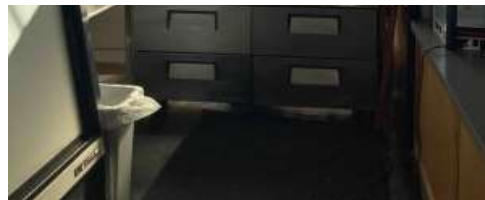
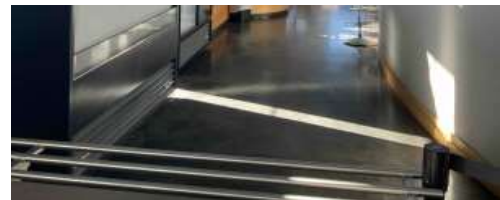
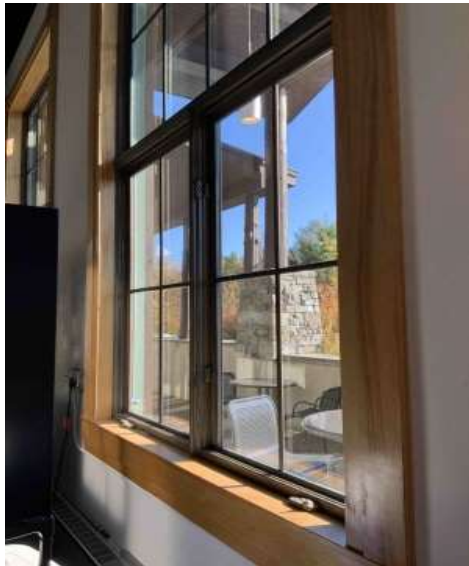
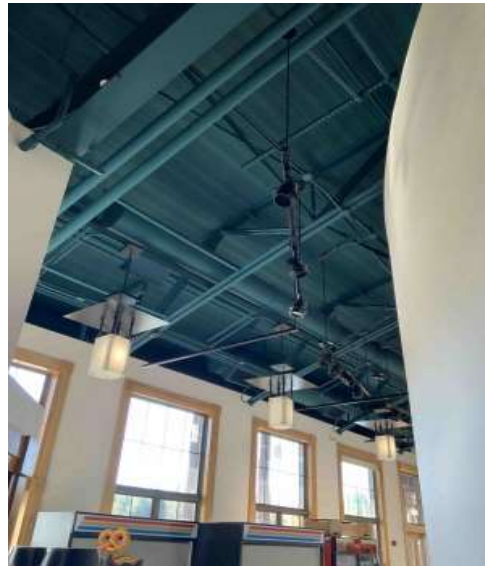
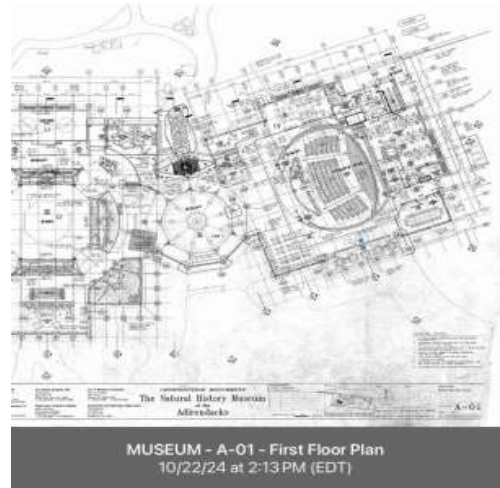
Museum	129	Temp Exhibit/Café	General Interior Condition	General interior conditions - floor fair, furnishings fair, fixtures fair,	251
--------	-----	-------------------	----------------------------	--	-----

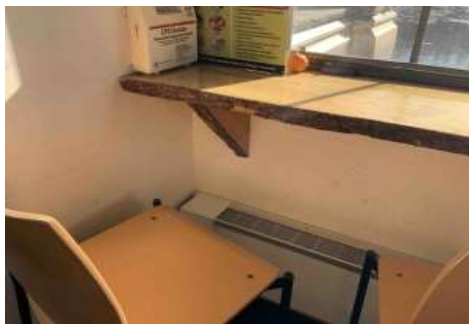
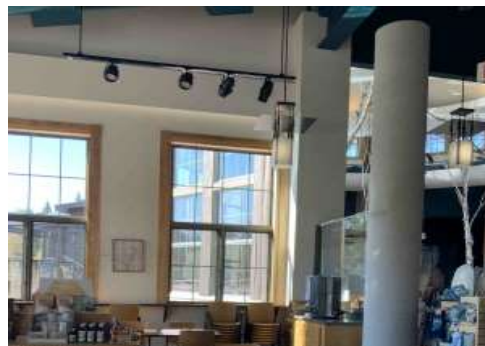
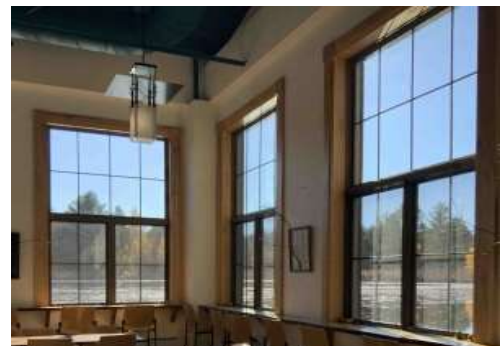
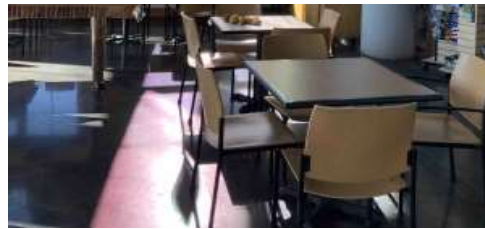
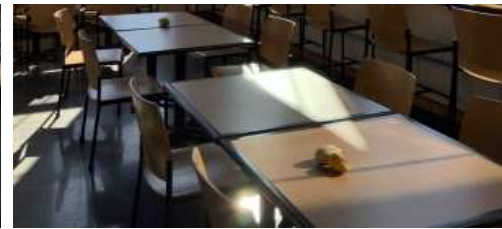
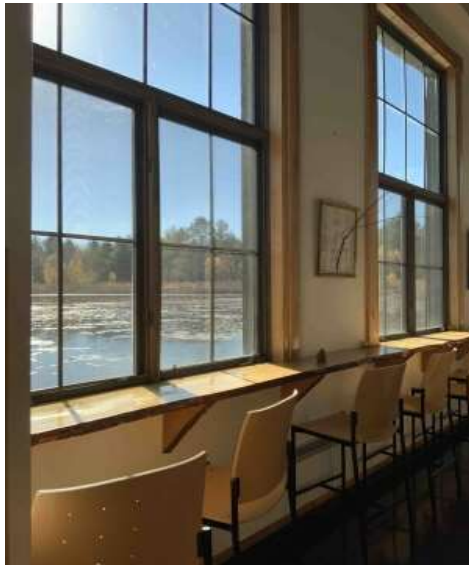
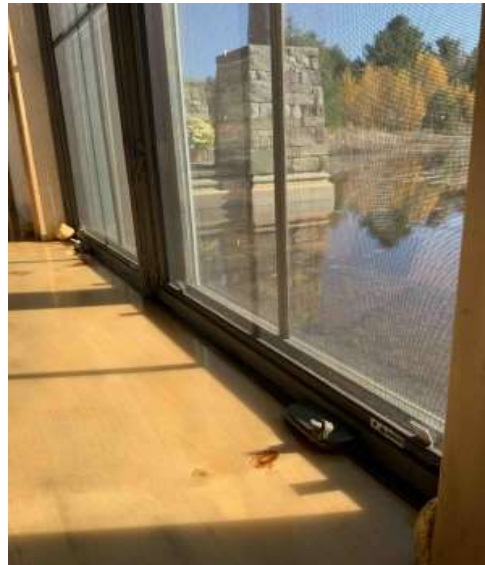
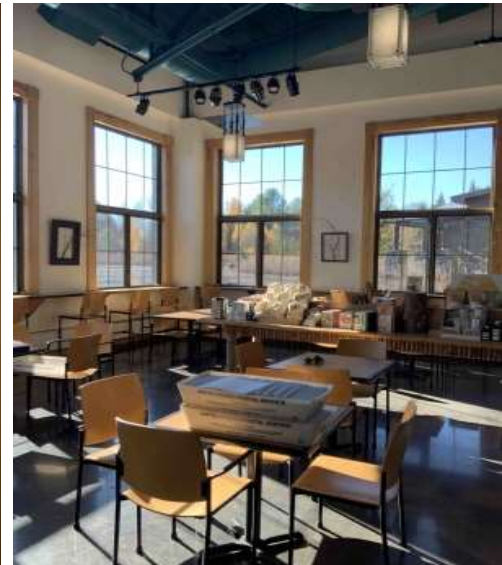
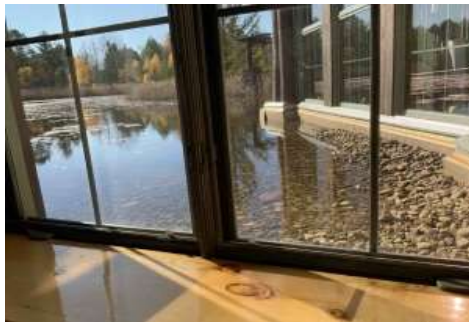
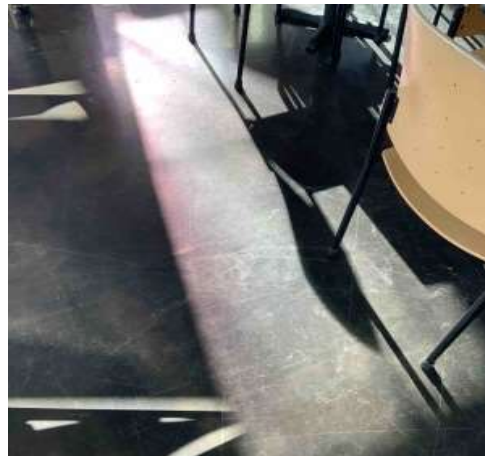
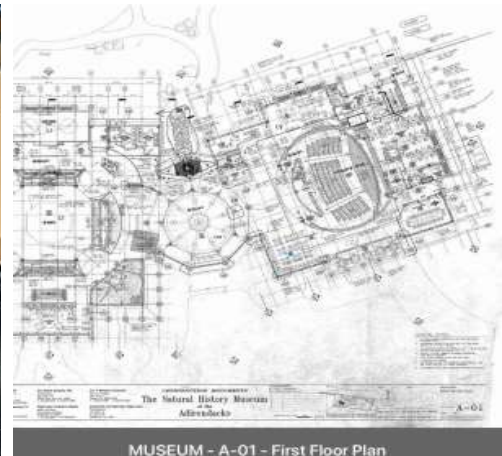
Museum	129	Temp Exhibit/Café	General Interior Condition	General interior conditions - floor fair, furnishings fair,	252
--------	-----	-------------------	----------------------------	---	-----

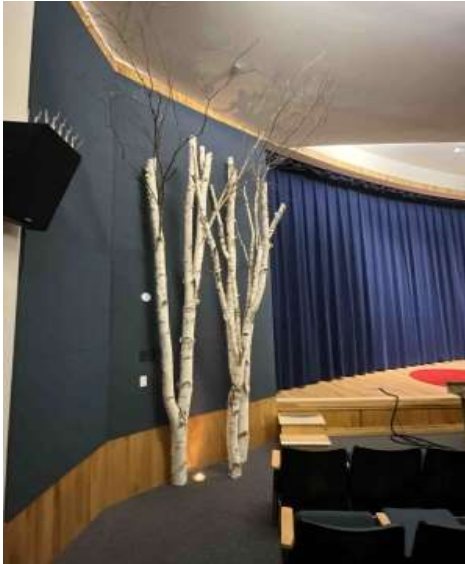
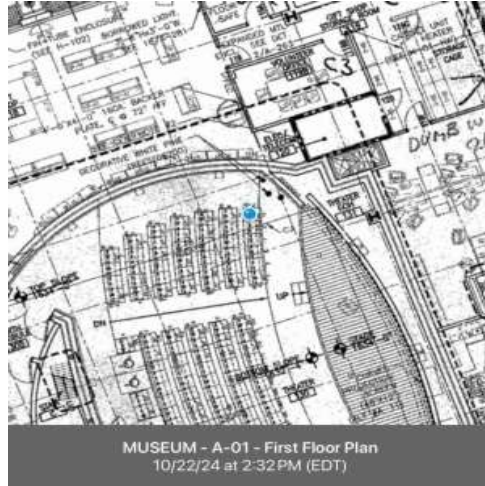
Museum	130	Theater	Arch	Birch tree replacement 5 years	231
--------	-----	---------	------	--------------------------------	-----

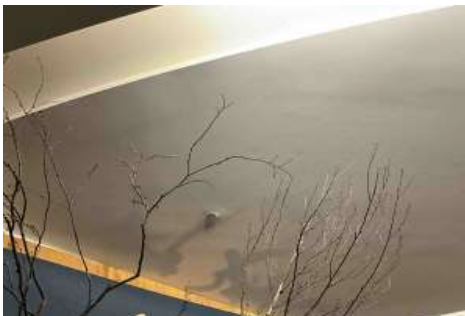
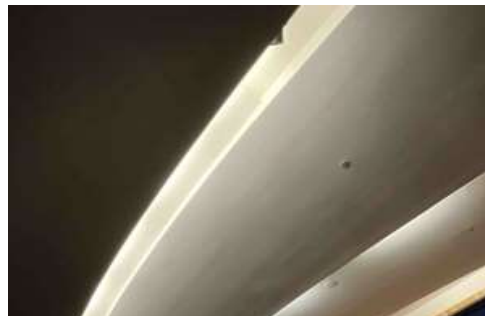
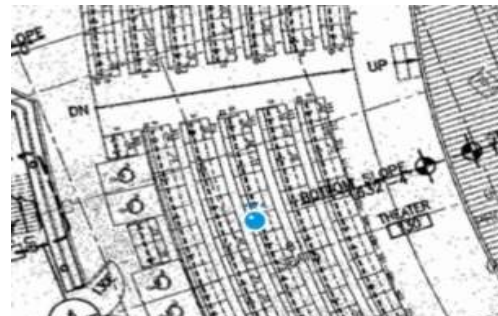
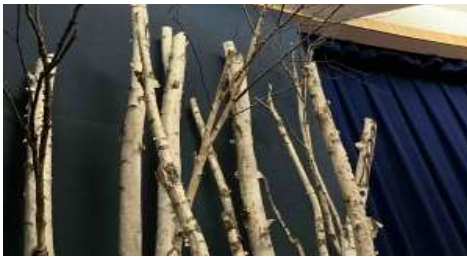
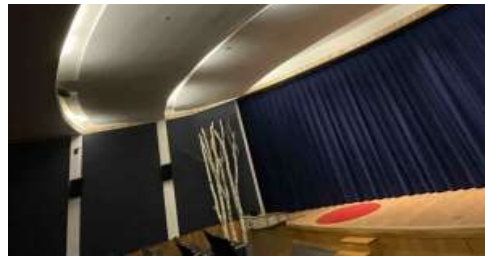
Museum	130	Theater	Arch	Ceiling patch and paint	232
--------	-----	---------	------	-------------------------	-----

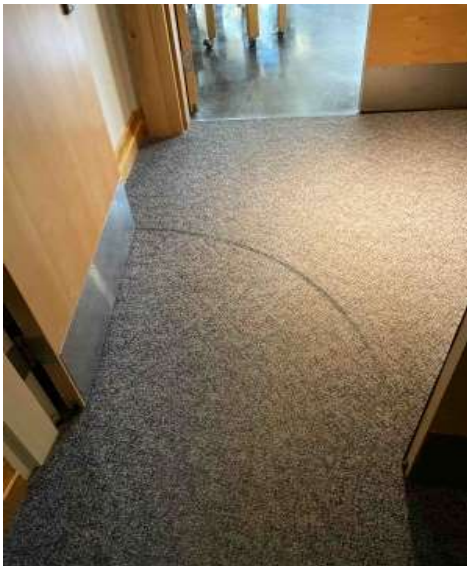
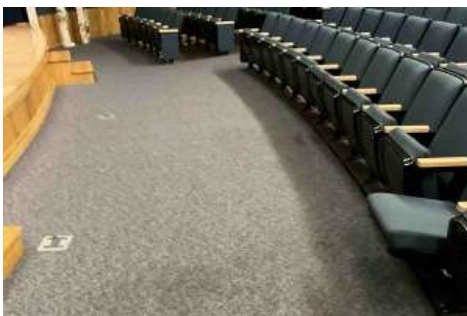
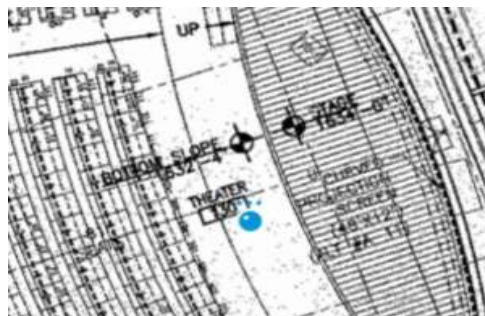
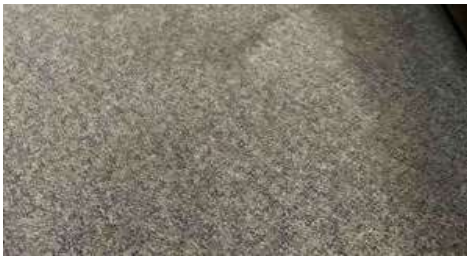
Museum	130	Theater	Arch	Carpet stains	233
--------	-----	---------	------	---------------	-----

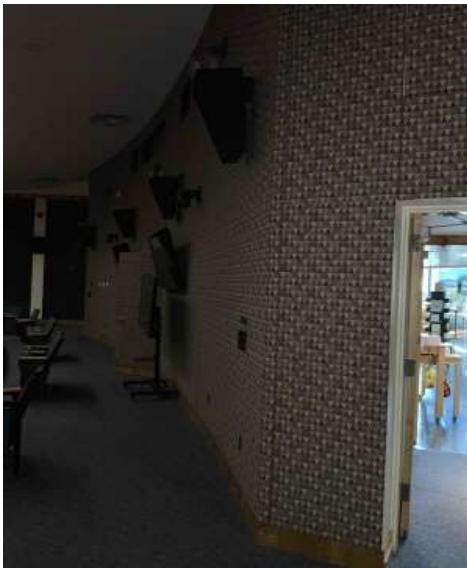
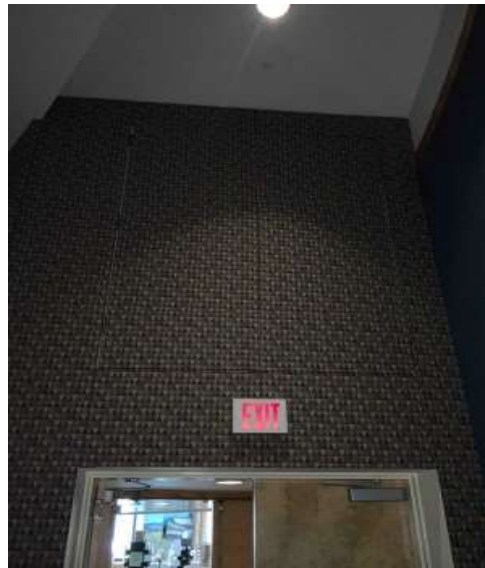
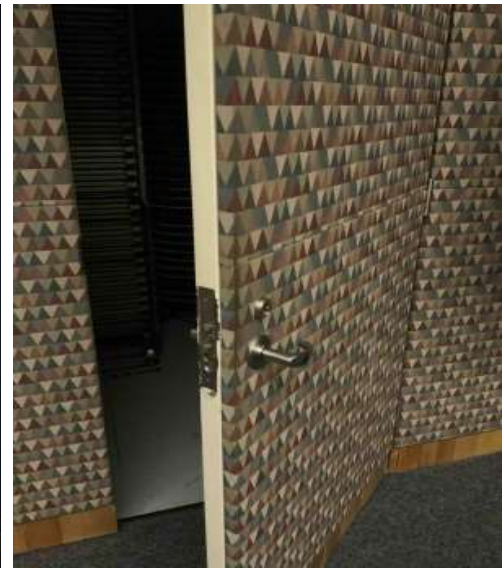
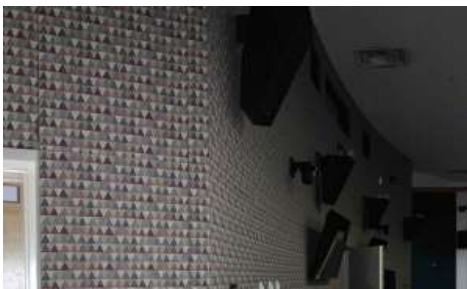
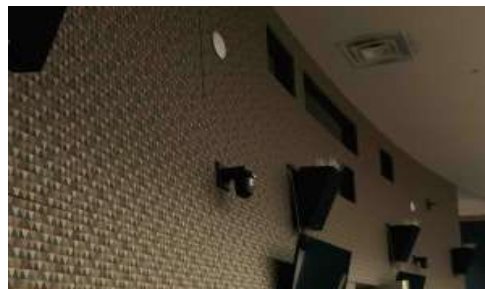
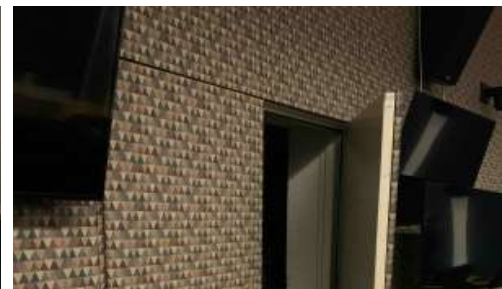
Museum	130	Theater	Back Wall	Trim needs work, potential fabric issues	260
--------	-----	---------	-----------	--	-----

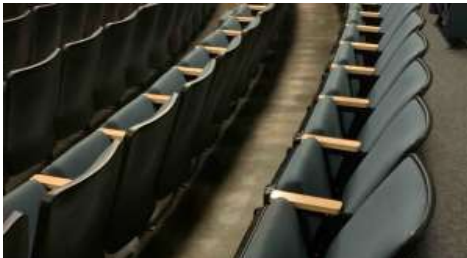
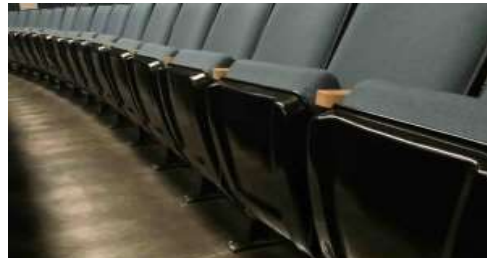
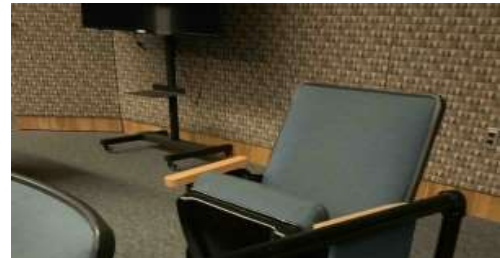
Museum	130	Theater	Chairs	In good condition	261
--------	-----	---------	--------	-------------------	-----

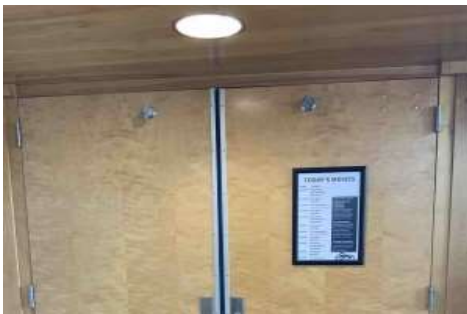
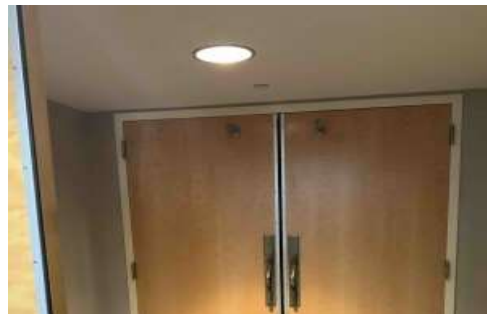
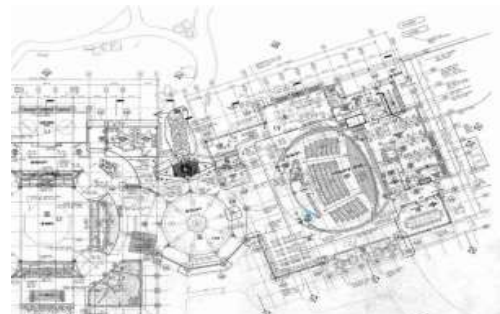
Museum	130A	South Vestibule	Door	Doors good, carpet fair	259
--------	------	-----------------	------	-------------------------	-----

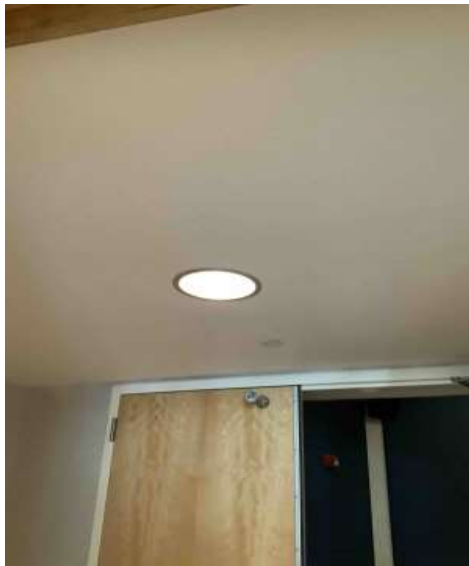
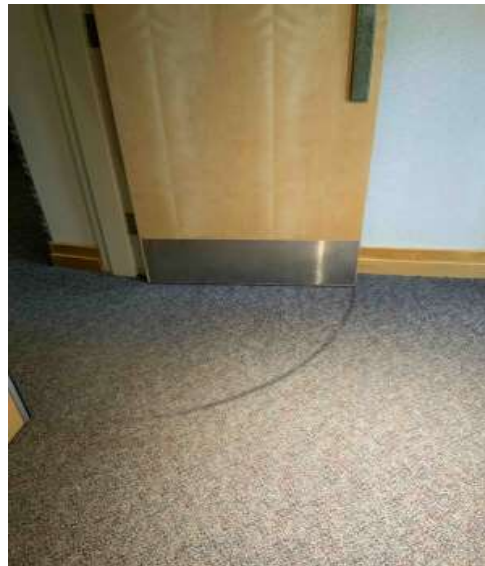
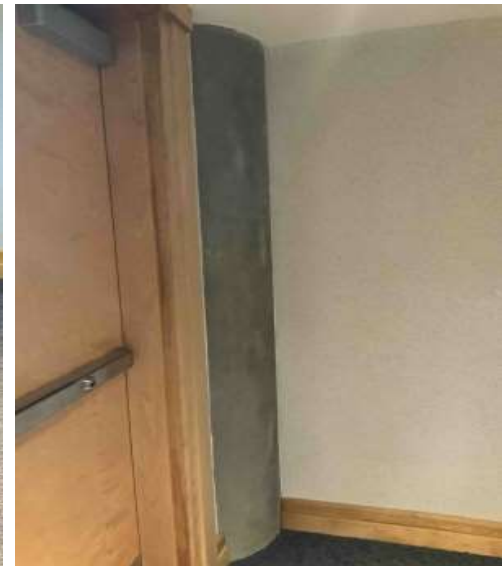
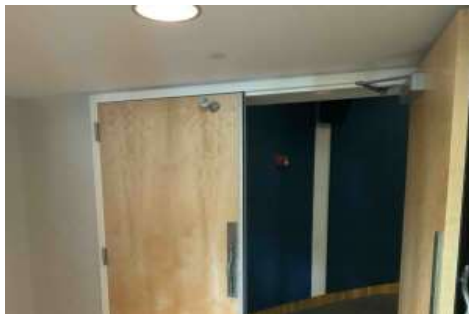
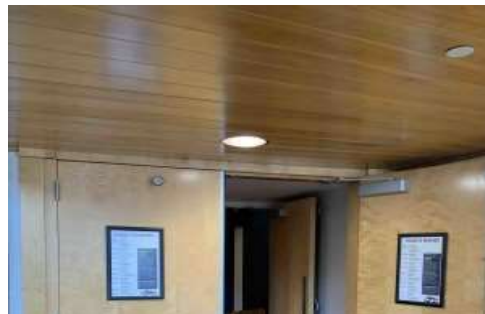
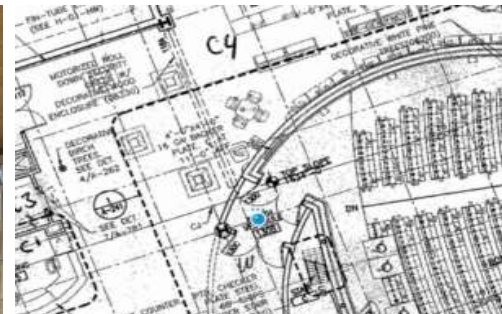
Museum	130B	North Vestibule	Door	Doors good, carpet fair	258
--------	------	-----------------	------	-------------------------	-----

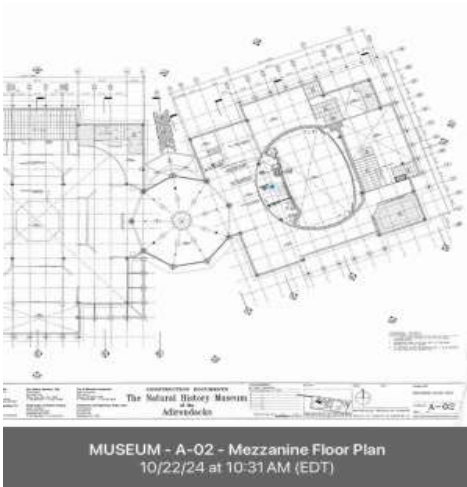
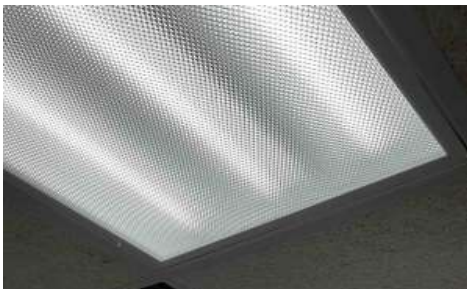
Museum	201	Projection Booth	Arch	Ceiling tile missing and sprinkler head cover missing 033	
--------	-----	------------------	------	---	--

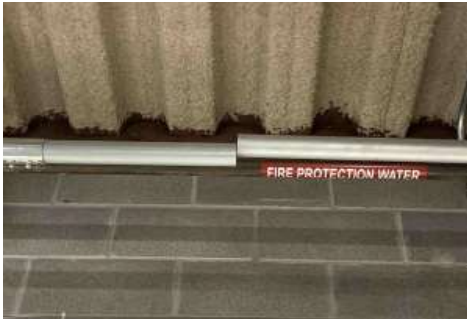
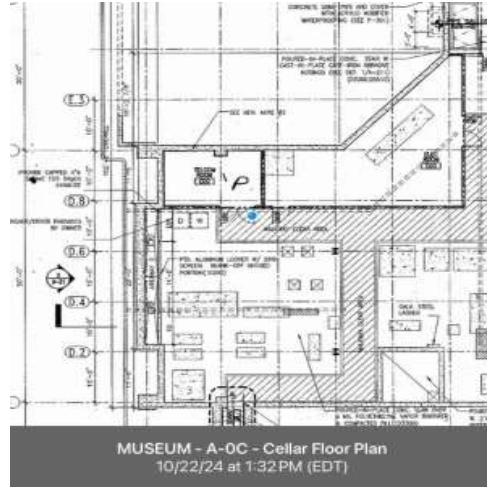
Museum	C01	West Cellar	Elec	WATER DRAINING THROUGH CONDUIT	112
--------	-----	-------------	------	--------------------------------	-----

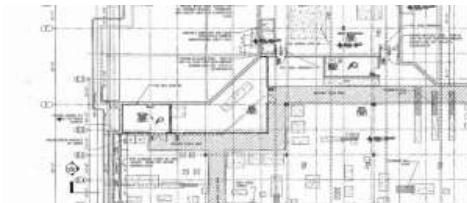
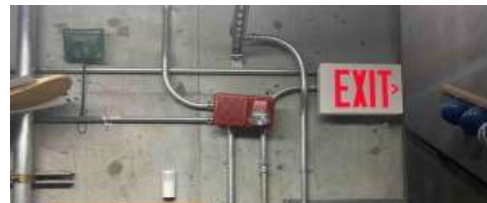
Museum	C01	West Cellar	Elec	FIRE ALARM NOT SECURED	118
--------	-----	-------------	------	------------------------	-----

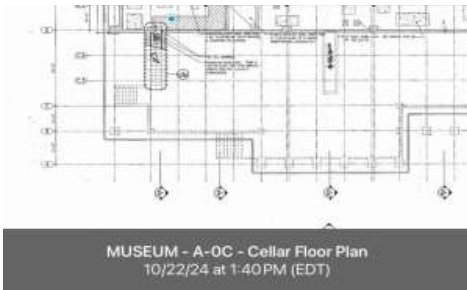
Museum	C01	West Cellar	Elec	GENERAL	125
--------	-----	-------------	------	---------	-----

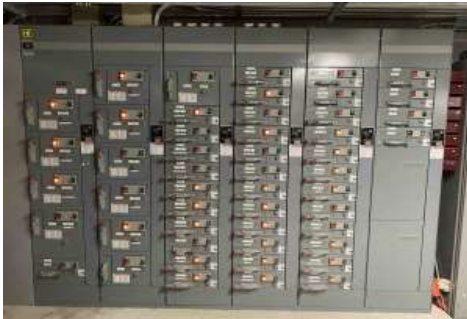
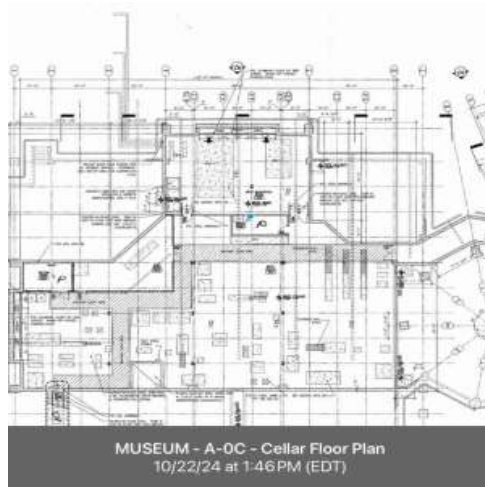
Museum	C01	West Cellar	Elec	FIRE ALARM NOT SECURED	126
--------	-----	-------------	------	------------------------	-----

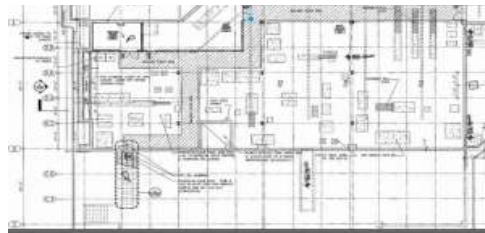
MUSEUM - A-0C - Cellar Floor Plan
10/22/24 at 1:49PM (EDT)

Museum	C01	West Cellar	Elec	NO EXIT SIGN	138
--------	-----	-------------	------	--------------	-----

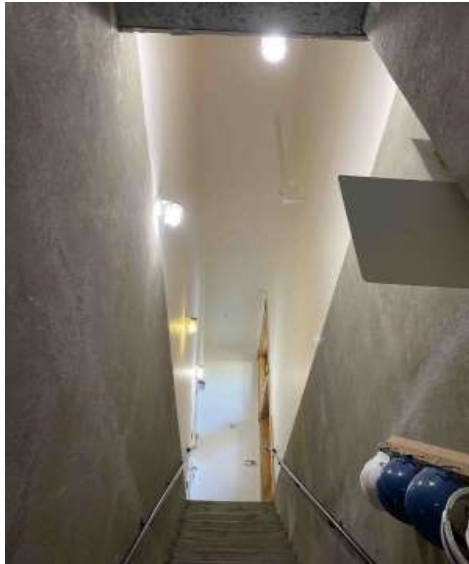
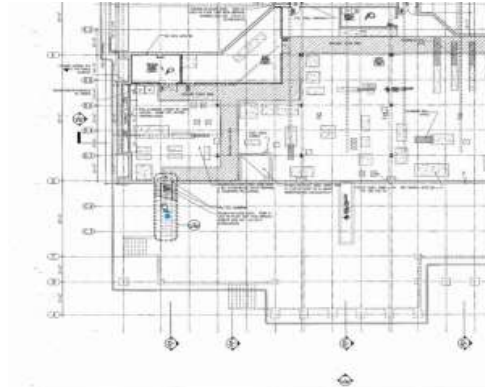
MUSEUM - A-0C - Cellar Floor Plan
10/22/24 at 2:02PM (EDT)

Museum	C02	Telcom Room	Elec	GENERAL	114
--------	-----	-------------	------	---------	-----

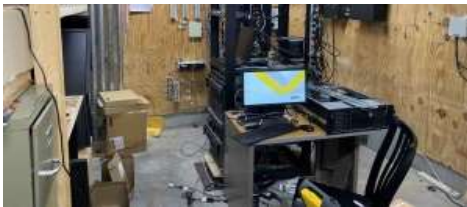
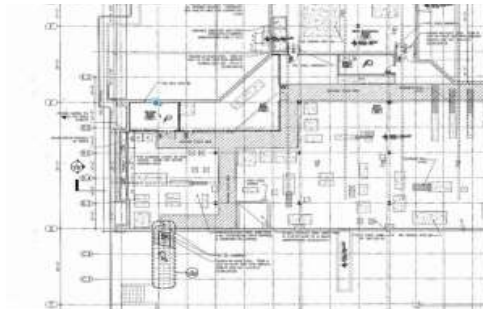
MUSEUM - A-0C - Cellar Floor Plan
10/22/24 at 1:36 PM (EDT)

Museum	C03	Elec. Room	Elec	GENERAL	116
--------	-----	------------	------	---------	-----

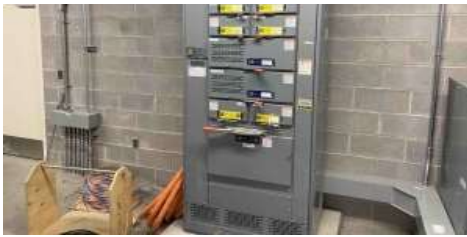
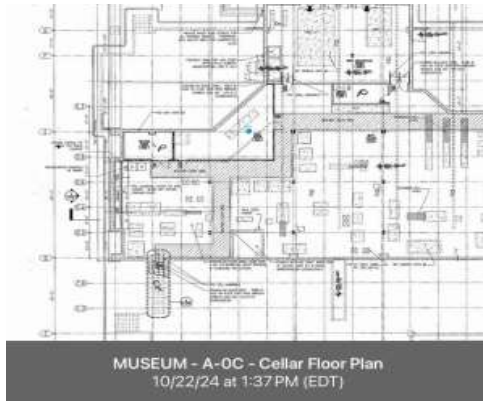
Museum	C03	Elec. Room	Elec	GENERAL	122
--------	-----	------------	------	---------	-----

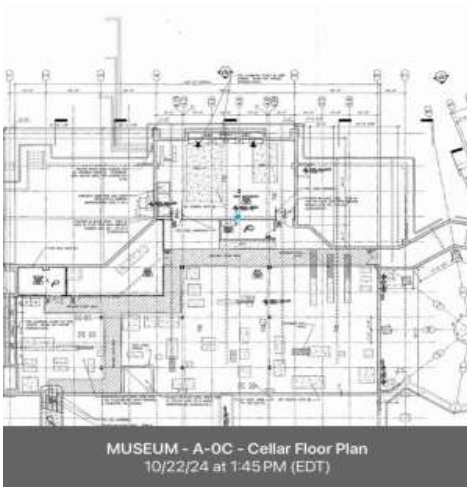
Museum	C05	West Mechanical Room	MPF	AHU 4 Duct rattling believed due to turbulence	235
--------	-----	----------------------	-----	--	-----

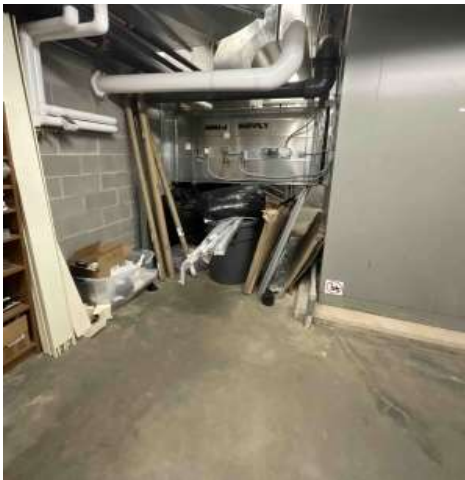
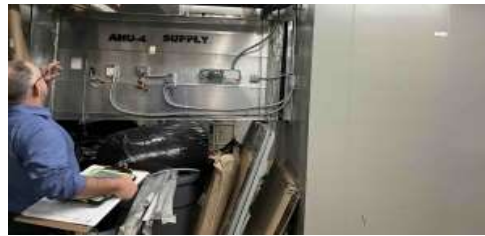
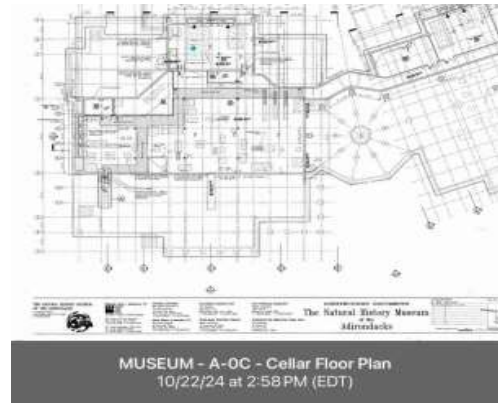
Museum	C05	West Mechanical Room	MPF	Casing damage due to apparent pump or pipe fitting failure Could not open condition unknown	236
--------	-----	----------------------	-----	--	-----

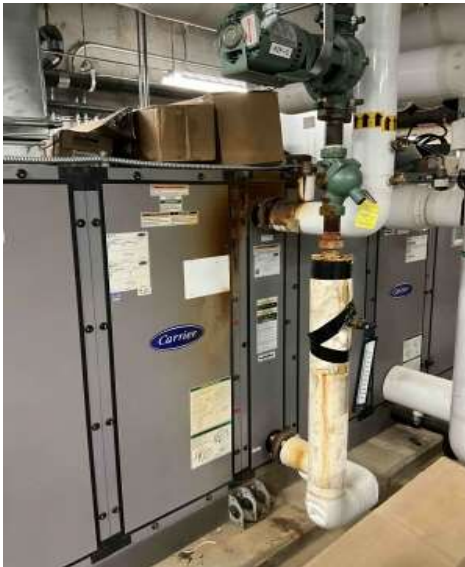
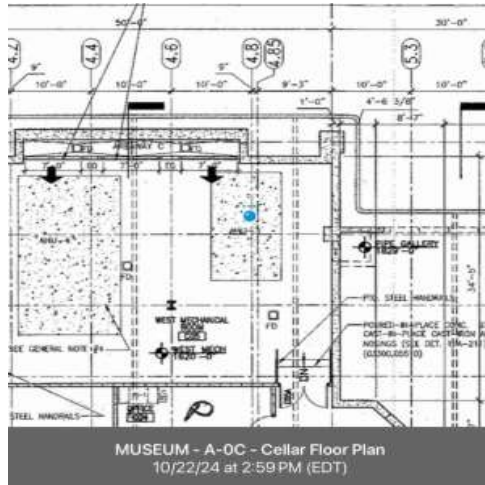
Museum	C05	West Mechanical Room	MPF	Water service Meter and backflow	237
--------	-----	----------------------	-----	----------------------------------	-----

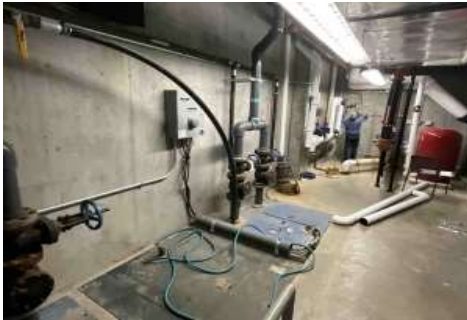
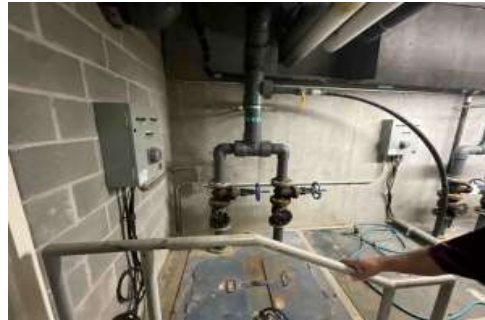
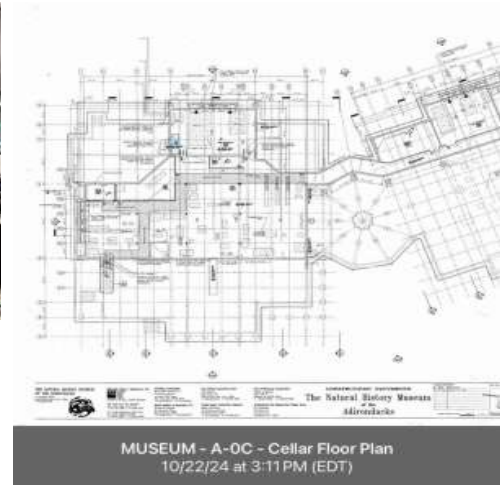
Museum	C09	Fire Pump Room	Elec	GENERAL	129
--------	-----	----------------	------	---------	-----

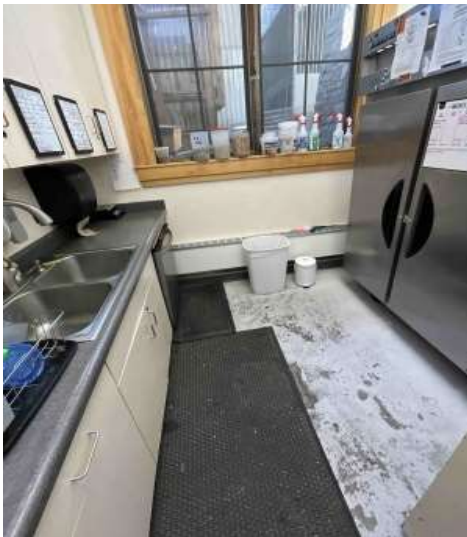
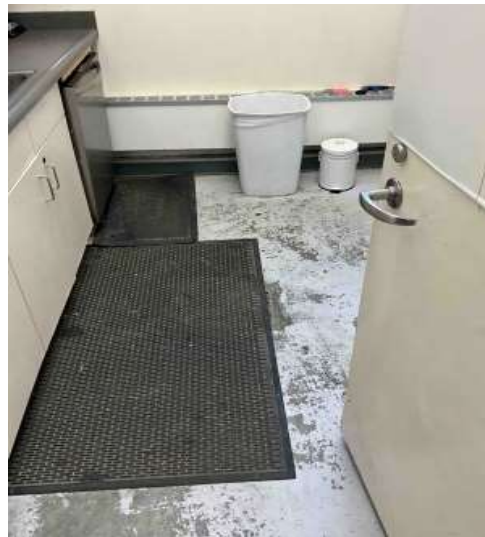
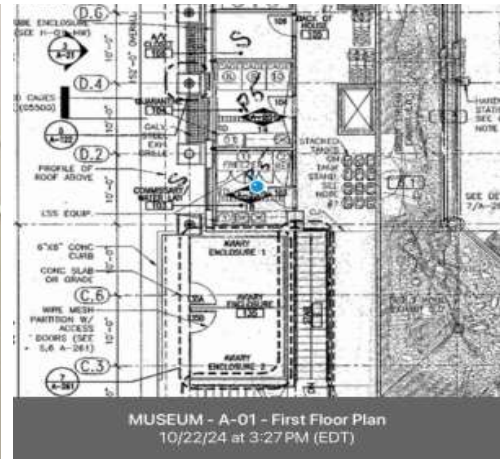
Museum	104	Quarantine	Arch	Floor seal,	242
--------	-----	------------	------	-------------	-----

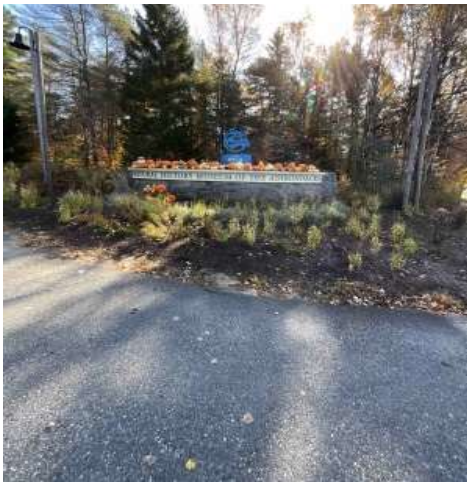
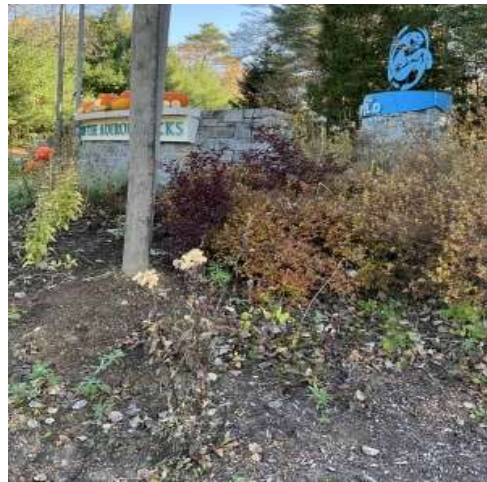
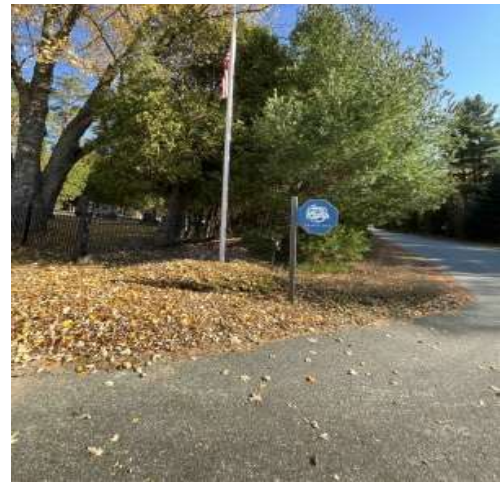
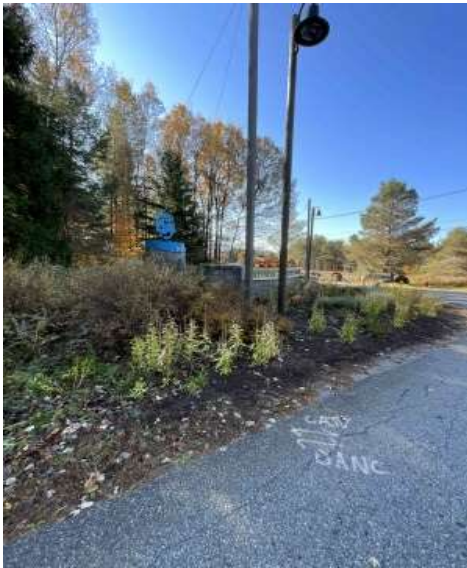
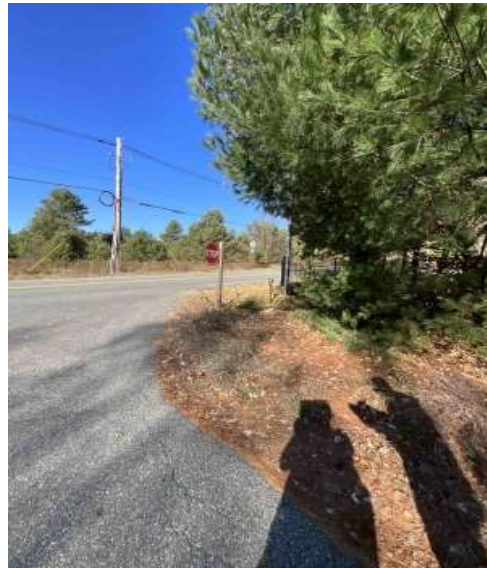
001	Overall Site	Civil/LS	Sign location	041
-----	--------------	----------	---------------	-----

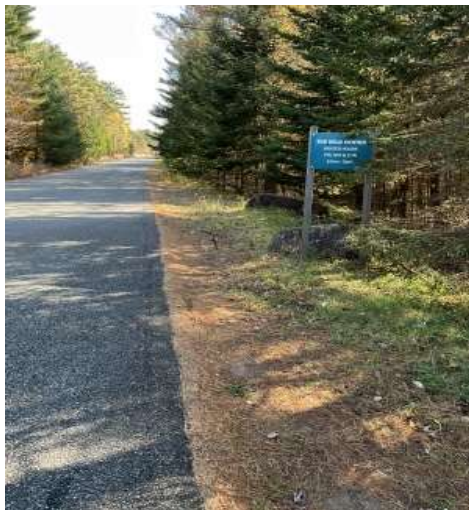
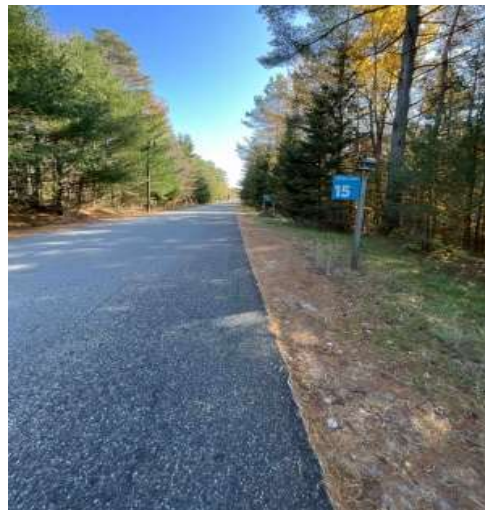
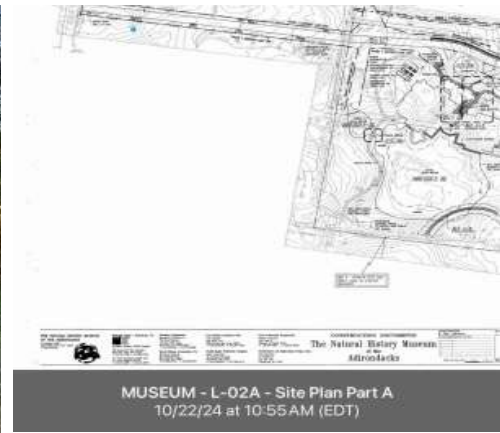
001	Overall Site	Civil/LS	Tree pruning around light fix	043
-----	--------------	----------	-------------------------------	-----

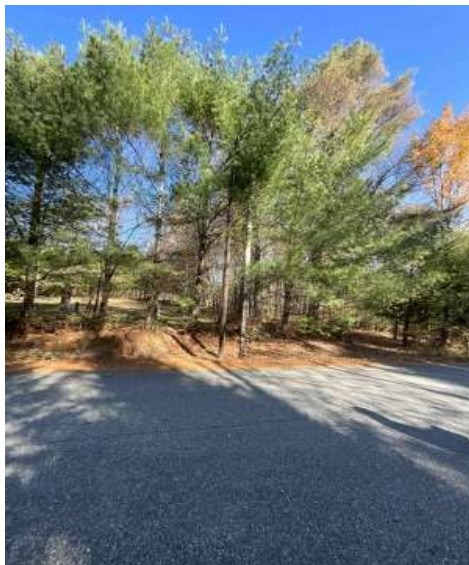
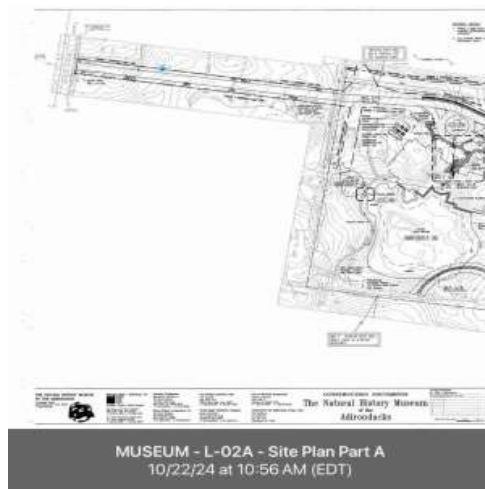
001	Overall Site	Civil/LS	Site lighting good cond	044
--	-----	--------------	----------	-------------------------	-----
