Wild Center Property Condition Assessment

LaBella Project No.: 2244417
Prepared On: 11/6/2024

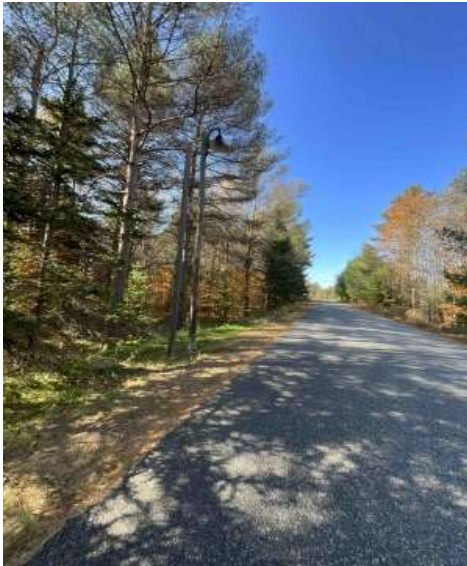
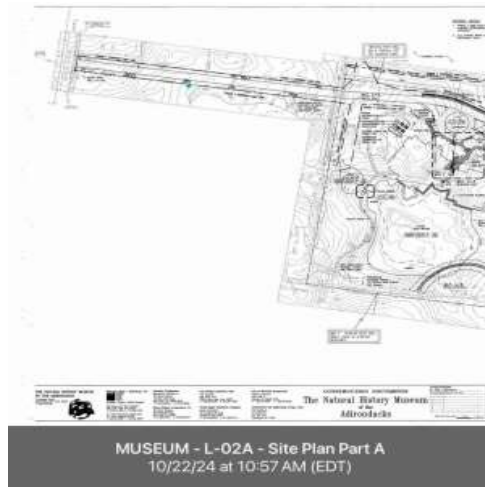
001	Overall Site	Civil/LS	Light fix good condition	047
--	-----	--------------	----------	--------------------------	-----

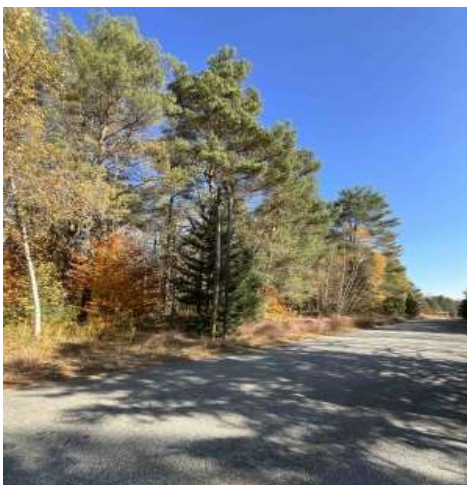
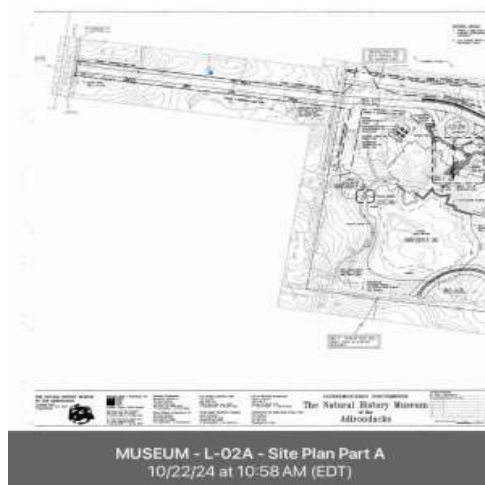
001	Overall Site	Civil/LS	Light fix good condition	048
--	-----	--------------	----------	--------------------------	-----

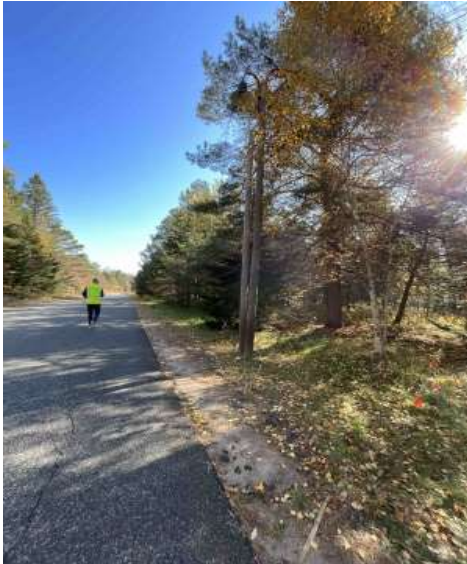
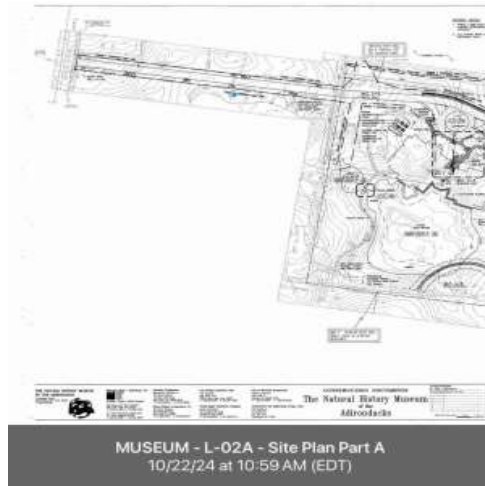
001	Overall Site	Civil/LS	Light fix good condition	049
--	-----	--------------	----------	--------------------------	-----

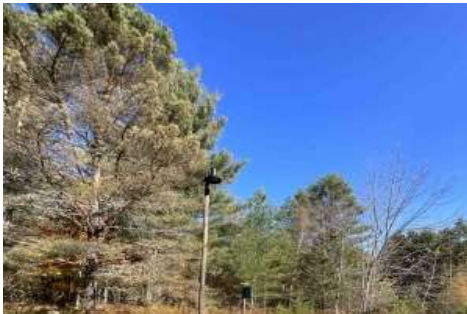
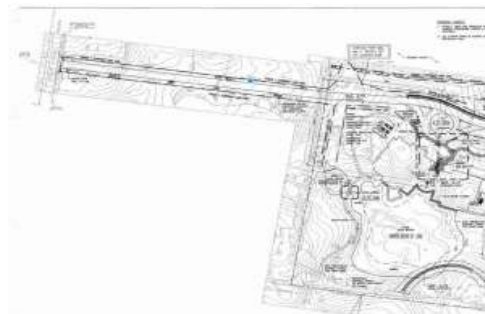
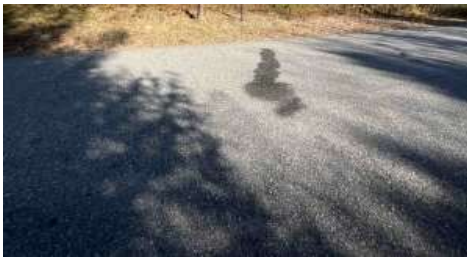
001	Overall Site	Civil/LS	Sign location	050
-----	--------------	----------	---------------	-----

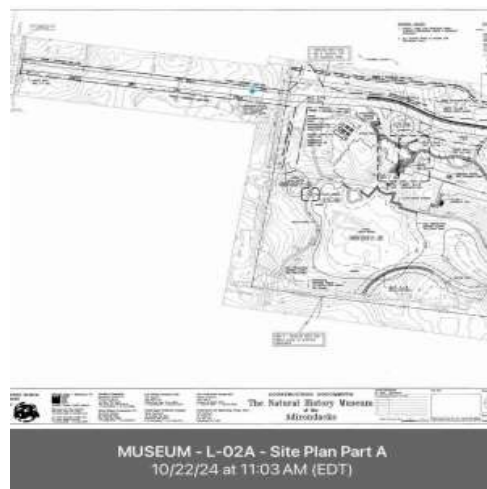
N/A		Civil/LS	Asphalt cracking wear and tear	061
--	-----	--	----------	--------------------------------	-----

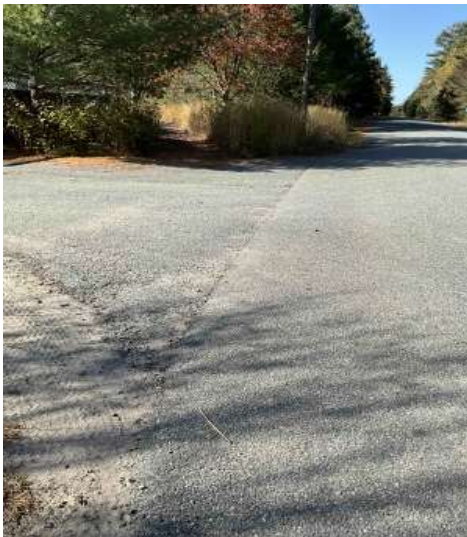
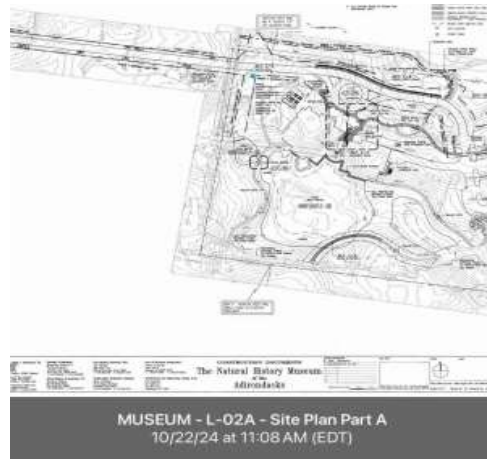
N/A		Civil/LS	Light fix good condition	062
--	-----	--	----------	--------------------------	-----

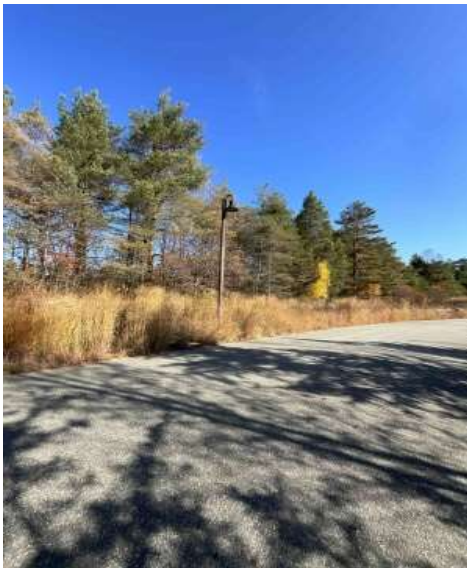
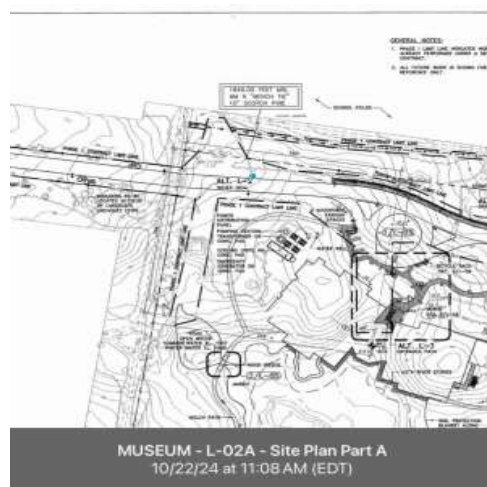
N/A		Civil/LS	Signage Vegetative mgmt	064
--	-----	--	----------	----------------------------	-----

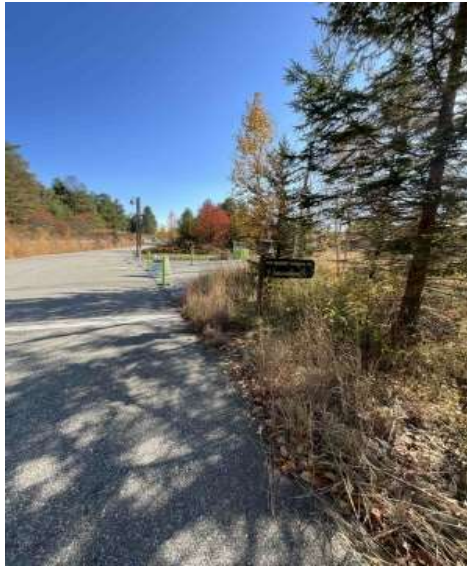
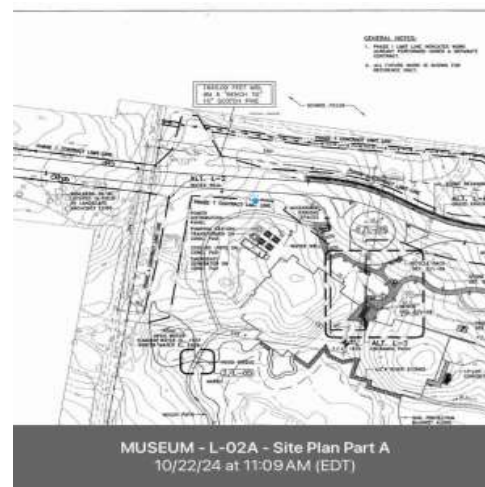
N/A		Civil/LS	Light fix good condition	065
--	-----	--	----------	--------------------------	-----

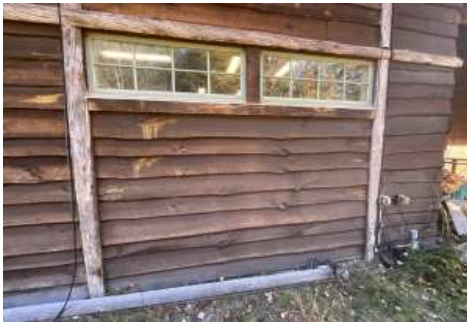
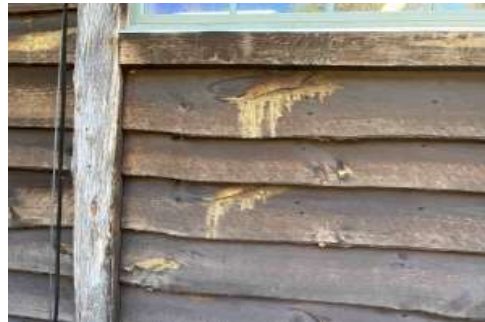
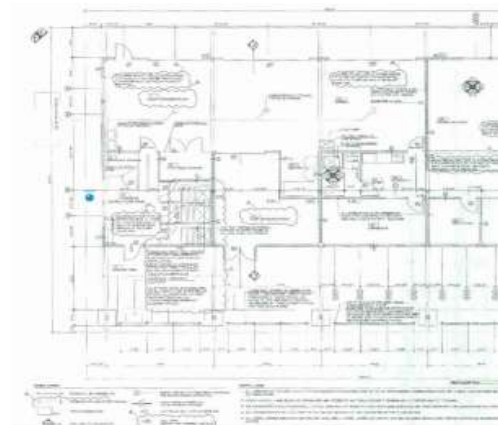
N/A	Siding	Crumbling/deteriorating	067
-----	--------	-------------------------	-----

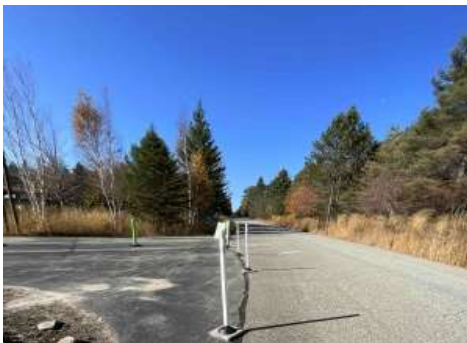
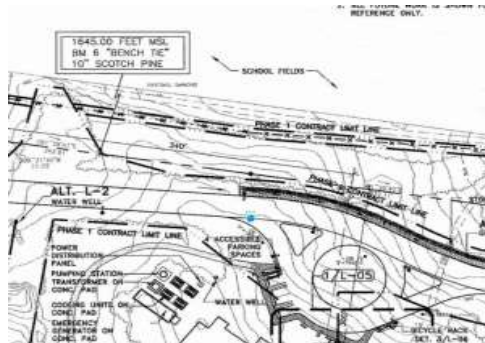
N/A	Civil/LS	Asphalt	068
-----	----------	---------	-----

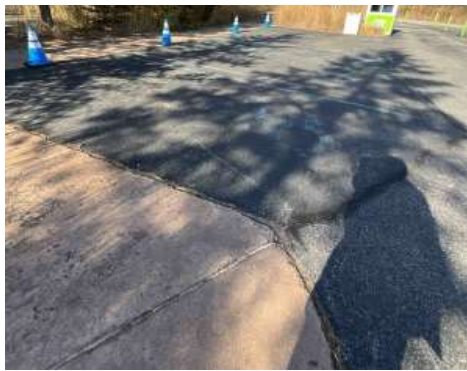
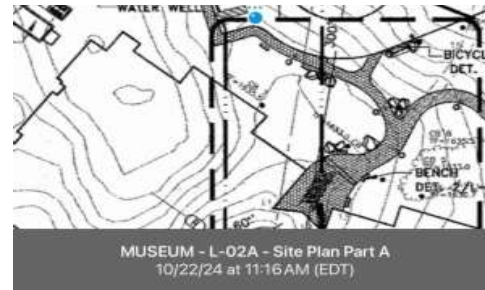
N/A		Civil/LS	Concrete wear and tear. Edging lip	076
--	-----	--	----------	------------------------------------	-----

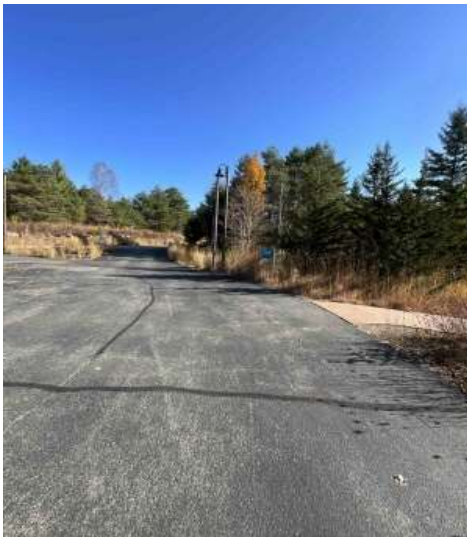
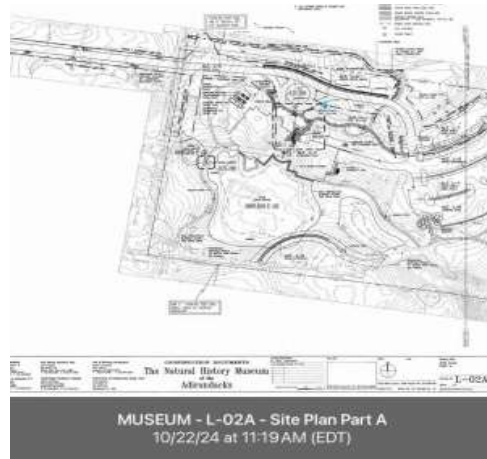
N/A		Civil/LS	Concrete wear and tear. Edging lip	079
--	-----	--	----------	------------------------------------	-----

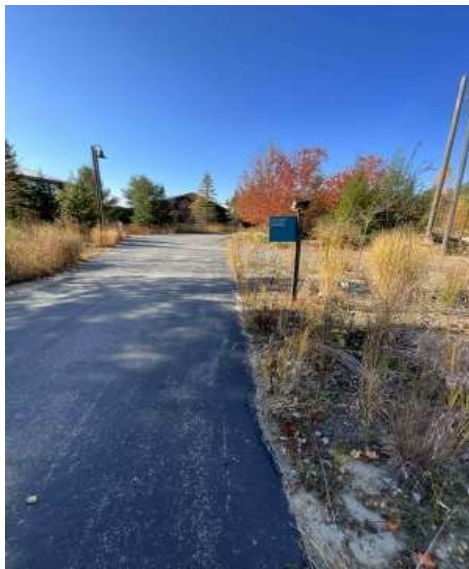
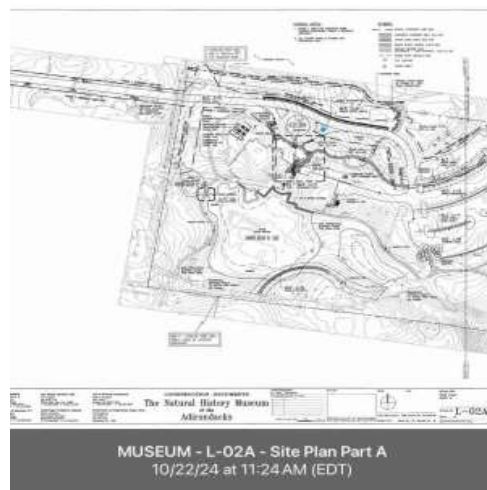
N/A		Civil/LS	Signage	090
--	-----	--	----------	---------	-----

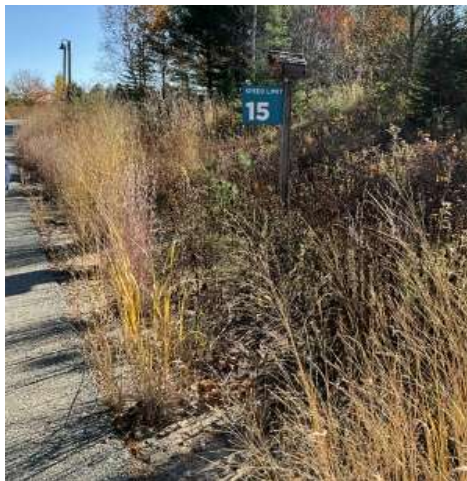
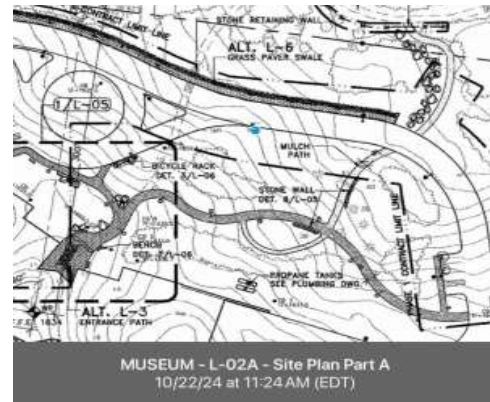
N/A		Civil/LS	Site lighting	091
--	-----	--	----------	---------------	-----

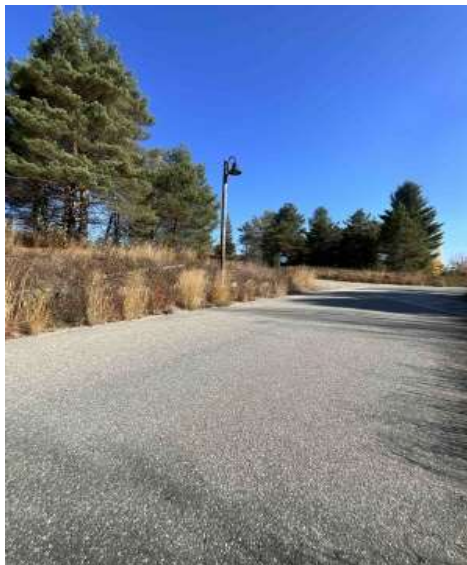
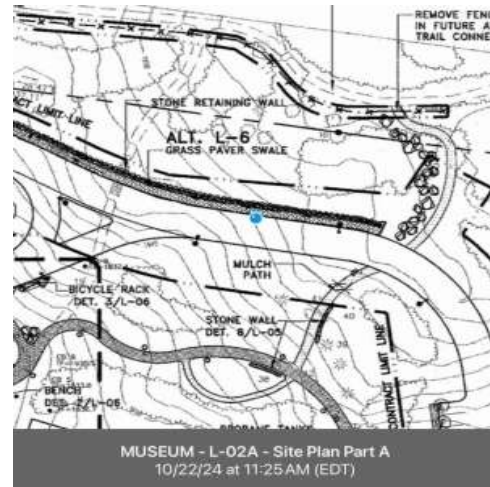
N/A		Civil/LS	Signage	092
--	-----	--	----------	---------	-----

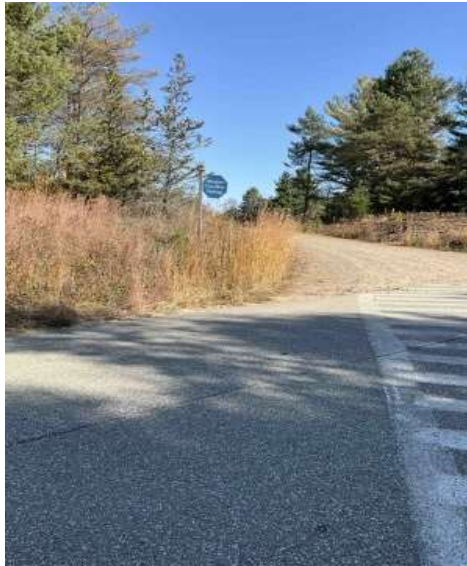
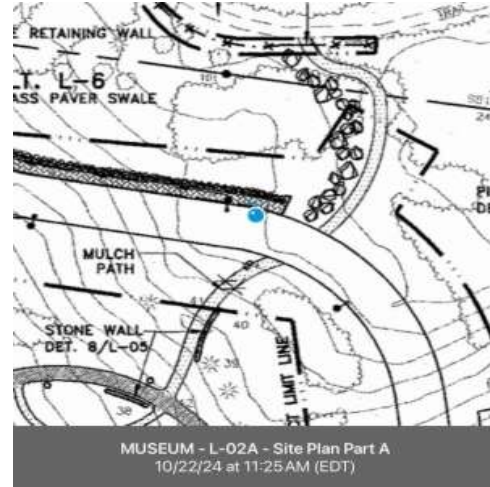
N/A		Civil/LS	Asphalt striping	094
--	-----	--	----------	------------------	-----

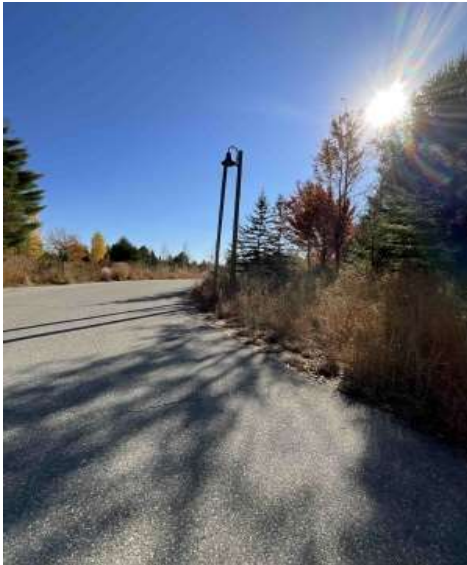
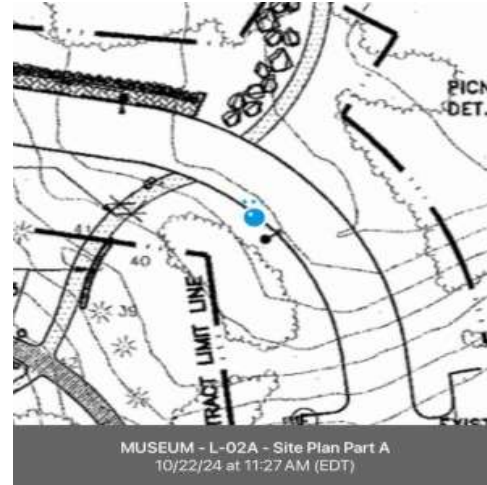
N/A		Civil/LS	Asphalt striping	099
--	-----	--	----------	------------------	-----

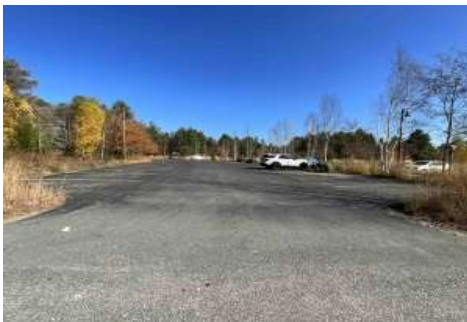
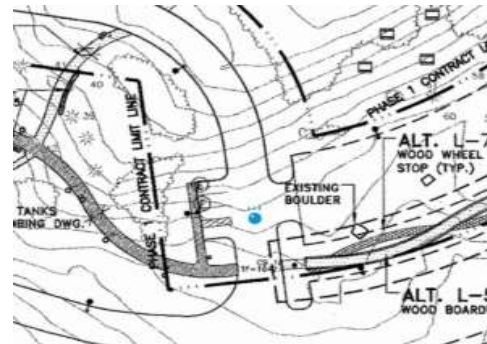
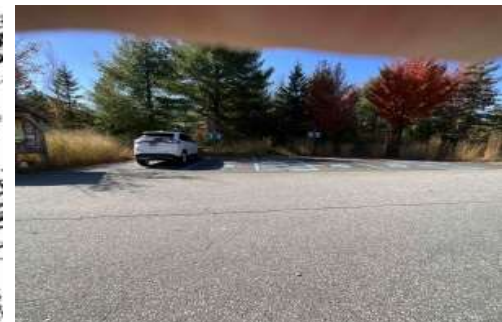
N/A		Civil/LS	Crosswalk Spalding	100
--	-----	--	----------	--------------------	-----

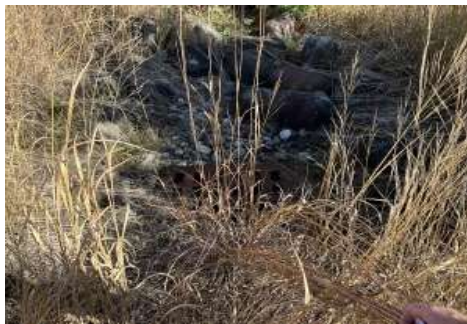
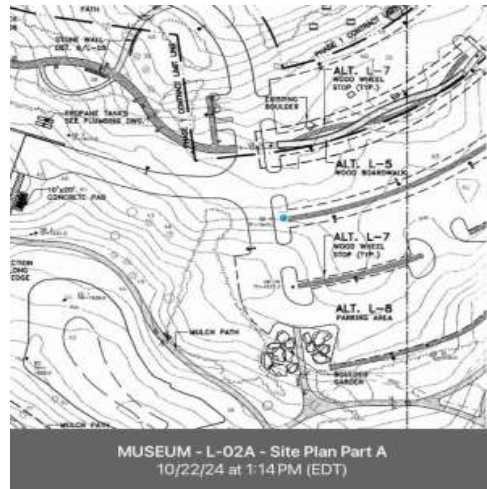
N/A	Civil/LS	Surface change	104
-----	----------	----------------	-----

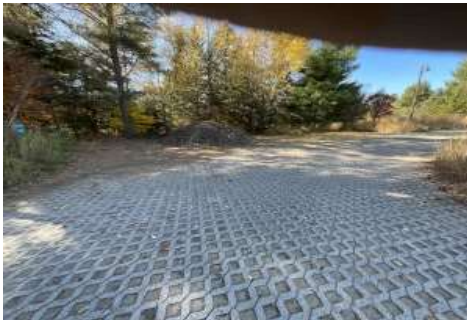
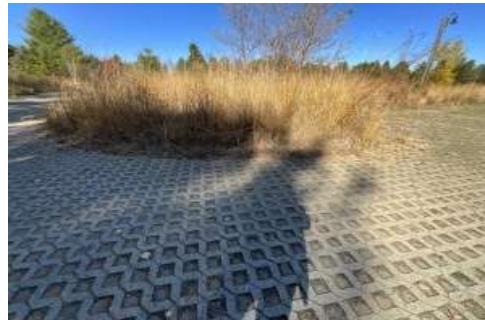
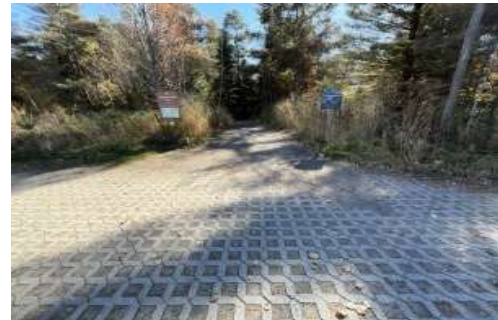
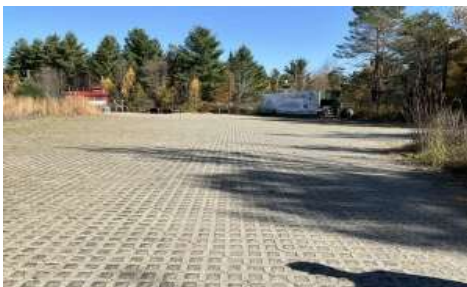
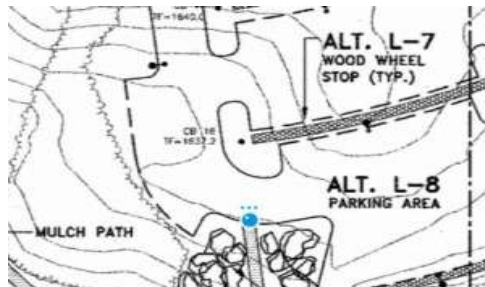
N/A		Civil/LS	Storm drain	106
--	-----	--	----------	-------------	-----

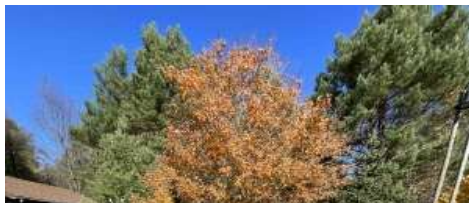
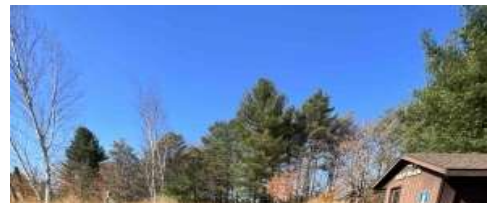
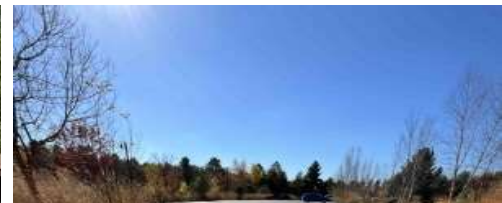
N/A		Civil/LS	Surface change	107
--	-----	--	----------	----------------	-----

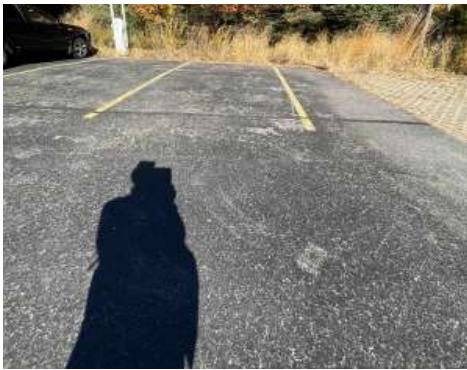
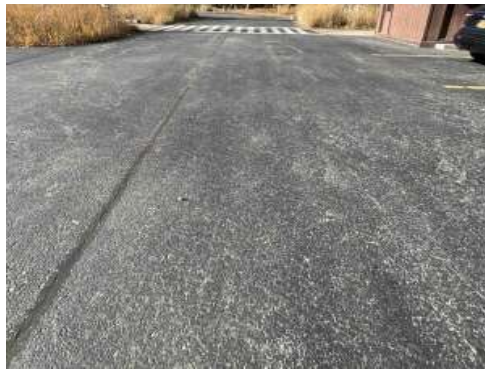
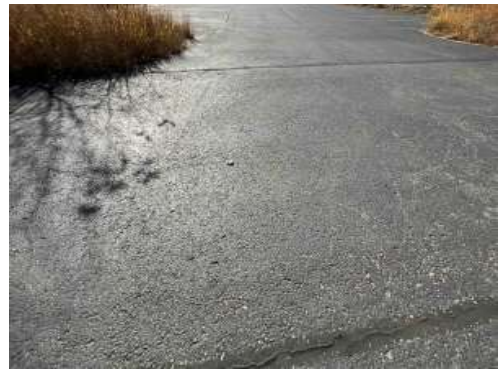
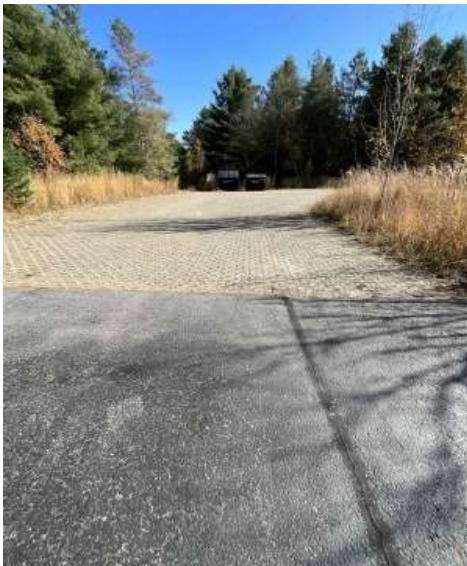
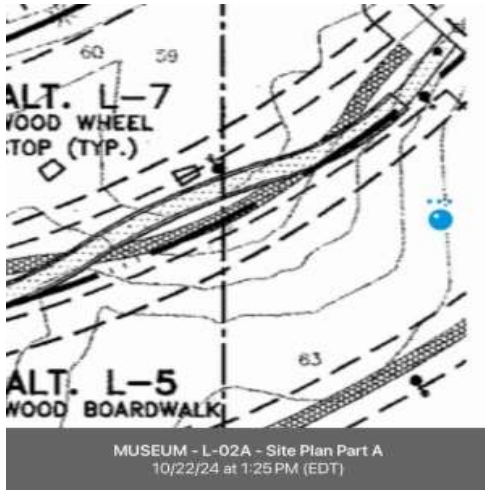
N/A		Civil/LS	Surface change	108
--	-----	--	----------	----------------	-----

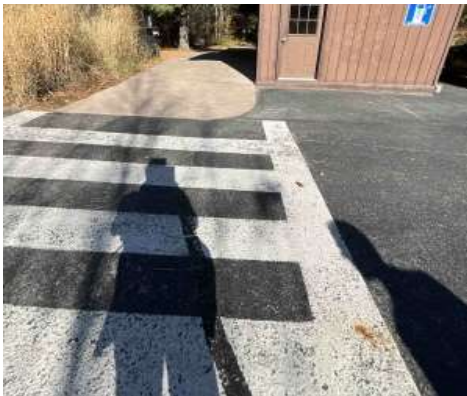
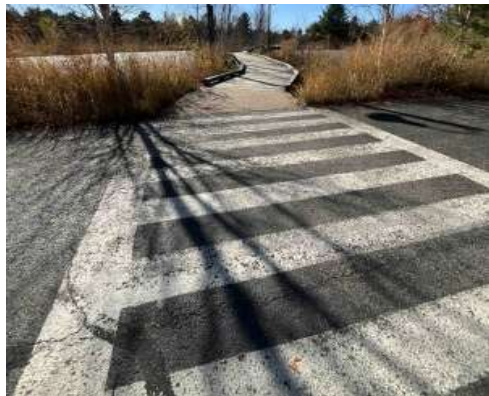
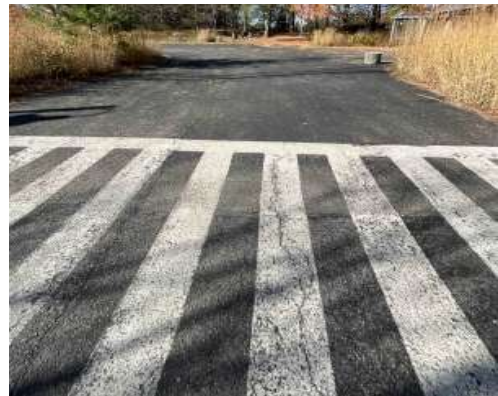
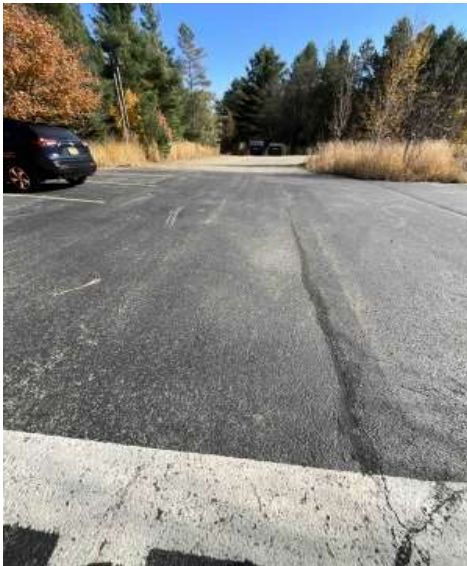
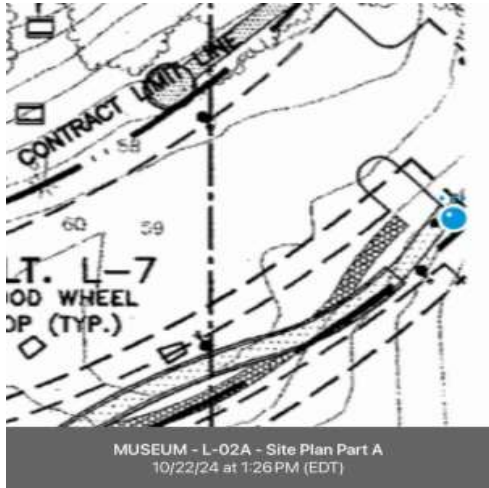
N/A		Civil/LS	Wild walk trail	109
--	-----	--	----------	-----------------	-----

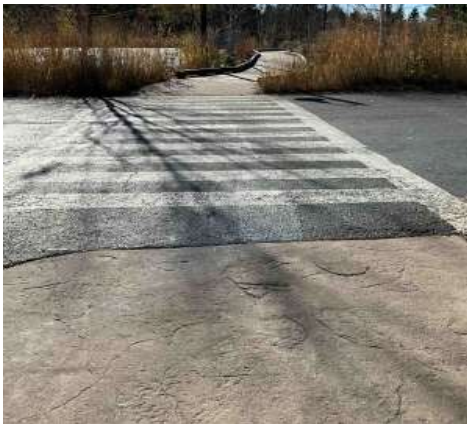
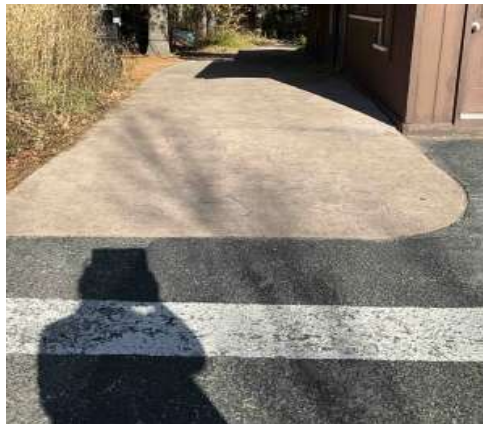
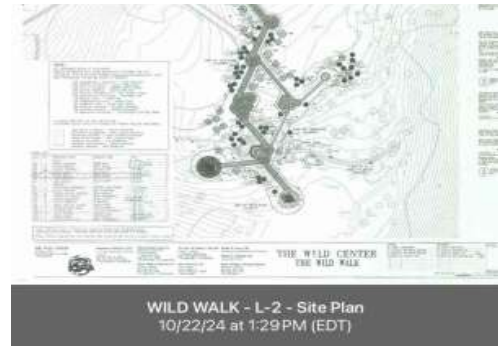
N/A		Civil/LS	Concrete Tripping hazard	110
--	-----	--	----------	-----------------------------	-----

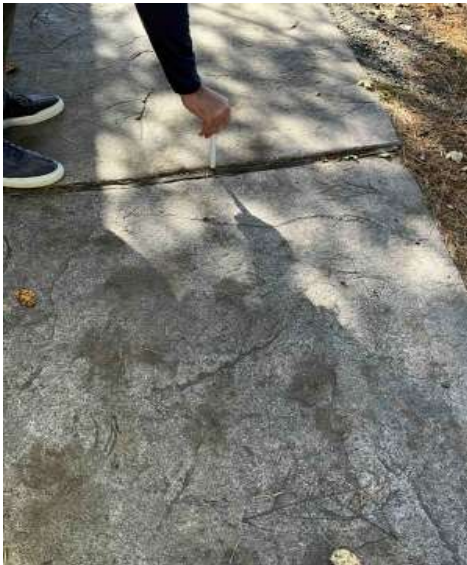
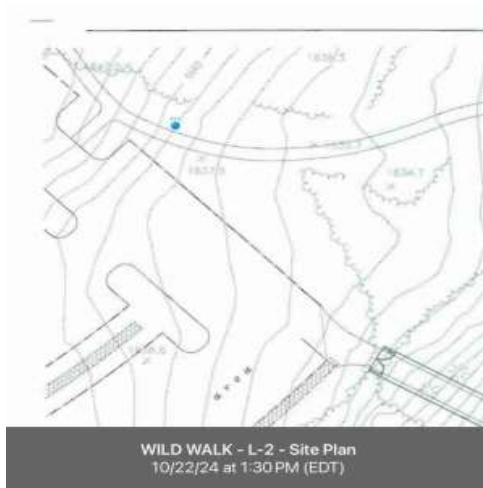
Building	Space Number	Space Name	Element	Description	ID
		N/A	Civil/LS	Concrete Tripping hazard	111

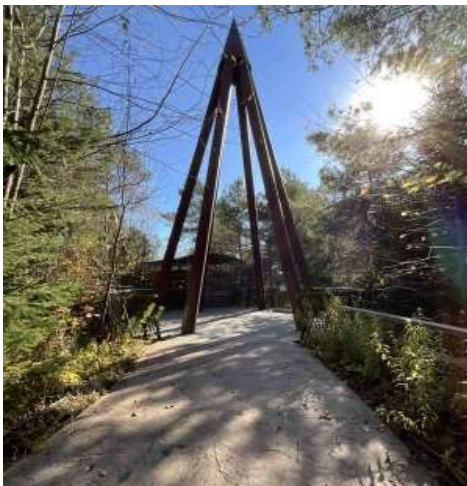
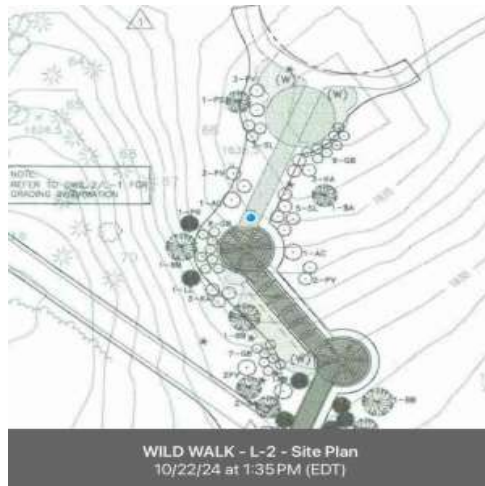
N/A		Civil/LS	Tree house structure	115
--	-----	--	----------	----------------------	-----

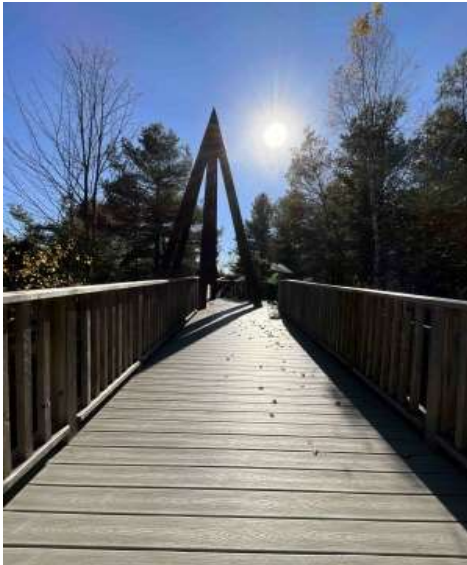
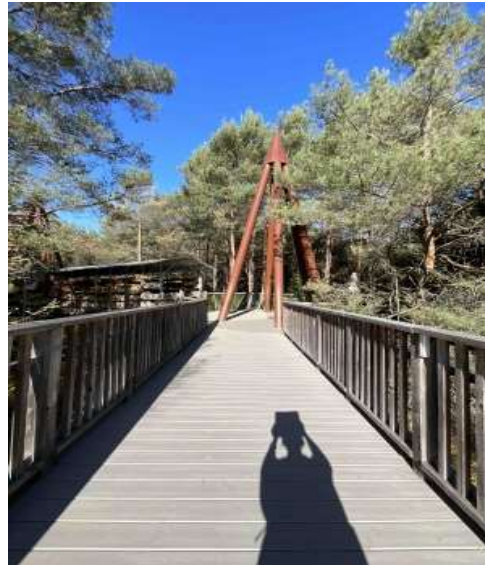
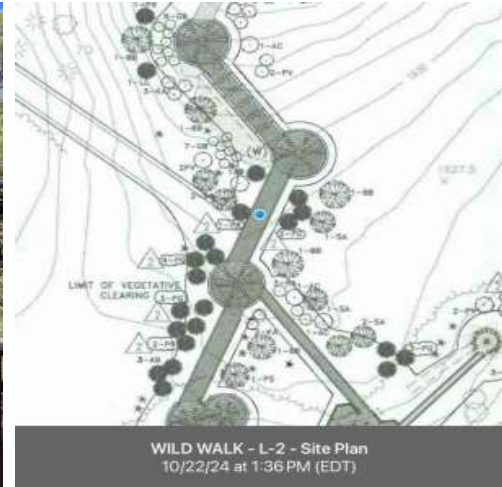
N/A		Civil/LS	Surface change	130
--	-----	--	----------	----------------	-----

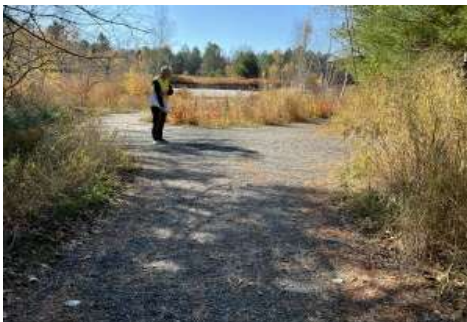
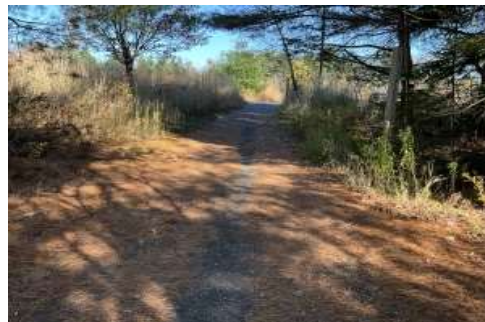
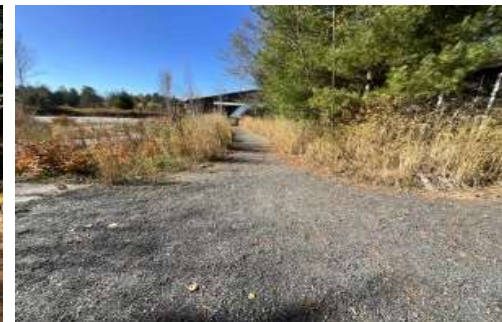
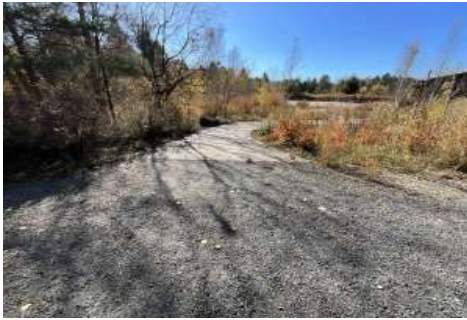
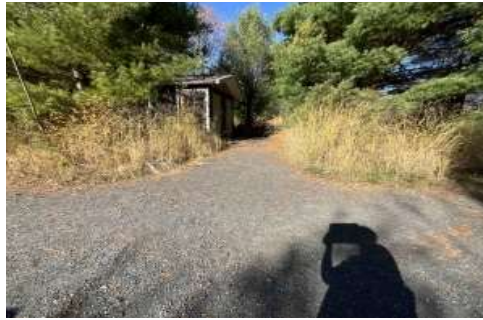
N/A		Civil/LS	Surface change	131
--	-----	--	----------	----------------	-----

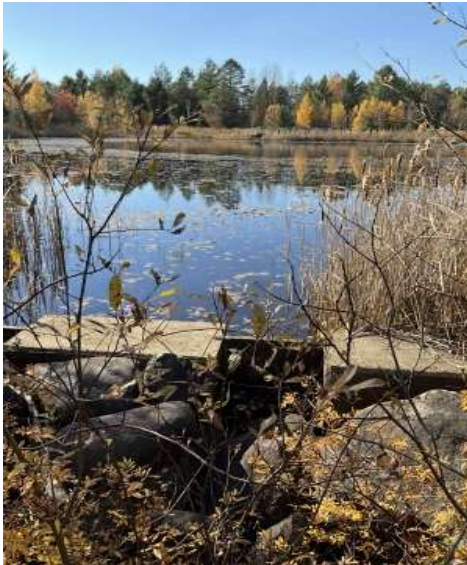
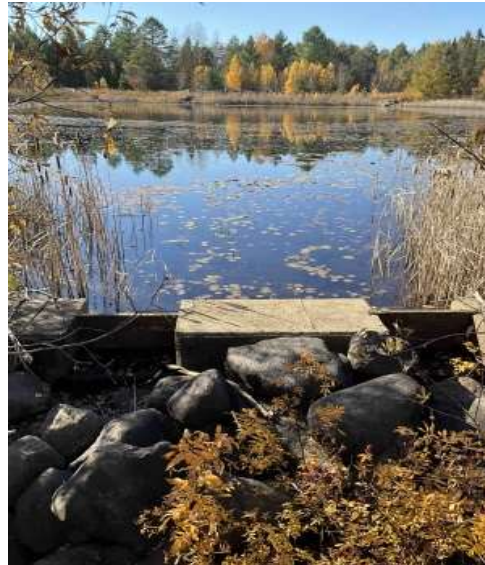
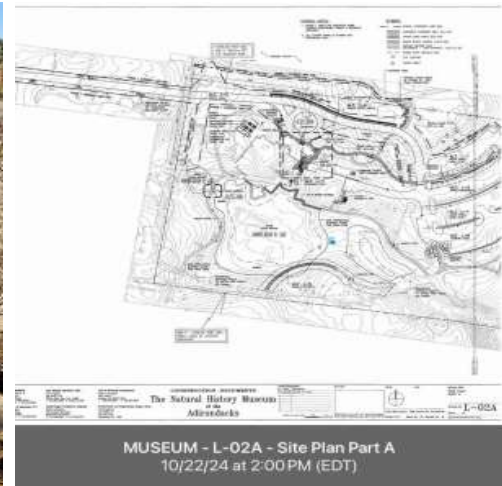
N/A		Civil/LS	Pond	136
--	-----	--	----------	------	-----

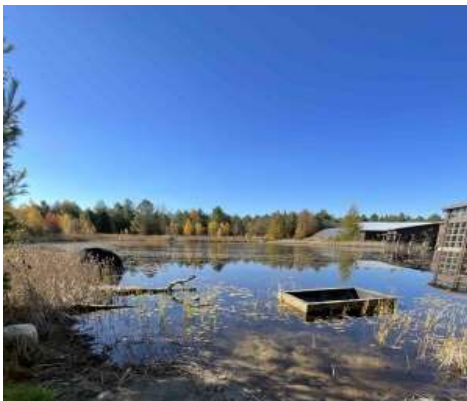
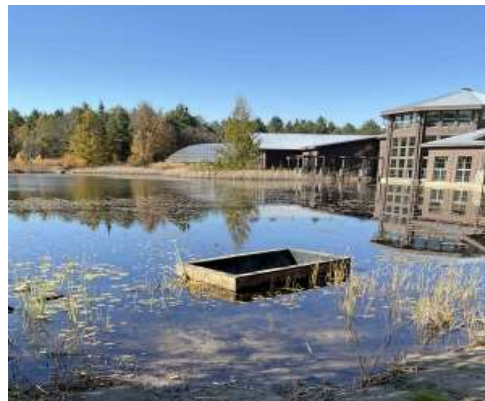
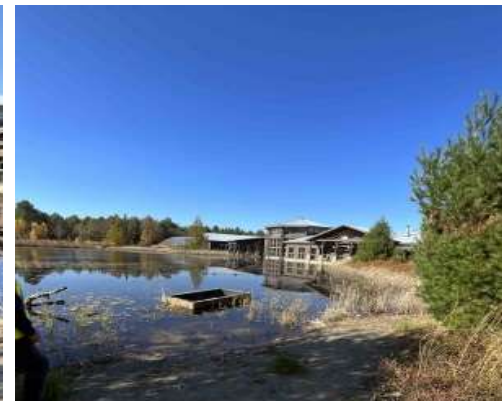
N/A		Civil/LS	Pond	137
--	-----	--	----------	------	-----

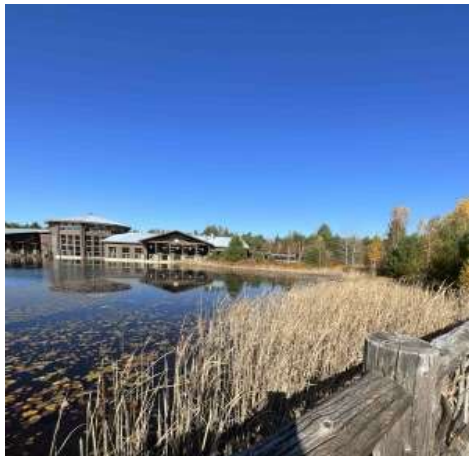
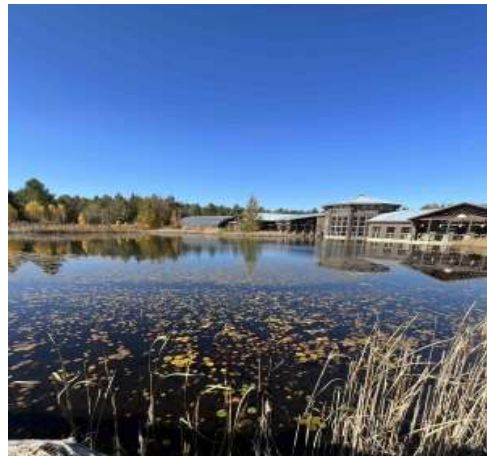
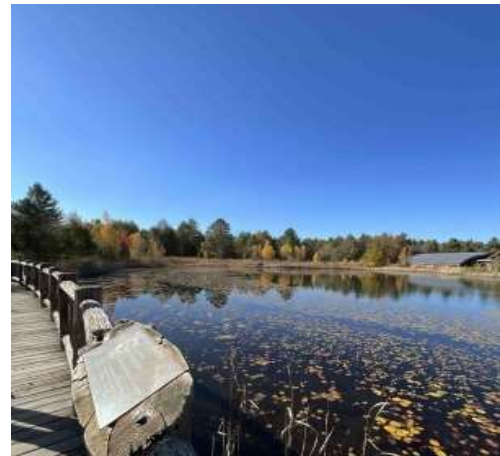
N/A	Civil/LS	Pond	139
-----	----------	------	-----

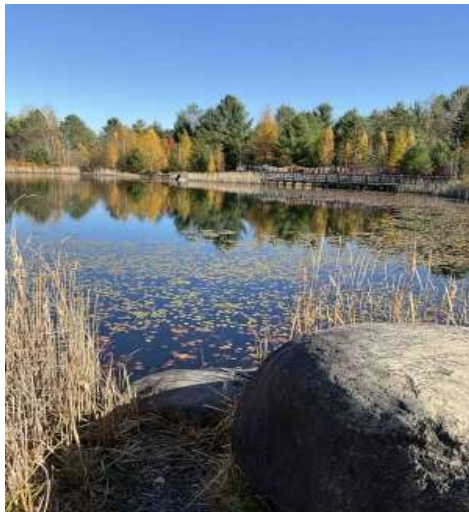
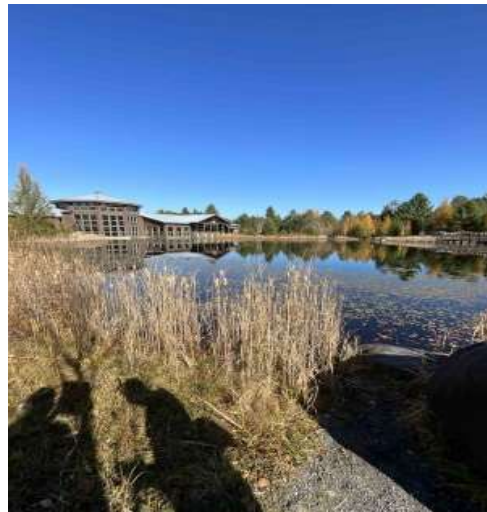
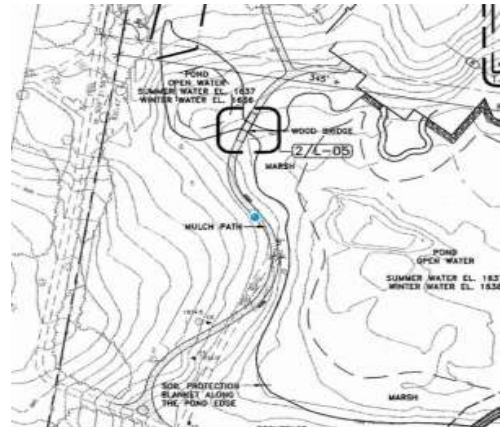
N/A	Civil/LS	Pond	140
-----	----------	------	-----

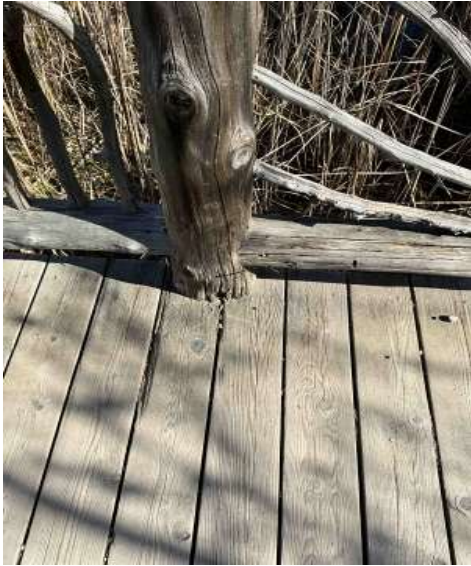
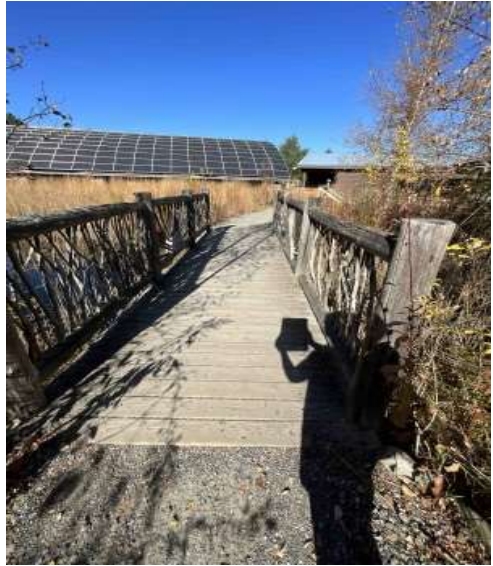
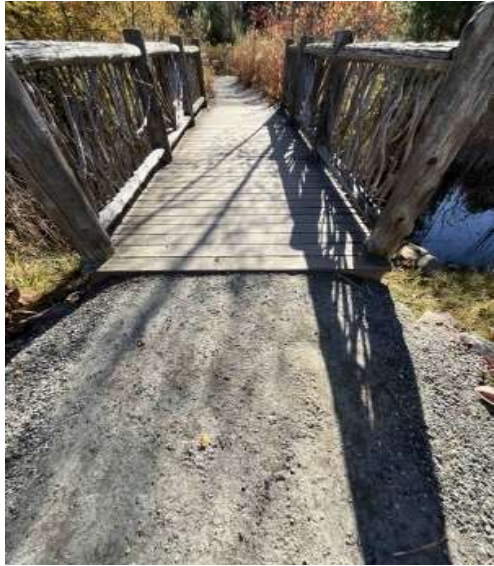
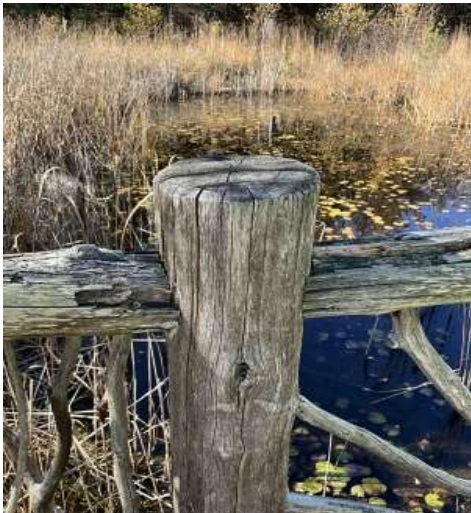
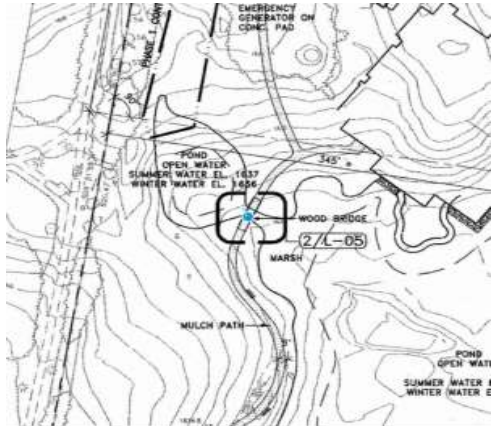
N/A		Civil/LS	Pond	142
--	-----	--	----------	------	-----

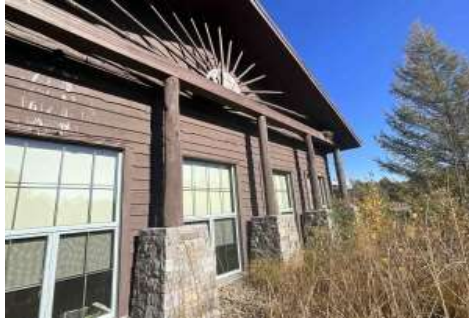
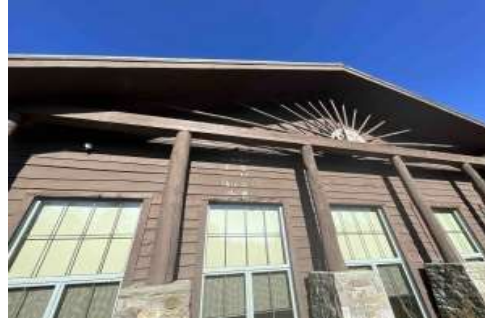
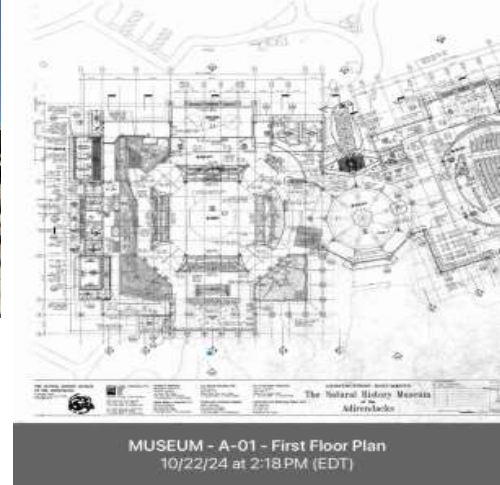
N/A		Siding	Damaged Paint	154
--	-----	--	--------	---------------	-----

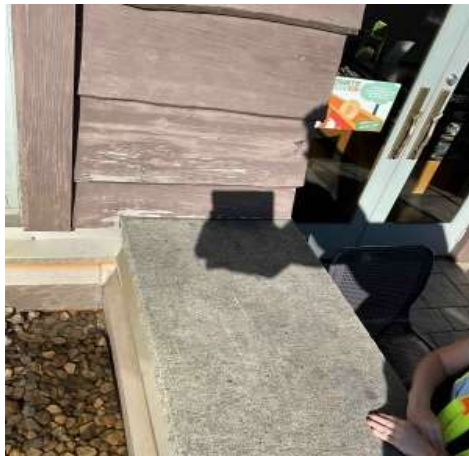
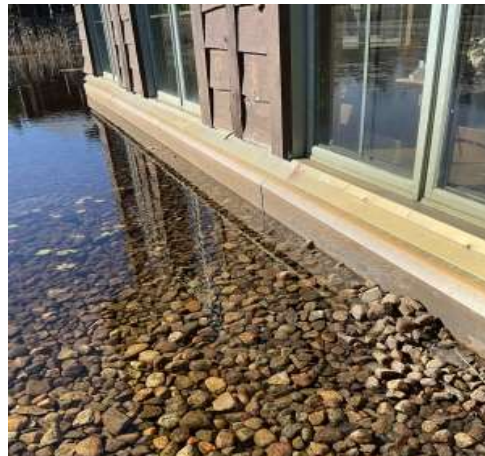
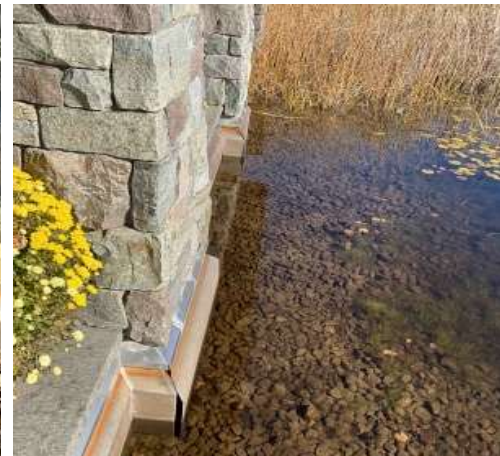
N/A		Civil/LS	Pond	165
--	-----	--	----------	------	-----

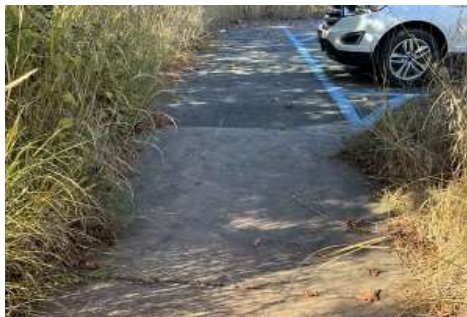
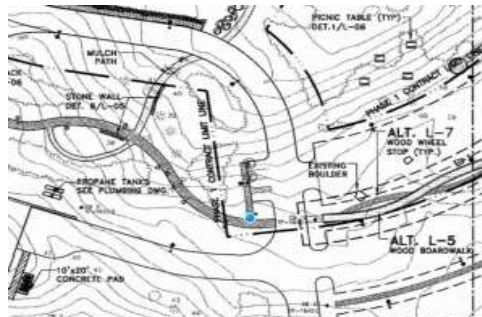
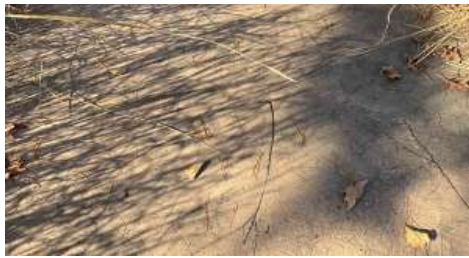
N/A		Civil/LS	Concrete Tripping hazard Concrete	179
--	-----	--	----------	---	-----

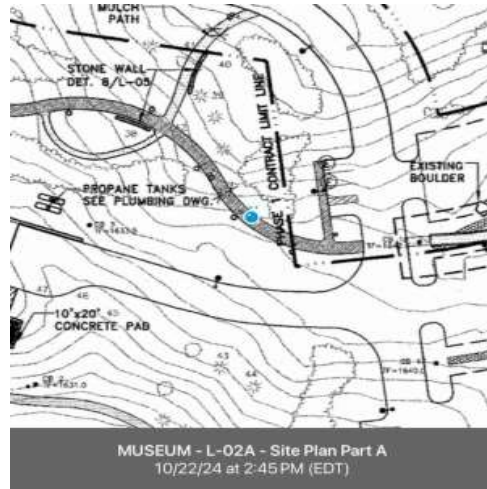
N/A		Civil/LS	Concrete Tripping hazard Concrete	180
--	-----	--	----------	---	-----

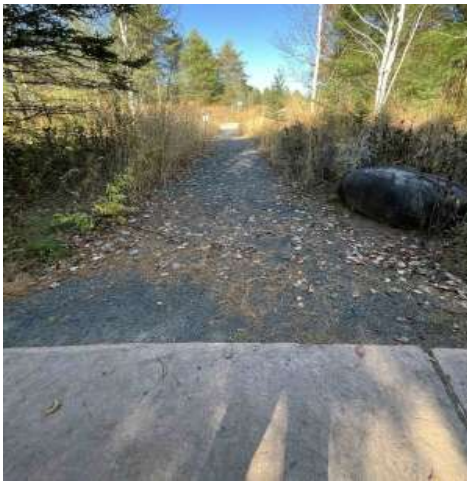
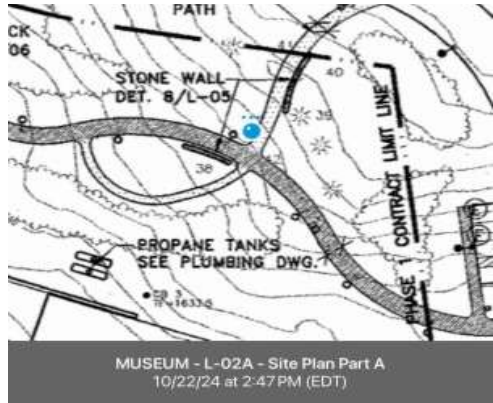
N/A		Civil/LS	Surface change	182
--	-----	--	----------	----------------	-----

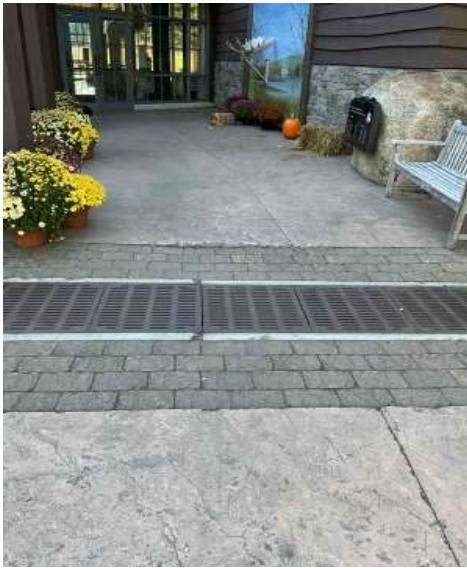
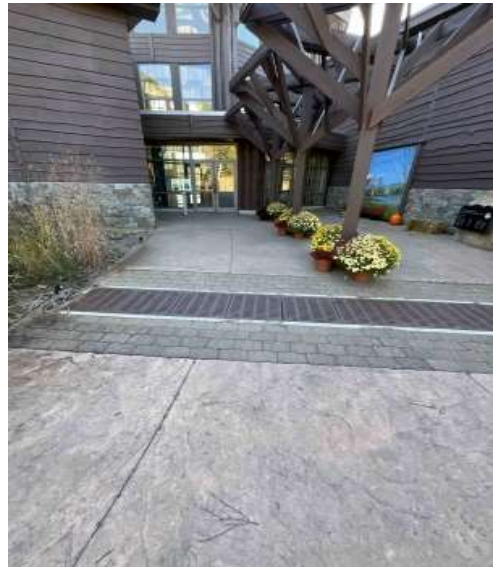
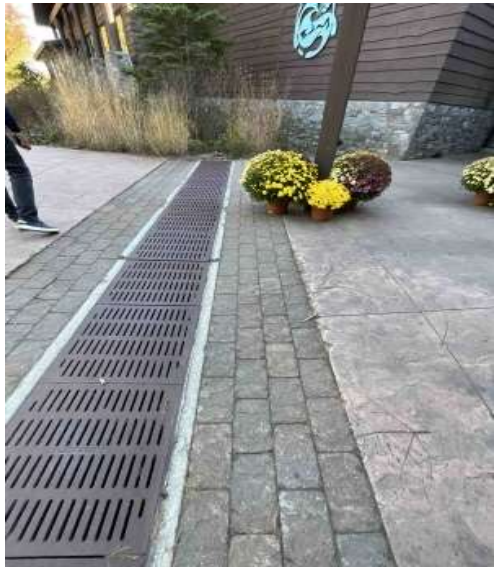
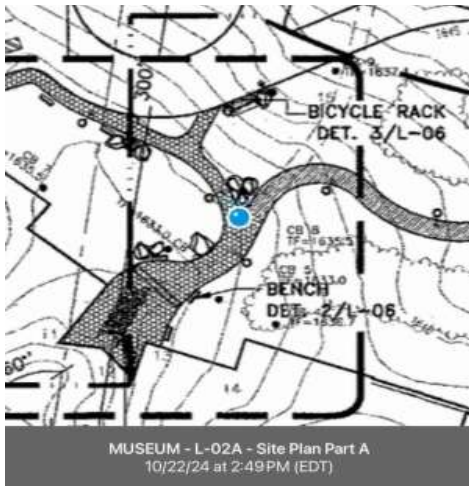
N/A		Civil/LS	Concrete Tripping hazard Concrete	187
--	-----	--	----------	---	-----
