Wild Center Property Condition Assessment

LaBella Project No.: 2244417
Prepared On: 11/6/2024

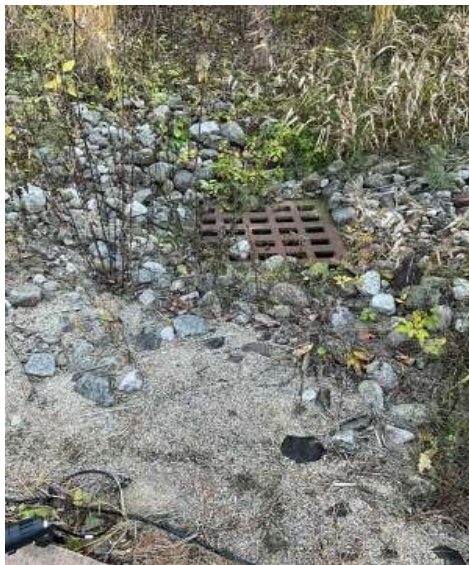
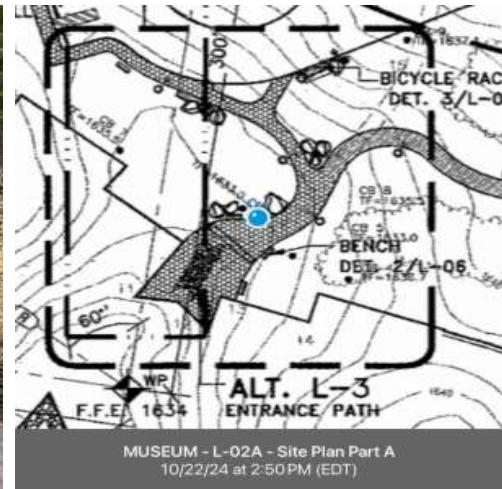
N/A	Civil/LS	Storm drain	188
-----	----------	-------------	-----

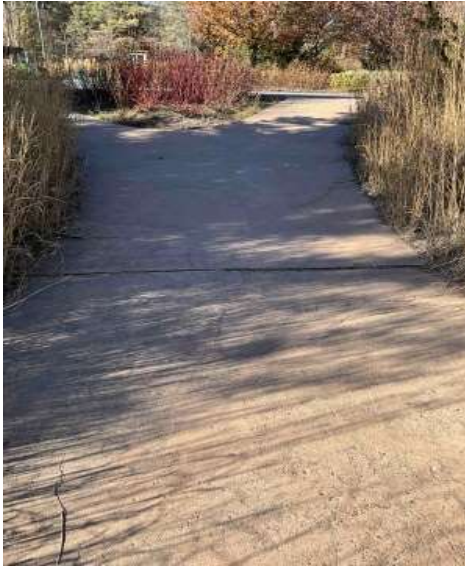
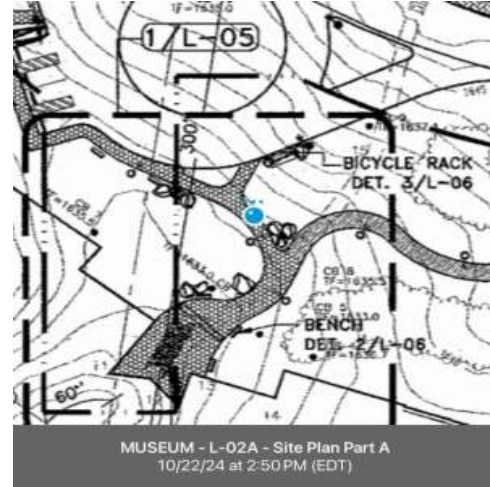
Building	Space Number	Space Name	Element	Description	ID
		N/A	Civil/LS	Concrete Tripping hazard Concrete	189

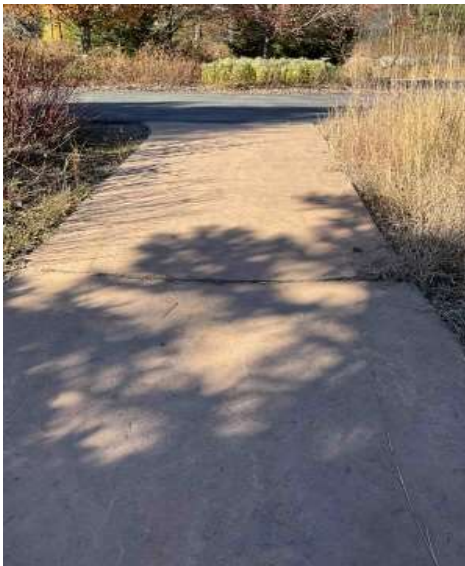
Building	Space Number	Space Name	Element	Description	ID
		N/A	Civil/LS	Concrete Tripping hazard Concrete	191
