## WILD CENTER PROPERTY CONDITION ASSESSMENT NARRATIVE

### 01 EXECUTIVE SUMMARY

#### FINDINGS REPORT AND CONCLUSION

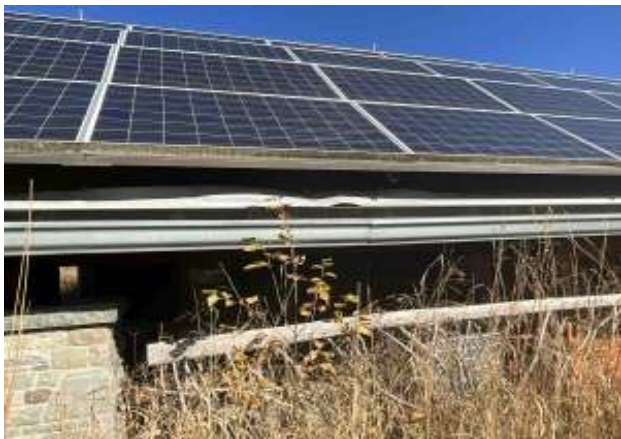
*Roof flashing at solar panel locations*

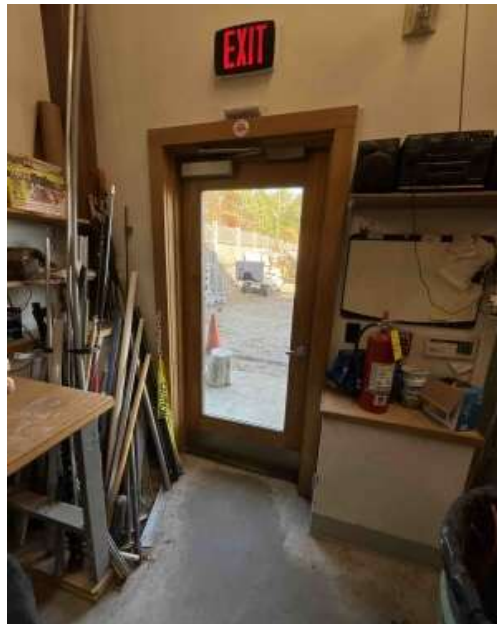
The fire door entrance into the Garage from the office space door is not latching and the exterior exit door has approximately 2-5 year replacement timeline. The overhead door at 108A weather gaskets are failing and frame shows damage. The Garage concrete floor has minor cracking and requires sealing throughout to prolong it's life.

*Garage exterior exit door*

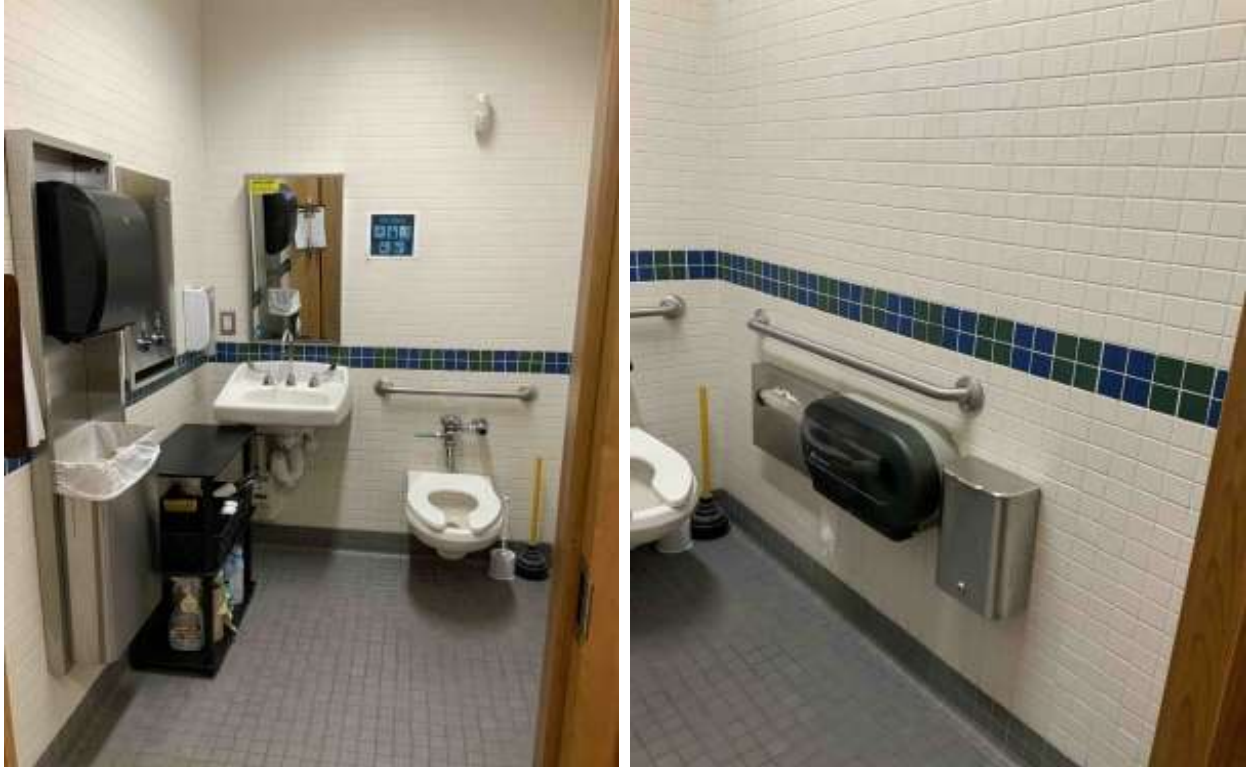
The restrooms are overall in good condition, with wall and flooring tiles remaining well-maintained and intact. Updating the vanity tops and accessories would help to modernize the spaces. To achieve code compliance, a vertical grab bar must be added to the ADA-accessible stall in each restroom, as well as in the unisex toilet room.

*Unisex toilet in admin area*

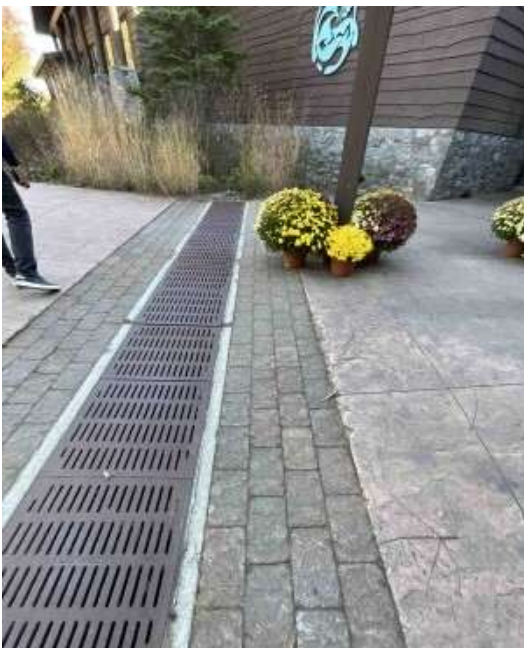
*Figure 1 Stormwater drainage near building front entrance*

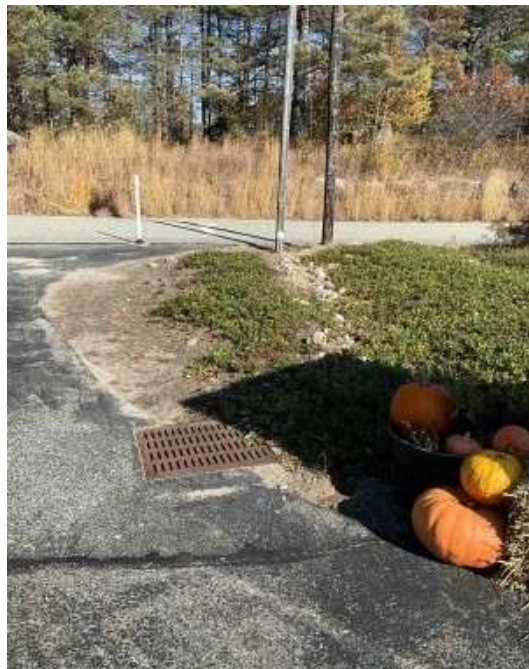
*Figure 2 Stormwater drainage near ADA drop off*
