## WILD CENTER PROPERTY CONDITION ASSESSMENT NARRATIVE

### 01 EXECUTIVE SUMMARY

#### FINDINGS REPORT AND CONCLUSION

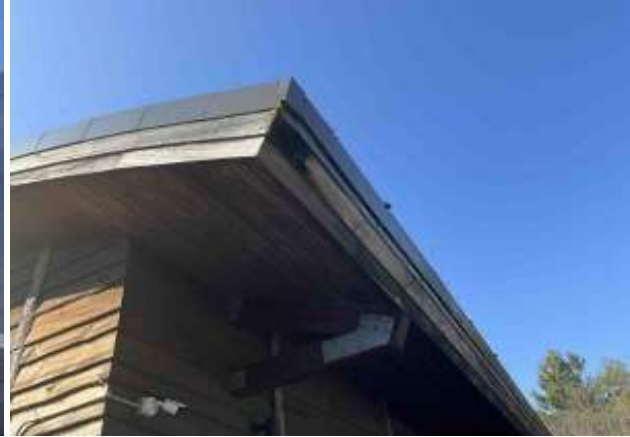
*Roof flashing at solar panel locations*

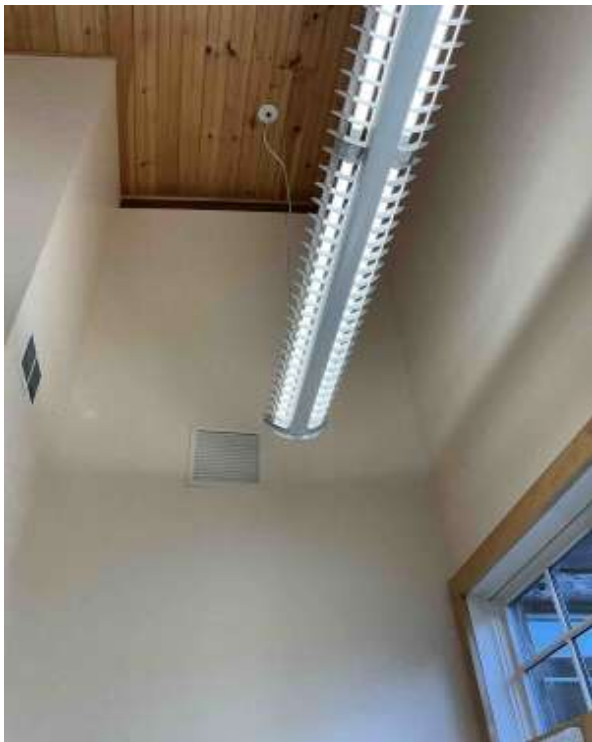
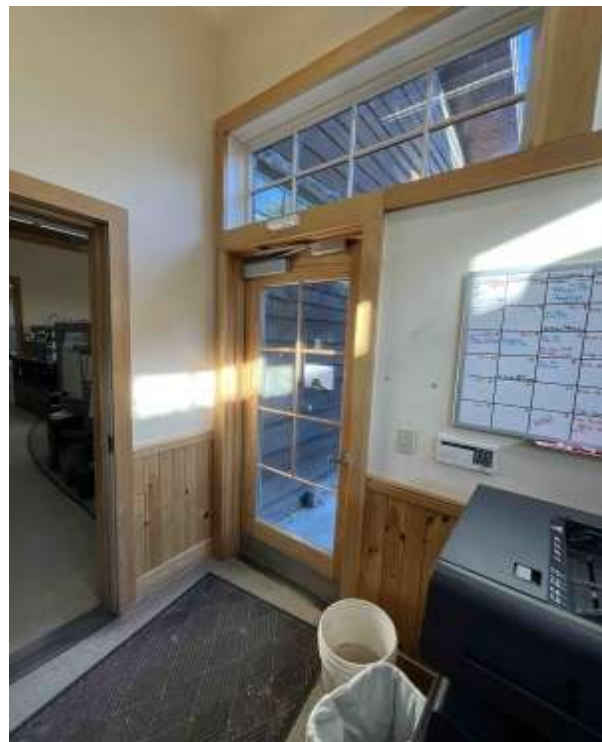
*Vestibules photos*

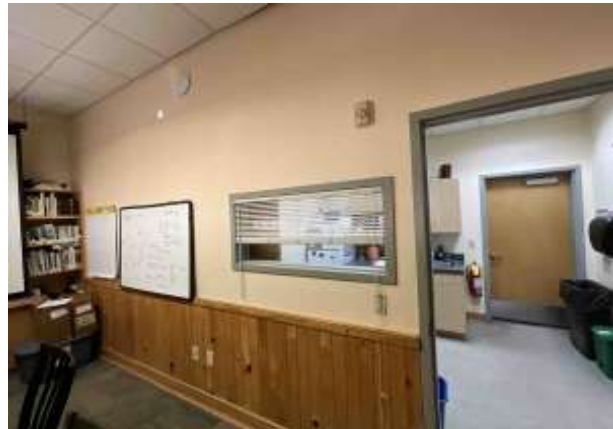
The Conference Room requires some minor repairs to the ceiling and patch and paint areas of walls. The adjoined Kitchenette is missing cabinet pulls but otherwise in good condition. And the HC Bathroom slate wall and floor tiles have staining and there's minor degradation.

*Conference Room into Kitchenette*

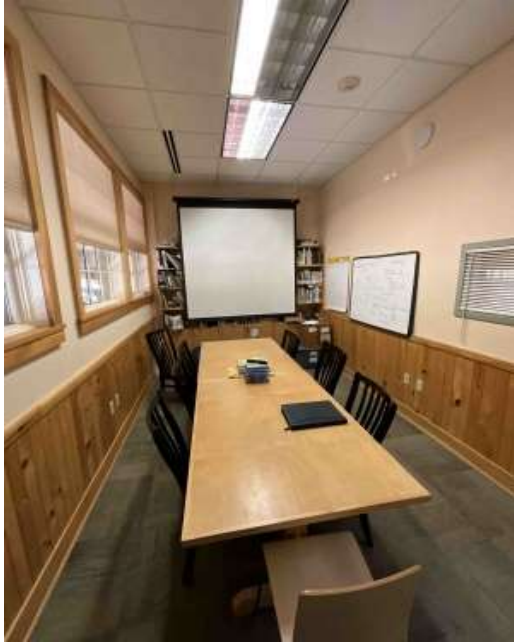
*Conference Room*

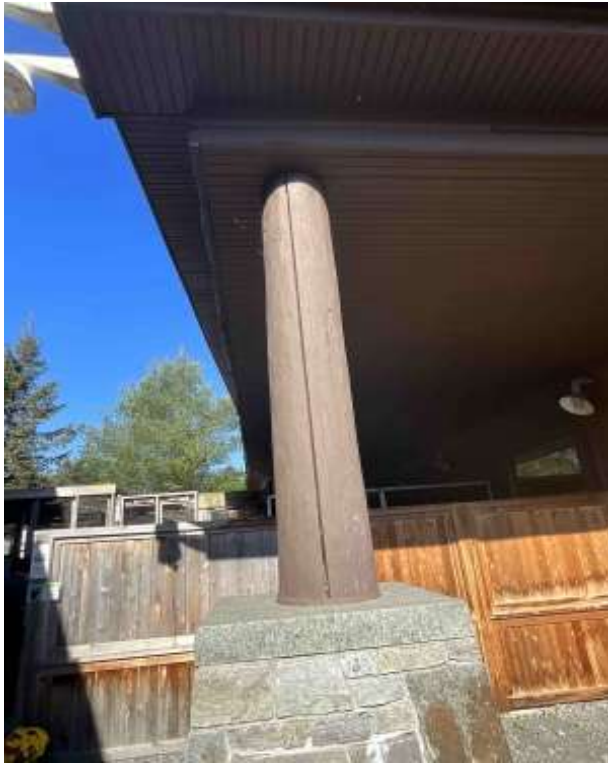
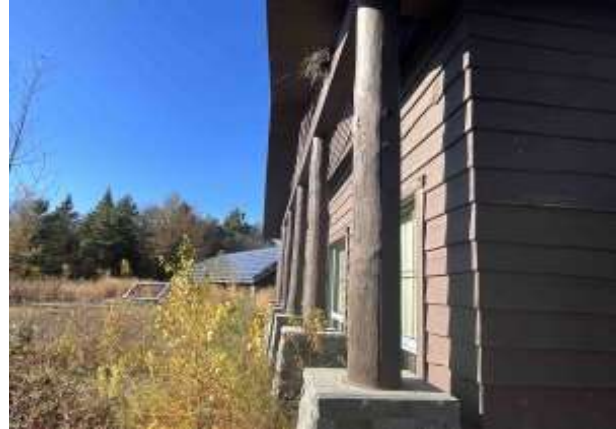
*Examples of timber columns*

Sections of the wood siding around the perimeter show signs of weathering, including peeling paint and minor rot. Repainting and selective board replacement are needed. Minor cracks and warped boards need replacement to restore integrity and appearance. Evidence of moisture damage in some areas should be mitigated to prevent further deterioration. There are some damaged timber columns as well that will need repair or maintenance.

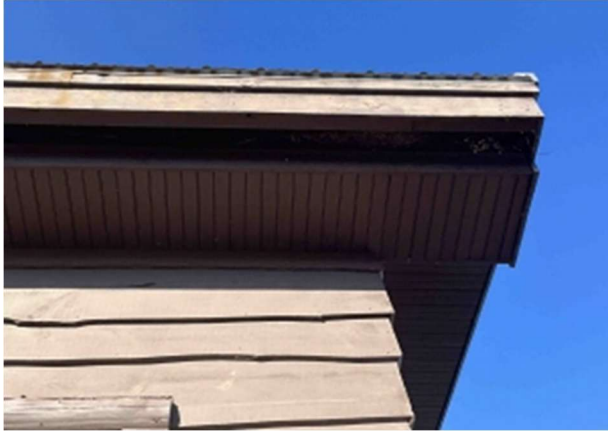
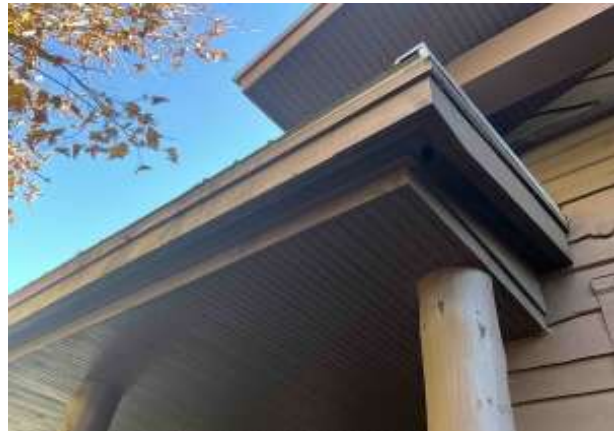
The corrugated metal roof system is structurally sound, but repairs are required to address areas of water leakage. The soffit and fascia components of the building are generally in good condition but require minor repairs to maintain their functionality and appearance.

*Examples of soffit and fascia*

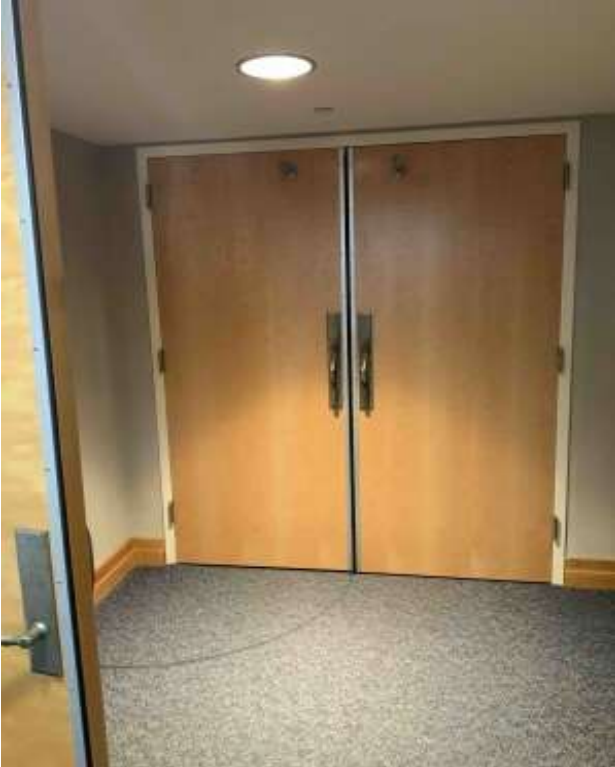
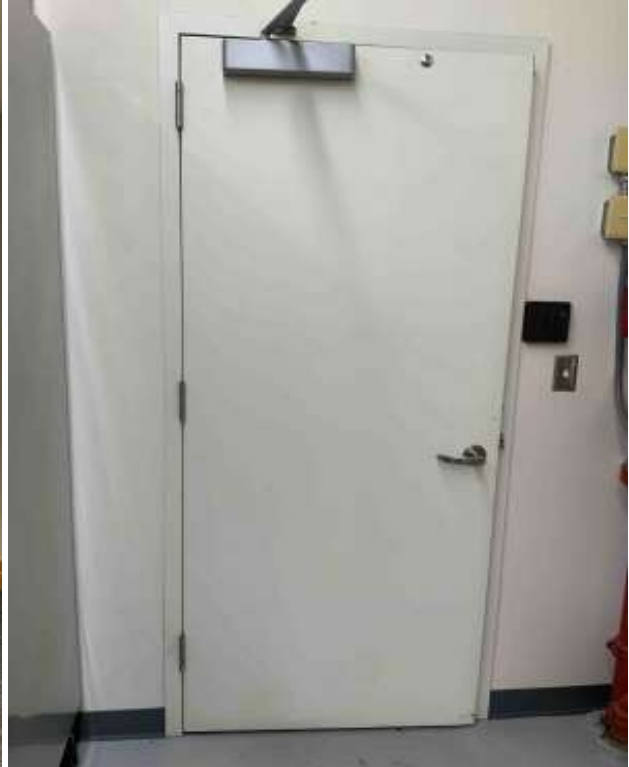
The interior doors throughout the building are generally in good condition, with no major structural or functional issues. However, regular maintenance and minor updates can help ensure continued functionality and appearance over time. We recommend replacing approximately half of the interior doors within 5 years and door hardware every 2 years for the next 10 years.

*Examples of wood and metal interior doors*

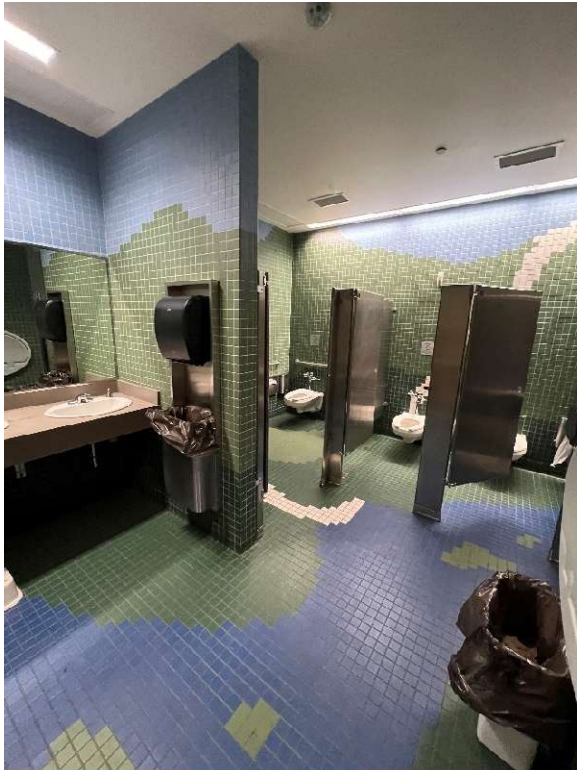
The restrooms are overall in good condition, with wall and flooring tiles remaining well-maintained and intact. Updating the vanity tops and accessories would help to modernize the spaces. To achieve code compliance, a vertical grab bar must be added to the ADA-accessible stall in each restroom, as well as in the unisex toilet room.

*Ladies public restroom*

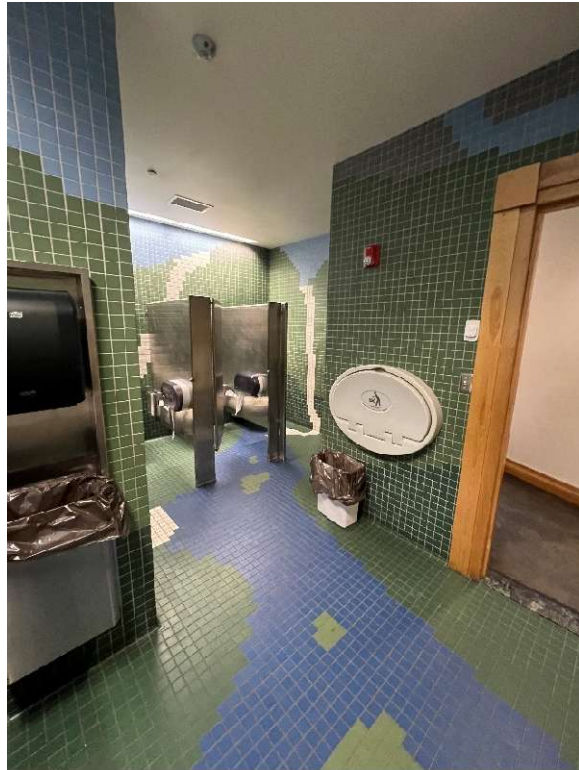
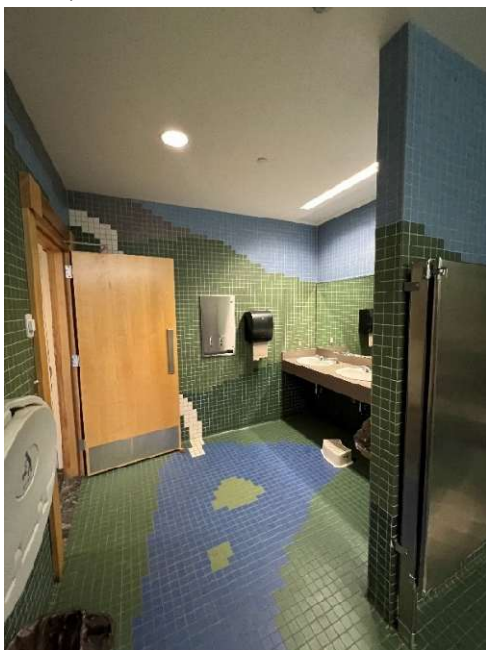
*Ladies public restroom*

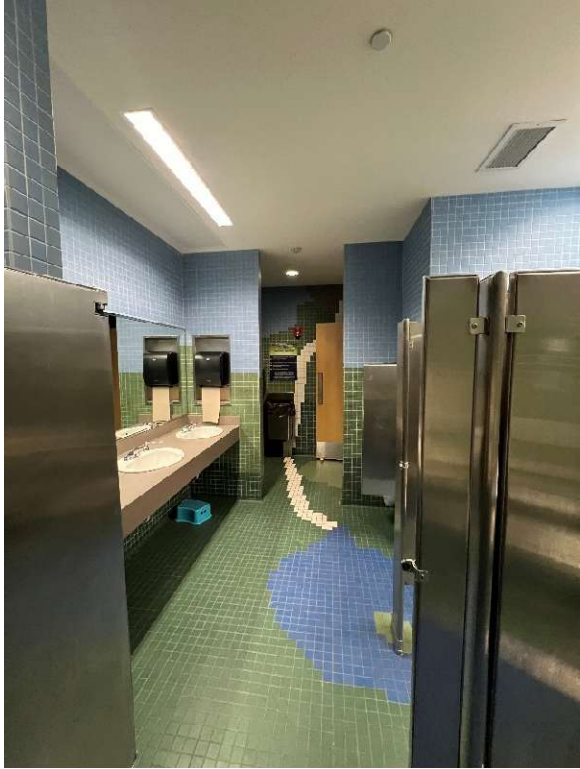
*Mens public restroom*

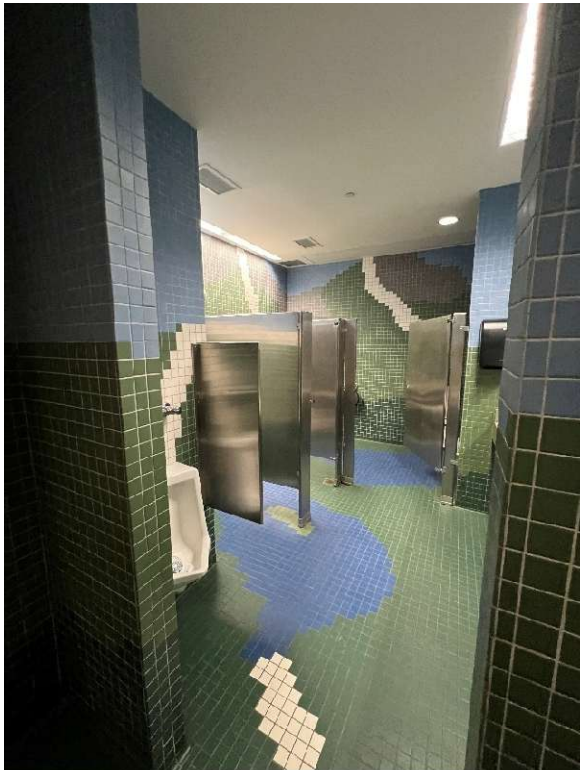
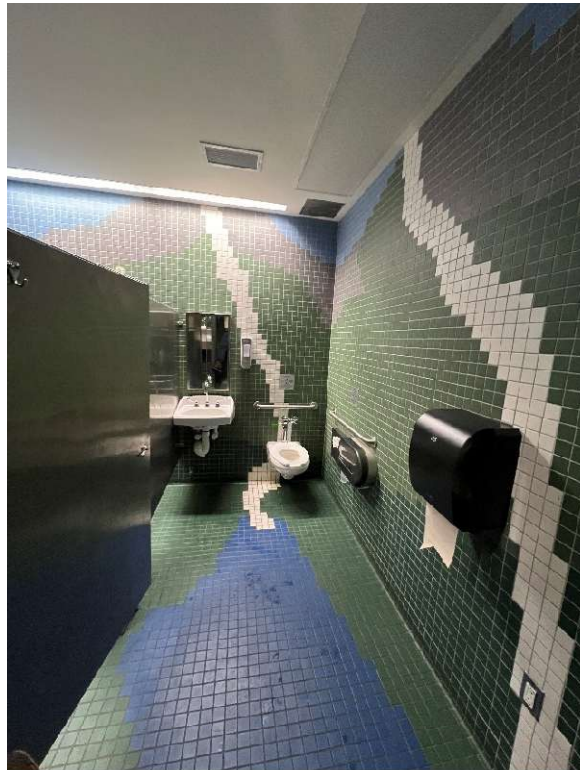
*Mens public restroom*

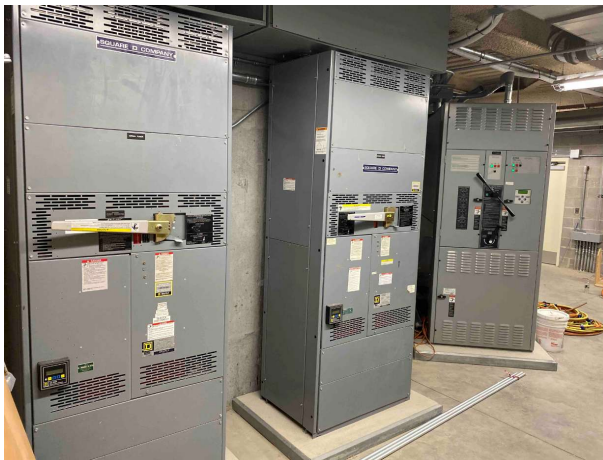
*Main switchgear and panelboards: Housekeeping*

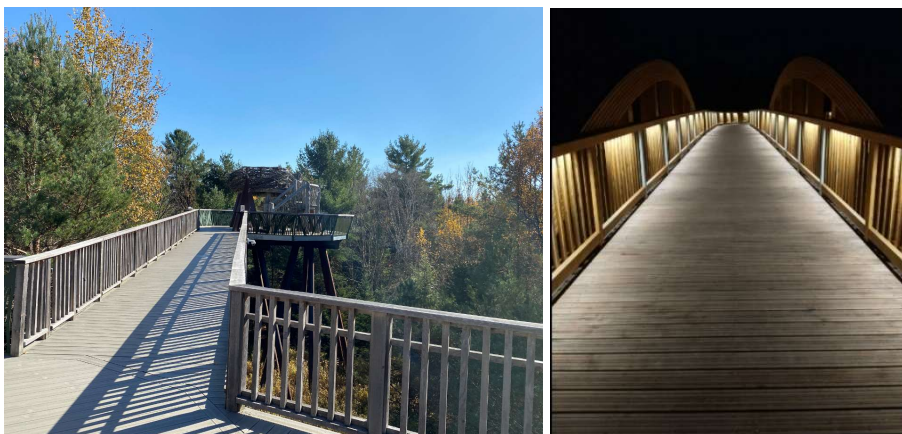
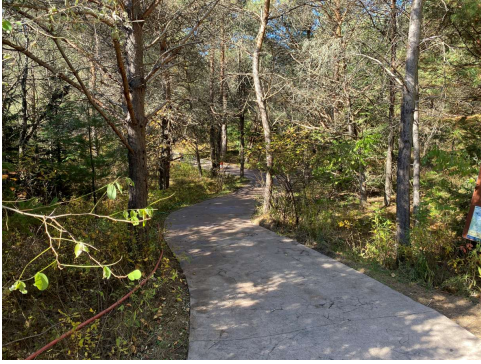
*Exterior Lighting:*

- Some pole mounted luminaries are missing on the entrance pathway.
- Egress walking paths within the preserve have limited to no lighting in almost all areas.

- **Exterior Lighting:** Recommend all lighting be updated to LED in existing locations to reduce energy costs and provide more adequate coverage for safety. Recommend replacement of light pole fixtures that are not currently working. Recommend installing light poles in locations where older poles have been damaged or no longer exist, to provide proper light coverage for visitors entering and exiting the facility.

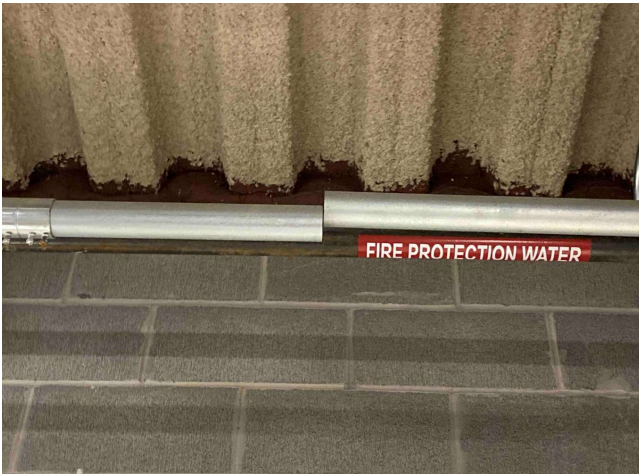
*General:*

Conduit in basement is being infiltrated with water as it transitions from external to internal.

- Recommend investigating and remediate the cause or removing in entirety. Existing conduit was cut open to remove water.
